CK-2453  
CK-2453

NORRISH 7.4km

2022 Inspection

Crossing Name Norrish Creek

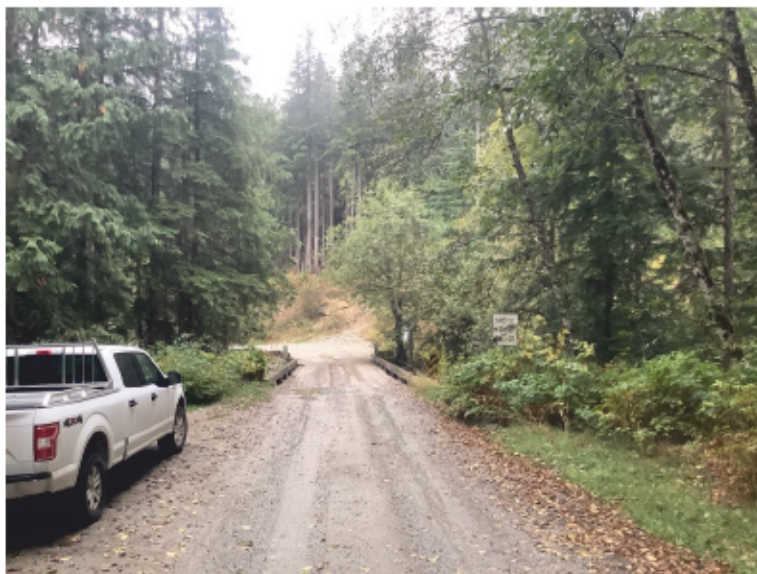
Approach from Left Bank when facing downstream

Left approach missing

| Repair Item | Repair Description |
|---|---|
| 1 Approach. Bridge Ahead<br>Signs. # of signs.<br>Priority:Low | Left approach |

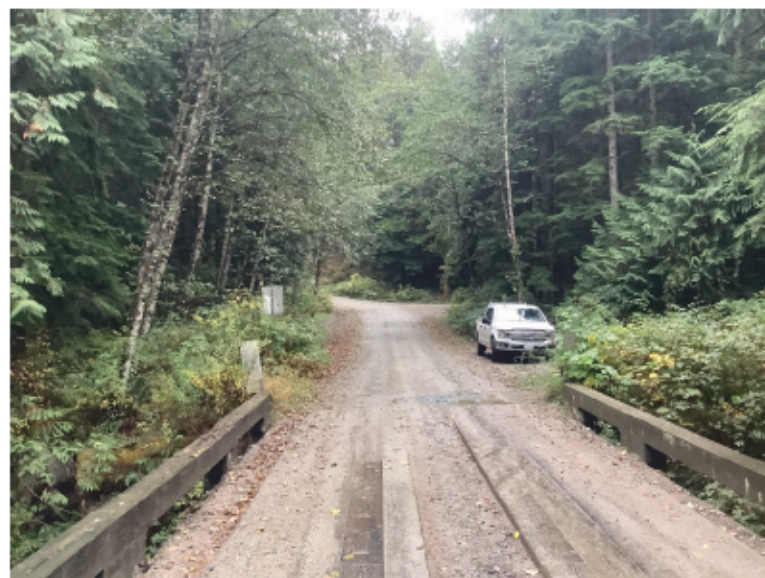
Approach from bridge deck of Left bank approach when facing downstream

Water runs onto deck from left approach.

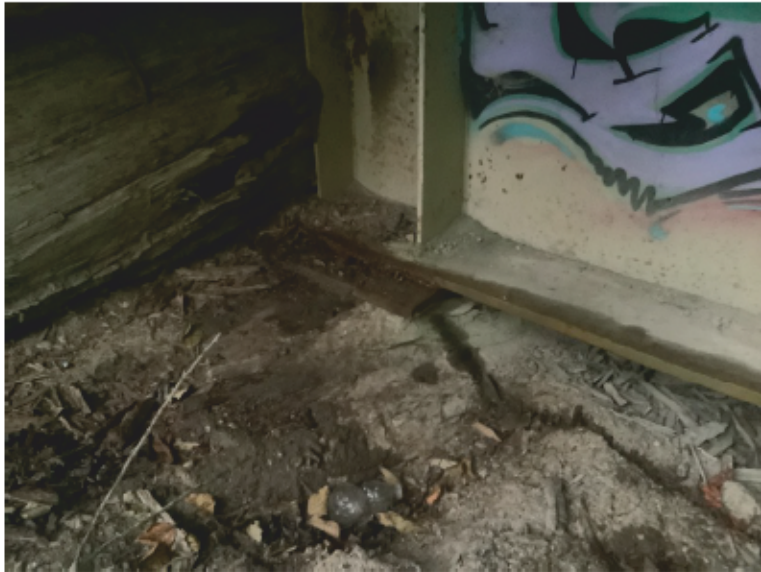
Bearing

Bearings Fair

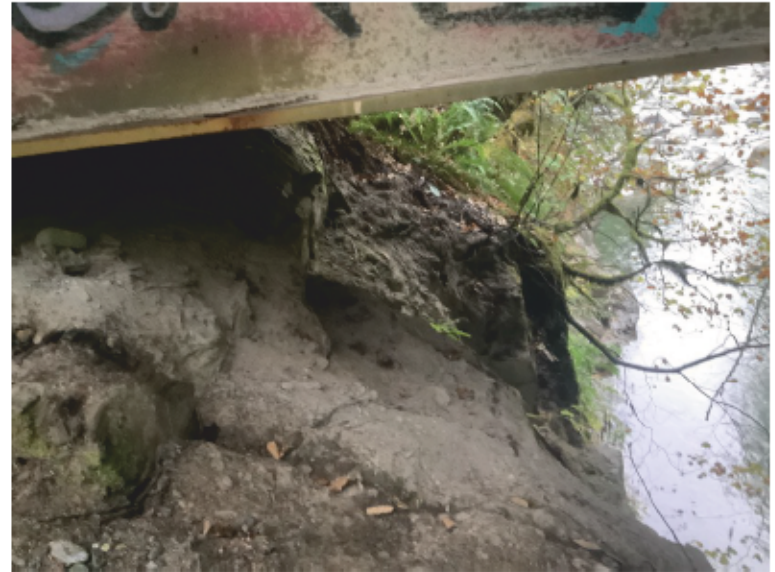
Right Bank Abutment when facing downstream

Ravelling below fill retainment logs on both sides.

| Item | Monitor Description | Frequency |
|---|---|---|
| 1 Erosion on both banks | | Routine Inspection |

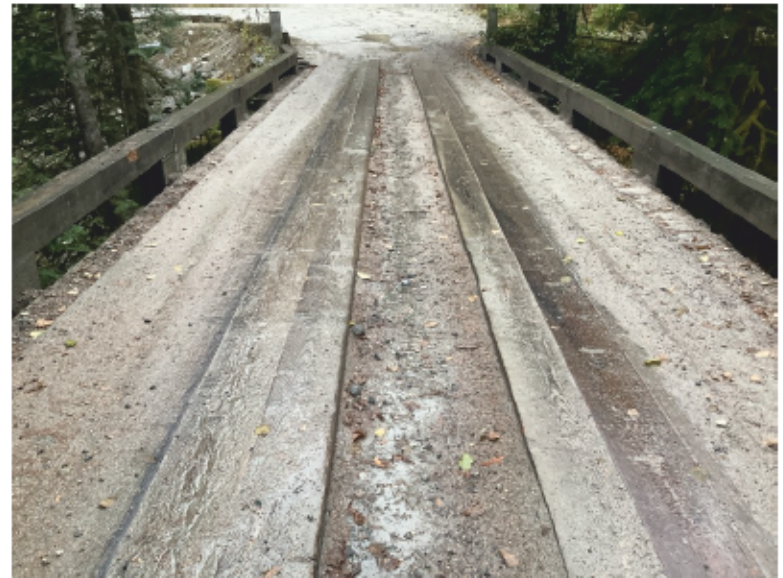
Deck

Sediment accumulating on deck

Slightly loose. All hardware present, likely due to age

Fair
