CK-2459  
CK-2459

HORNET 0.4km

2022 Inspection

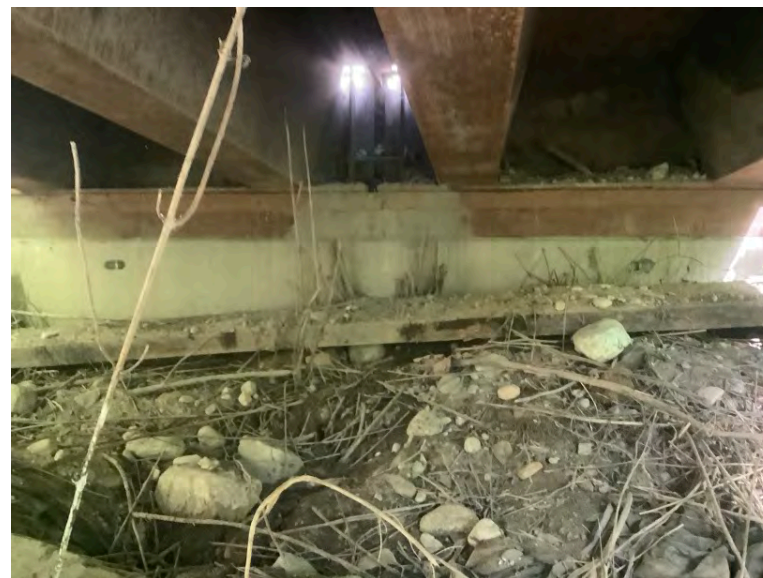
Bearing

Bearings **Good** 4x10 atop a 6x10 timber

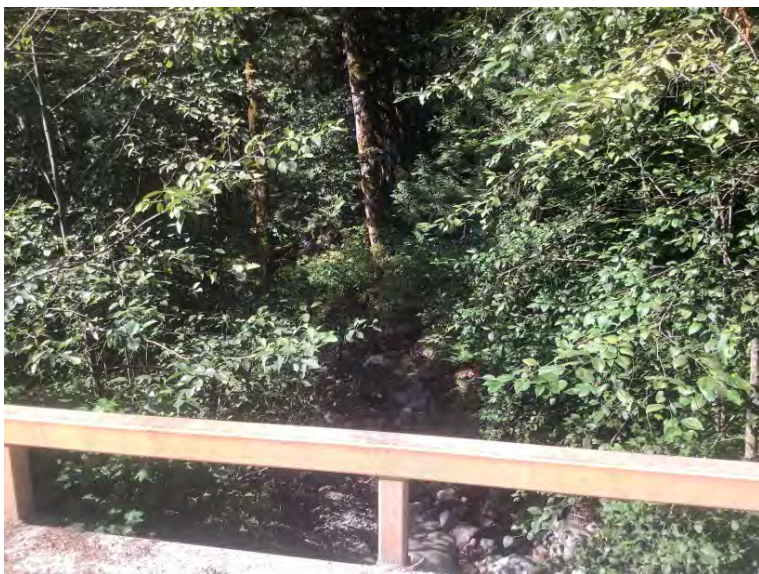
Downstream from Crossing

Riprap **Fair** Steep with some downstream scour, bearings set far back so low risk

Comments Monitor downstream scour. Currently stable.

| Item | Monitor Description | Frequency |
|---|---|---|
| 1 Downstream riprap | | Routine Inspection |

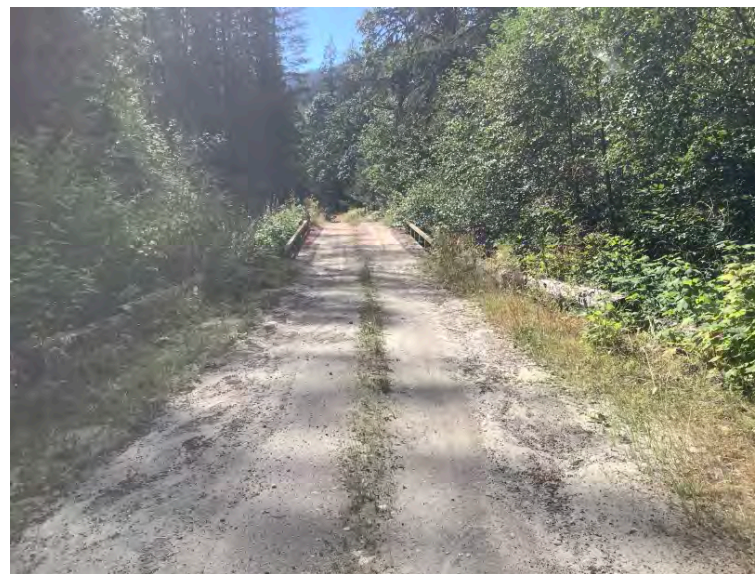
Approach from Right Bank when facing downstream

Brushing Required **Y** Minor brushing required

| 1 Approach. Area/sight line brushing. m². Priority:Low | |

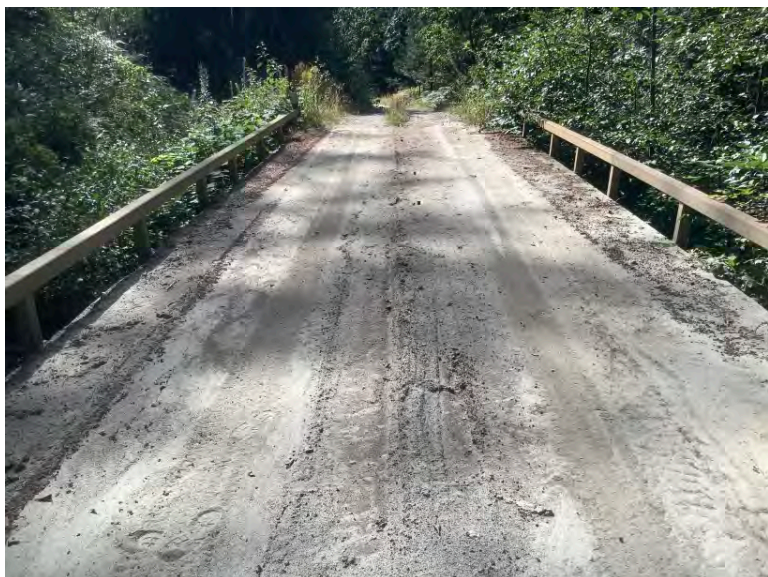
Steel Deck Plate      **Good**      Fines accumulating on deck. Should clean

Comments: sweep/ clean deck
