CK-2462  
CK-2462A

HORNET 2.8km

2022 Inspection

Structure Class Temporary Bridge

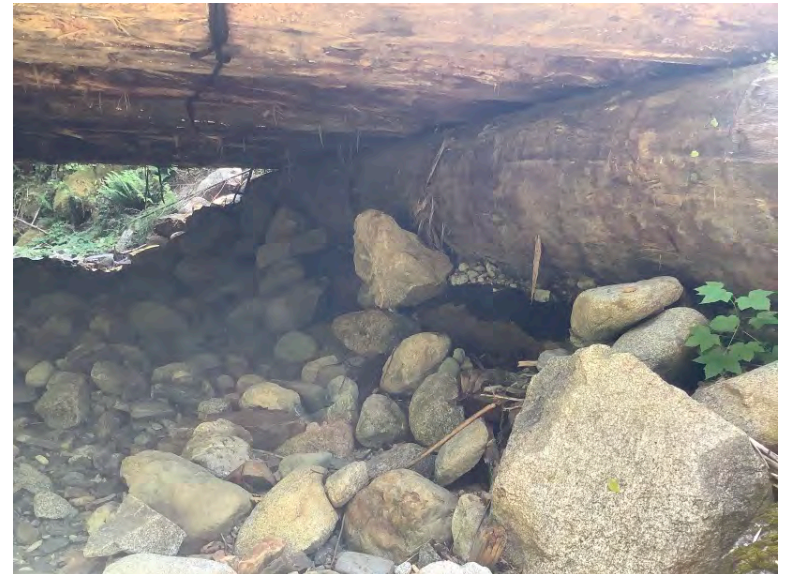
Left Bank Abutment when facing downstream

Large over sized single sills sitting above/behind old bottom crib log

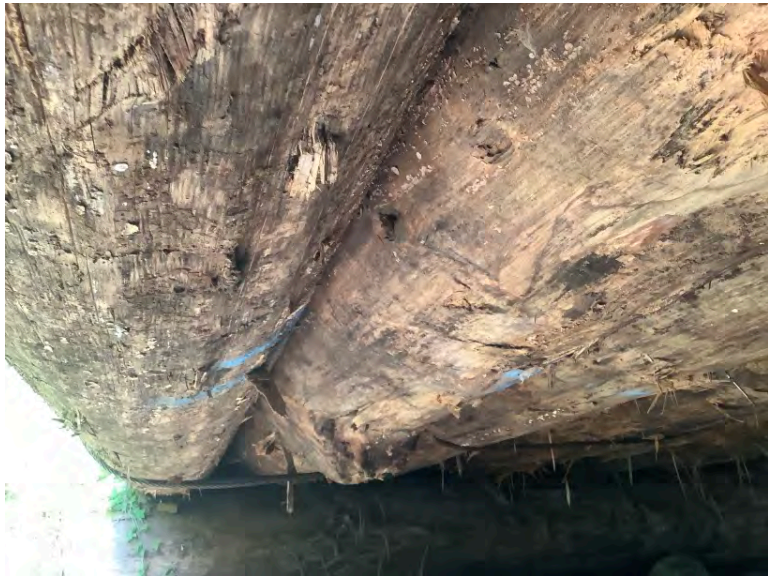
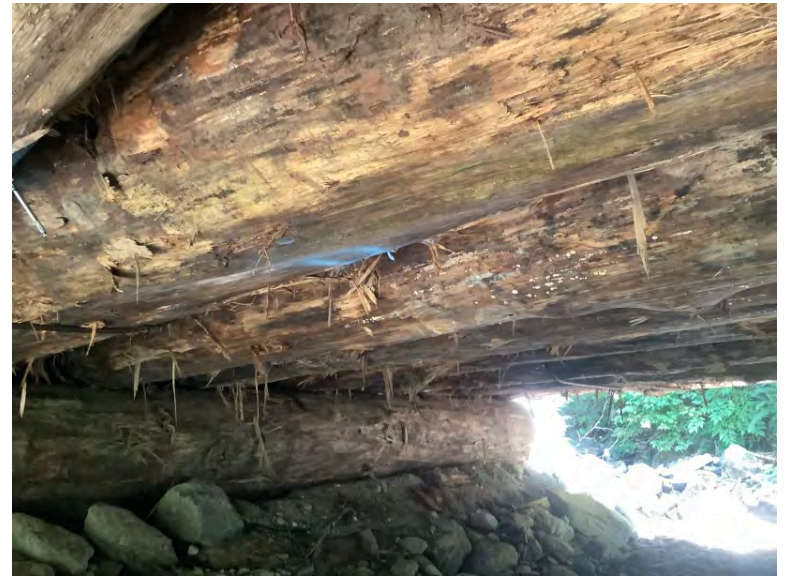
Stringers

| 2 | Fd | Y | 845 | 55 | Fair | Spot checked interior stringers. All appear |
