CK-2466  
2466

GARNET 7.6km

2022 Inspection

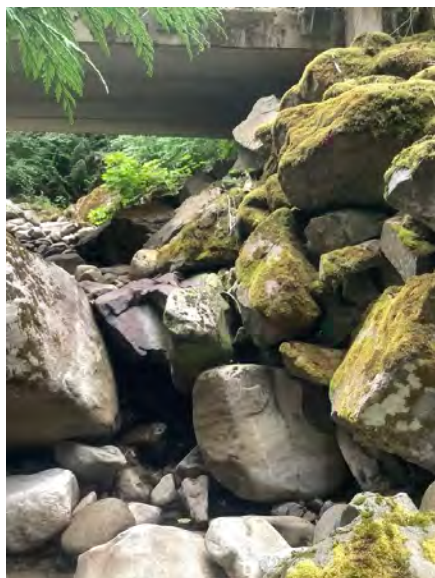
Riprap **Fair** Downstream left oversteepened. Scour around large rock within channel and at toe

Riprap and scour left bank

| Item | Monitor Description | Frequency |
|---|---|---|
| 1 | Monitor left bank riprap toe for further scour | Routine Inspection |

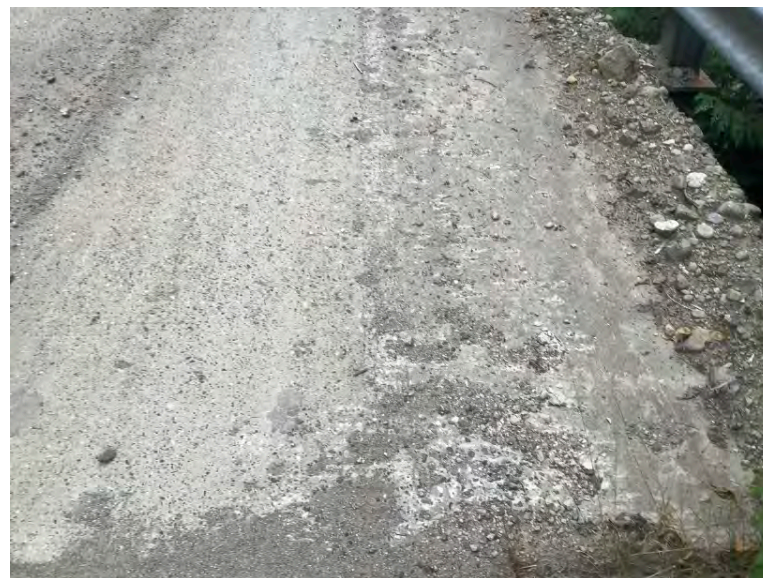
Comments: monitor deck panel damage

Concrete Deck      **Fair**      Some damage from tracked machines
