CK-2472  
CK-2472

MAISAL 11.5km

2022 Inspection

Crossing Name Upper Maisal

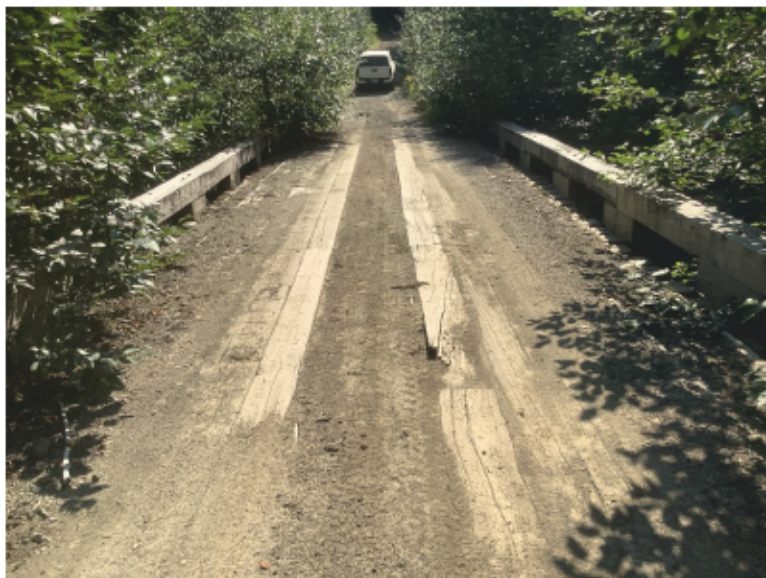
Running Planks      Fair      Few boards needs to be renailed

Deck to Girder Bolts      Poor      No clips or bolts to top flange observed. Panelized deck appears to rely on gravity load only for restriction onto girders

| Repair Item | Repair Description |
|---|---|
| 3 Structure. Timber deck maintenance. # of signs. Priority:Medium | Fasten deck panels to girders |
