CK-2474  
CK-2474

NAHATLATCH 46km

2022 Inspection

Inspection Company Chartwell Resource Group Ltd

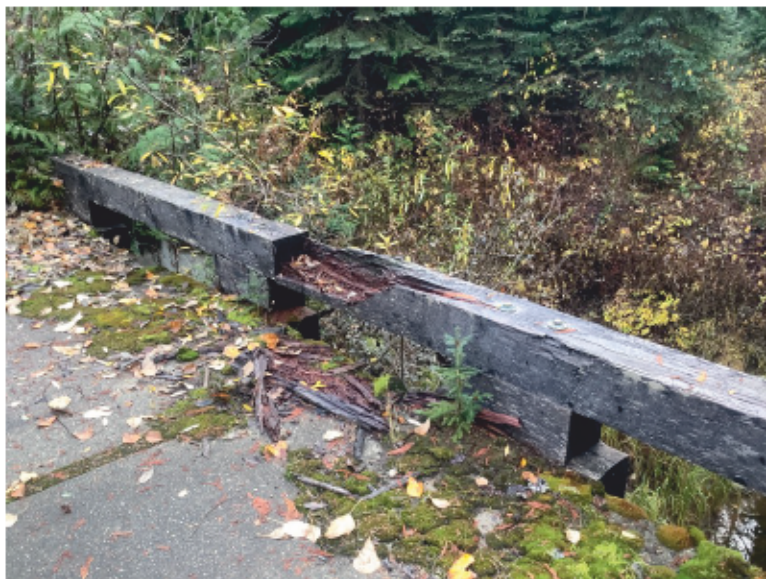
Guard Rail

Load Rated by: MoF, M.Lowe, RPF, PEng, February 16, 2023  
Load Rating: 5 Tonnes GVW  
Next Inspection: September 1, 2025  
Comments: Load rating reduced due to guard rail condition. Replace rails to achieve design load rating.

Curb Rail/Blocks/Posts      Poor      Rotten

Overall Deck Condition      Poor      Due to guard rail condition.

- 1 Structure. Concrete structural maintenance. m<sup>2</sup>. Priority:Low Low due to access
- 2 Structure. Joint replacement. m<sup>2</sup>. Priority:Low Low due to access
- 3 Structure. Full Curb Replacement. . Priority:Medium
- 4 Approach. Area/sight line brushing. m<sup>2</sup>. Priority:Low

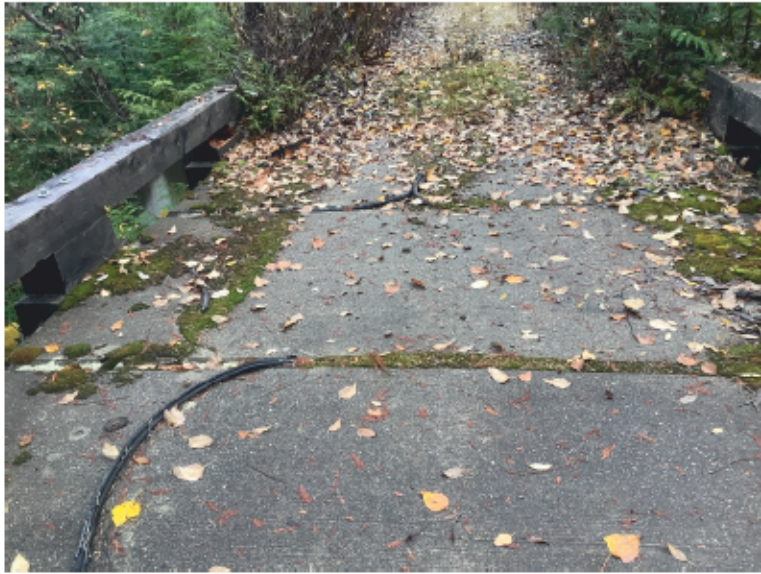
Concrete Deck      Fair      Damage to panel 1 from left bank. Removable panels

Deck Joints      Poor      Rubber gaskets failing

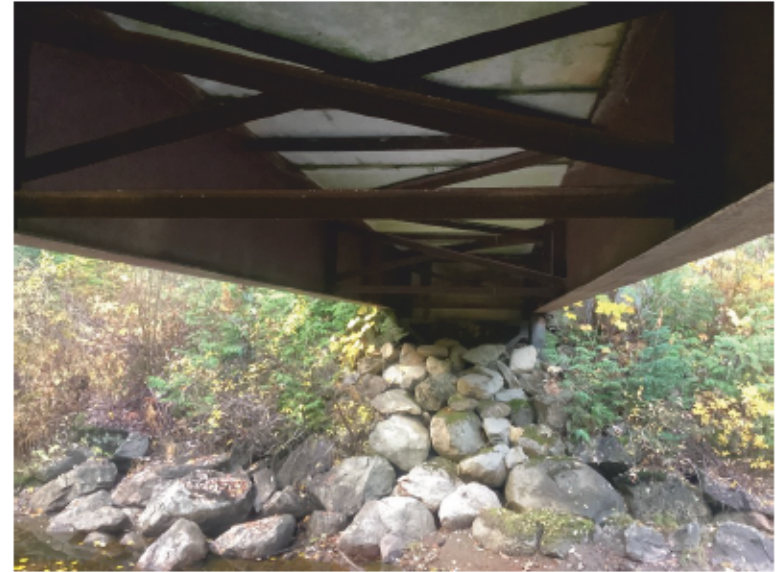
Superstructure

Girders Fair

Minor corrosion through

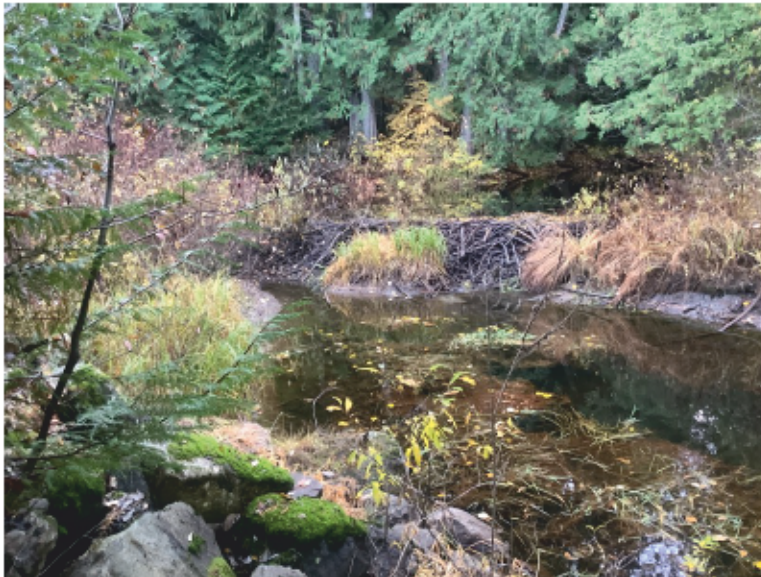
| Comments | 5' beaver dam directly upstream. | | | | |

Beaver dam 15m upstream 5' tall
