CK-2475  
CK-2475

NAHATLATCH 46.5km

2022 Inspection

Crossing Name Nahatlatch River

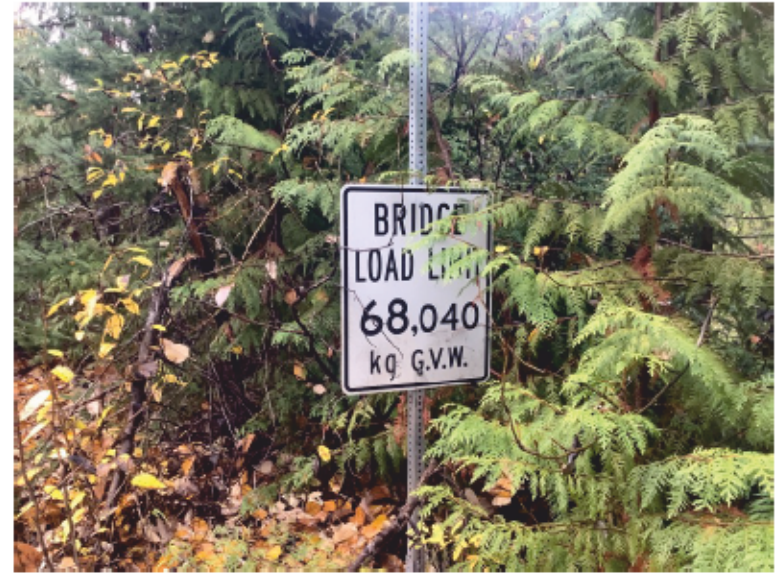
Load Rating Sign

Posted Load Rating 68040

Last inspection stated wrong load limit posted

| Repair Item | Repair Description |
|---|---|
| 4 Structure. Add Load Rating Signs. # sites. Priority:High | Install updated load rating |

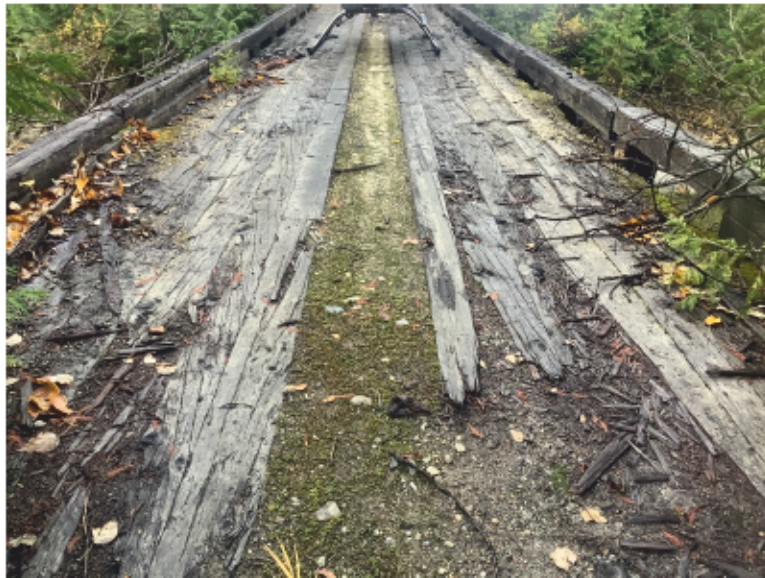
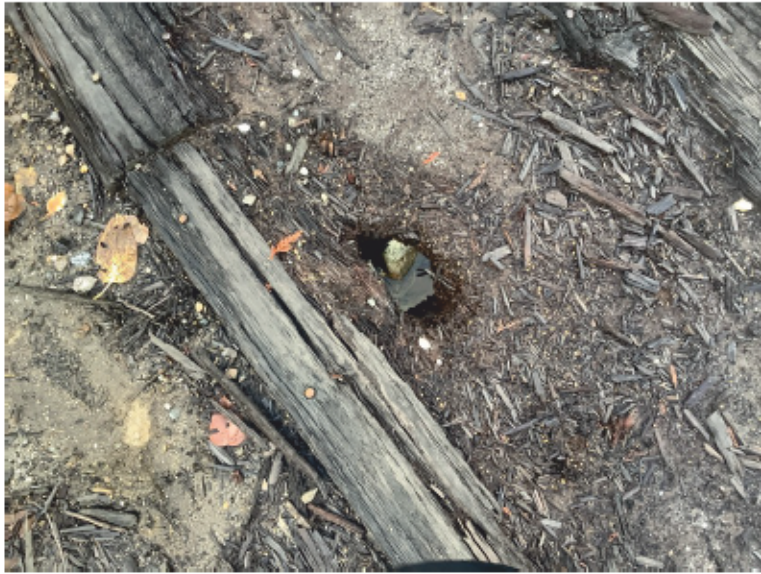
| Running Planks | Poor | Rotten/ worn past usable life span |

| Sub Deck | Poor | Creosote - due one hole 10m from left end. |

| Nails | Poor | Protruding. |

| Overall Deck Condition | Poor | Due to rail and plank condition |

| Repair Item | Repair Description |
|---|---|
| 1 Structure. Major redecking (crossies or laminated deck). m. Priority:High | Running planks and entire guard rail system. Hole in sub deck to be replaced. Depending when works are carried out entire sub deck may require replacing. |

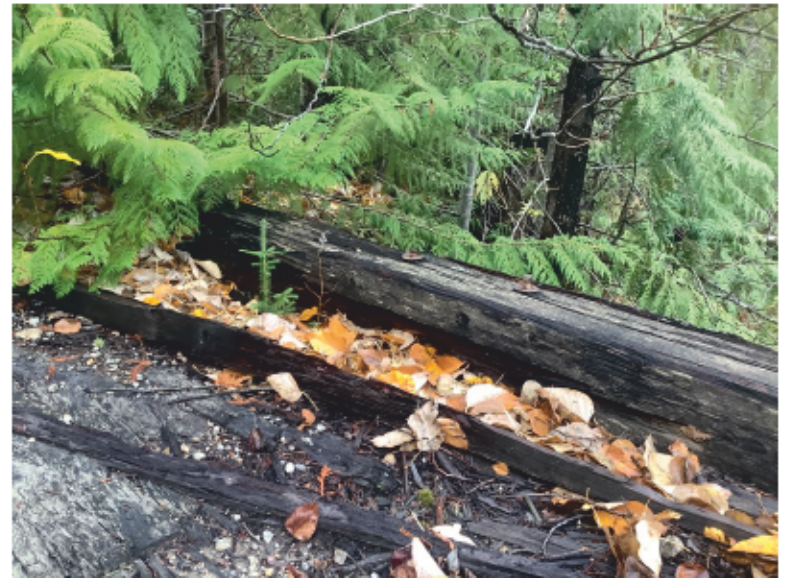
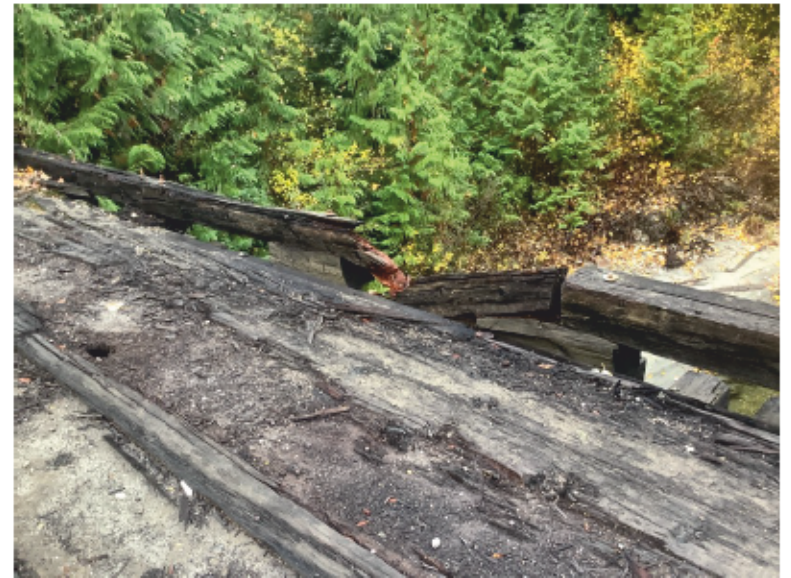
Guard Rail

| Curb Rail/Blocks/Posts | Poor | Rotten |

| Hardware | Poor | Loose bolts |

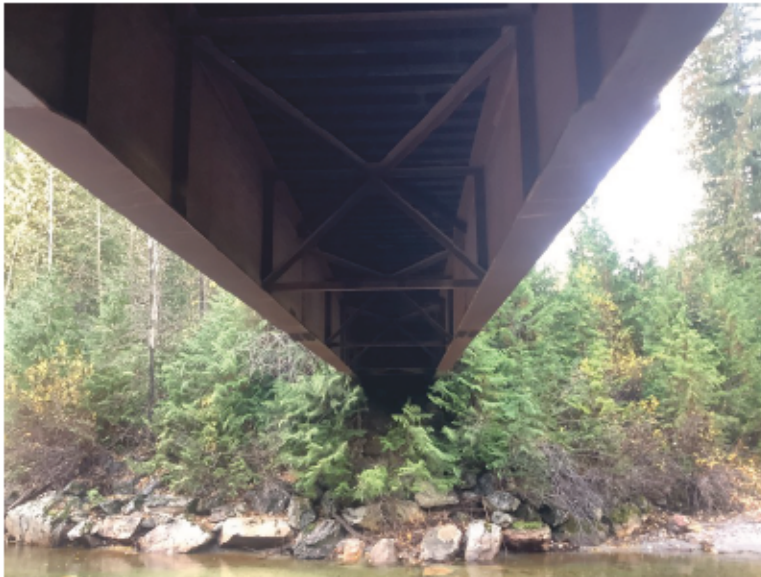
Superstructure

Girders Fair

Minor corrosion throughout

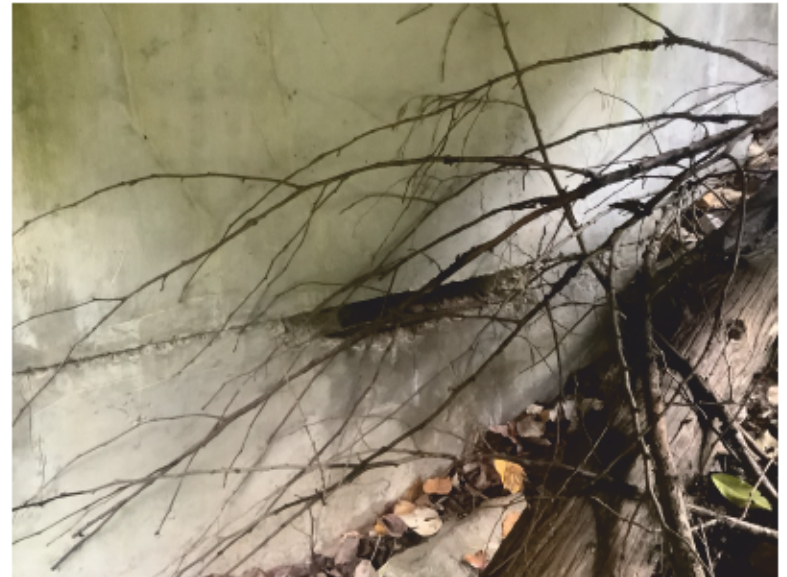
Concrete n right bank abutment

Right abutment Fill containment structure, spalling and has exposed rebar.

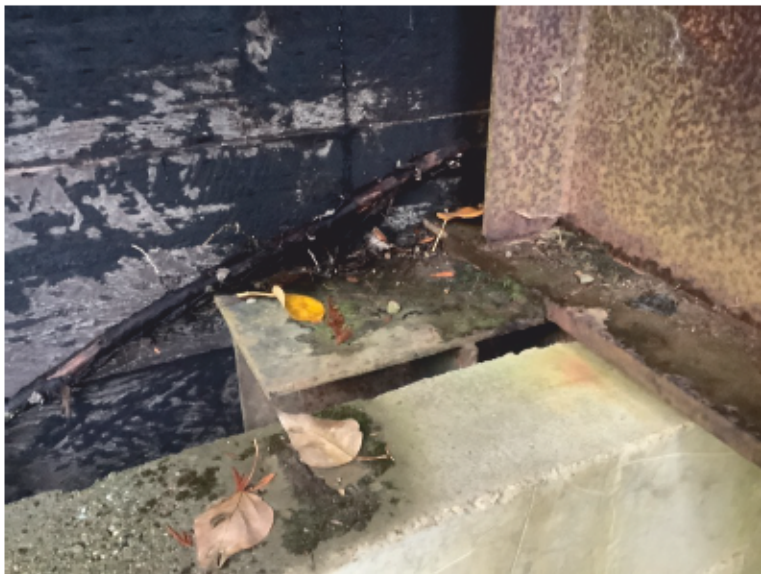
Bearing

Bearings Fair
