CK-2487  
CK-2487

## STS'AILES (WEST) 7.9km

2022 Inspection

**Re: EN23NAN900 District of Chilliwack Bridge Inspection Reports**

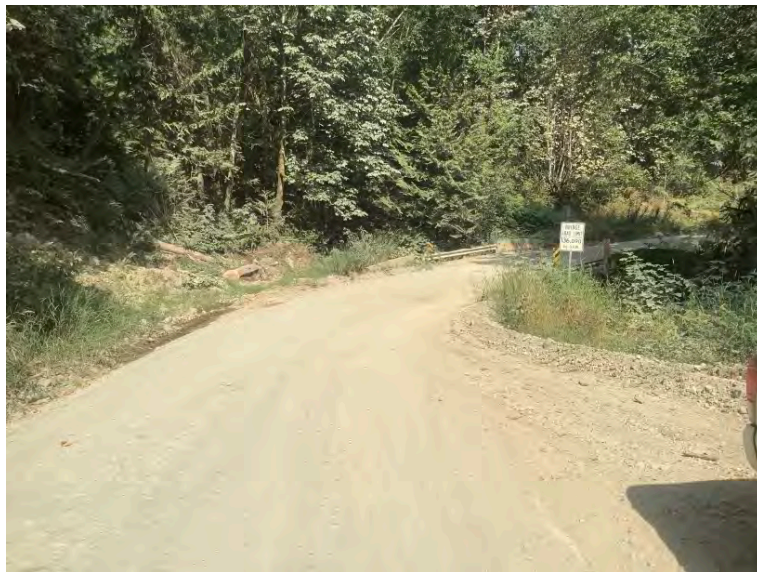
Approach from Right Bank when facing downstream

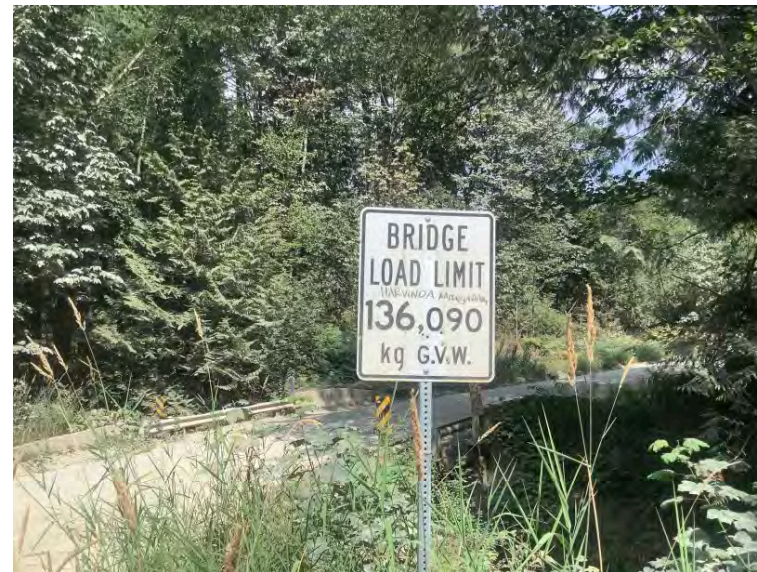
Load Rating Sign

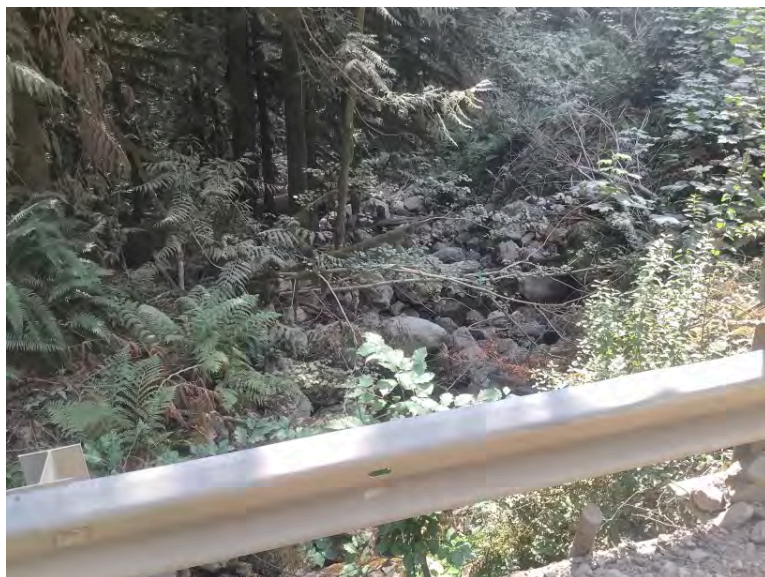
Downstream from Crossing

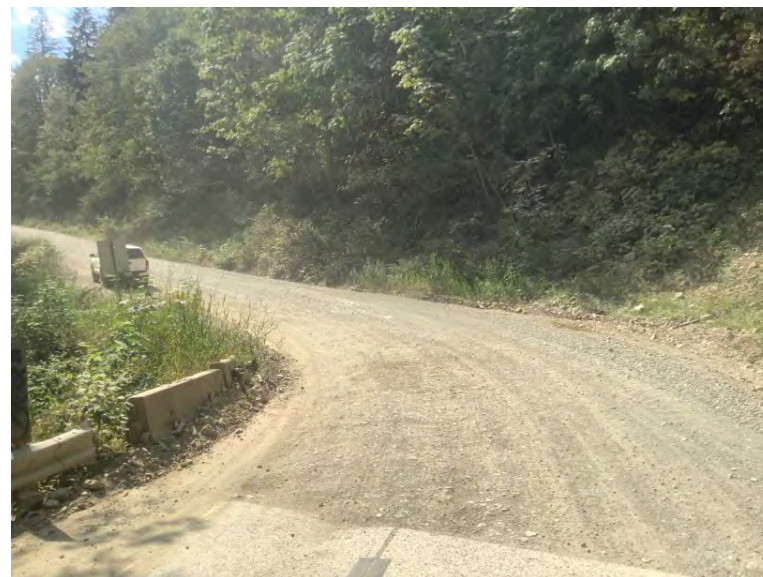
Approach from bridge deck of Right bank approach when facing downstream

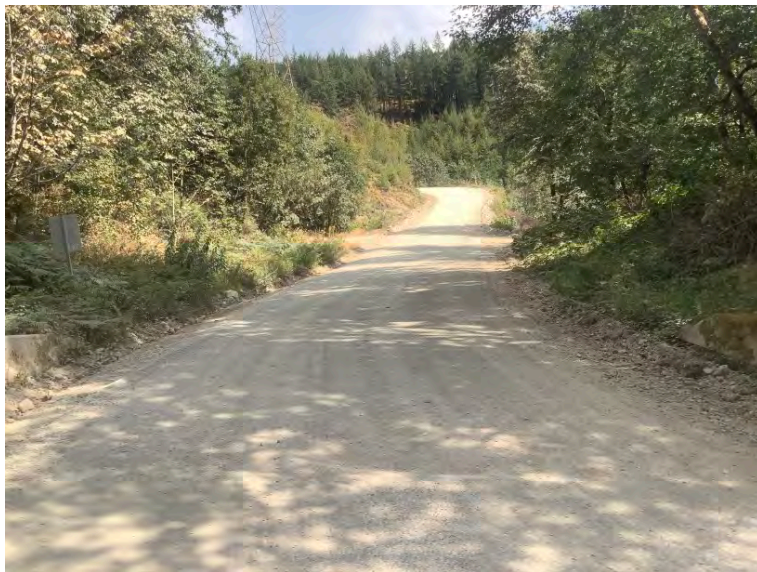
Approach from bridge deck of Left bank approach when facing downstream

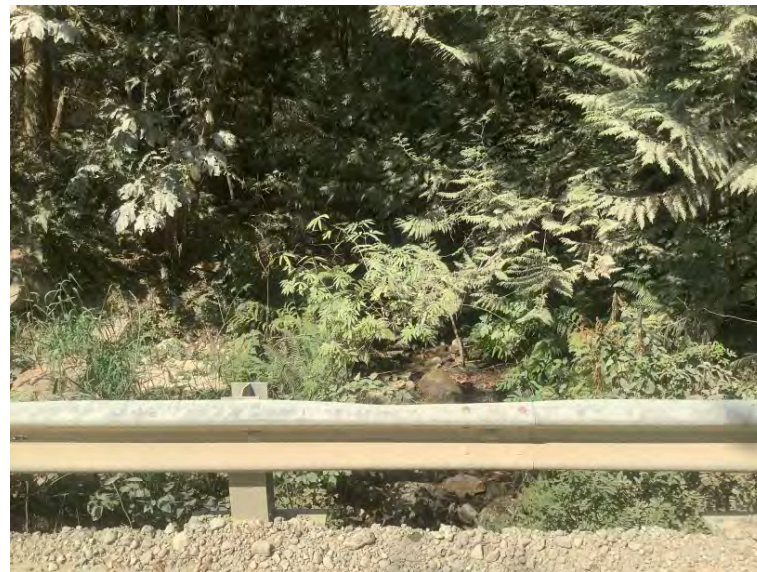
Upstream from Crossing

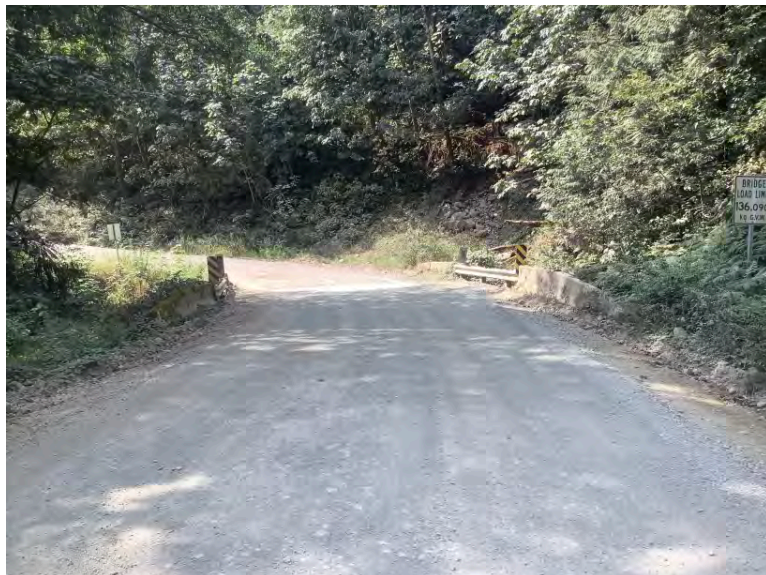
Approach from Left Bank when facing downstream

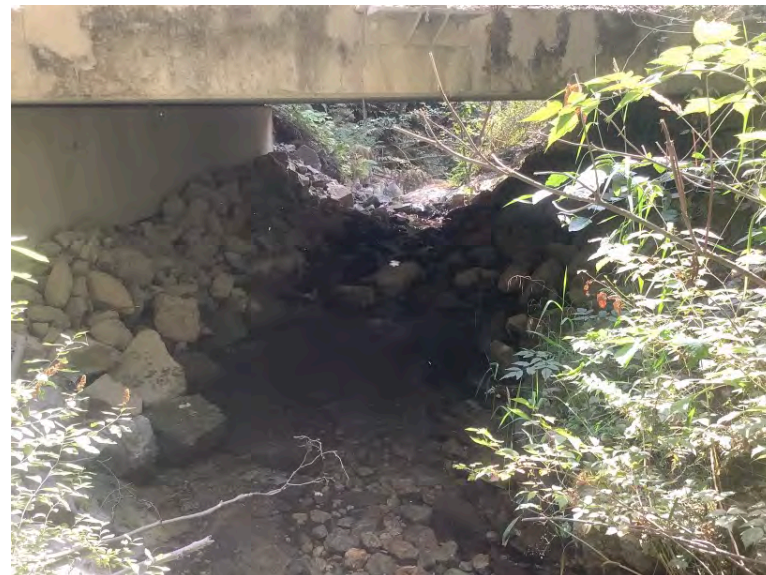
Upstream Profile

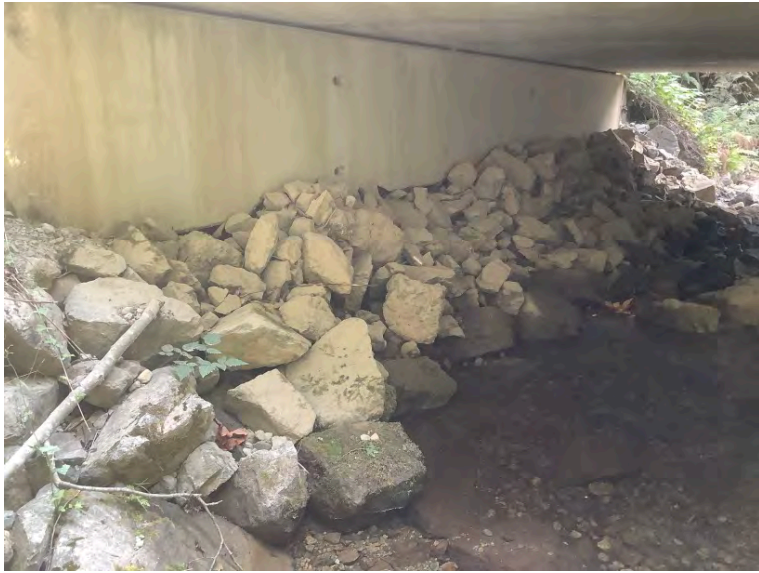
Left Bank Abutment when facing downstream

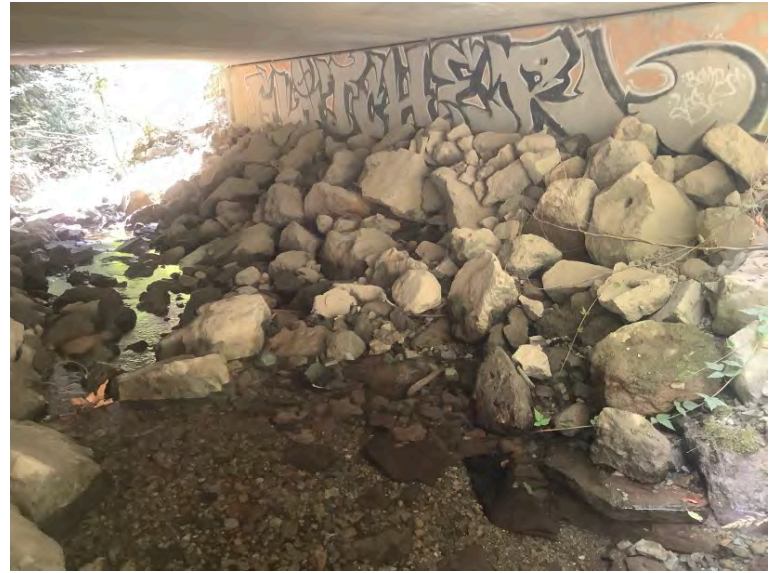
Right Bank Abutment when facing downstream

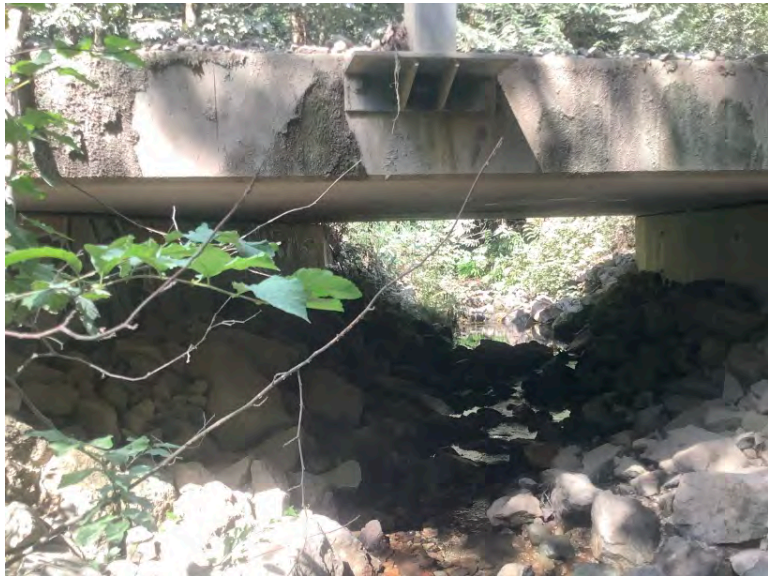
Downstream Profile

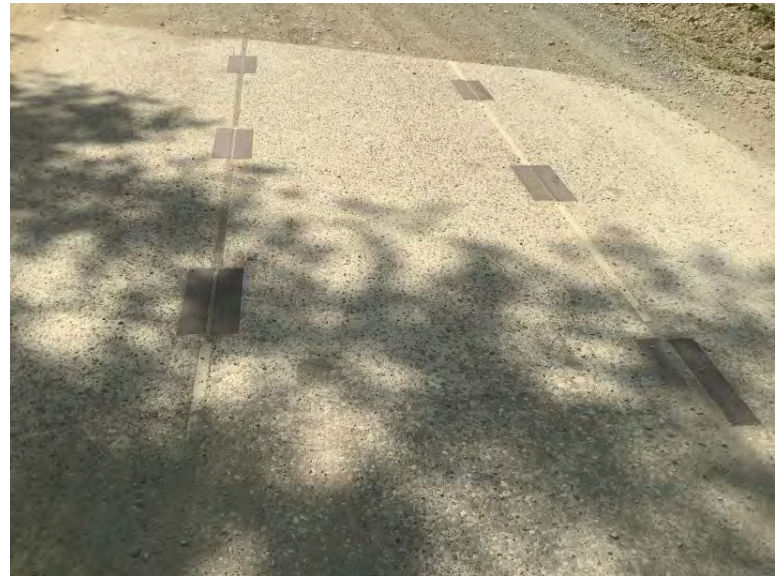
Sediment on deck

Deck
