CK-2490  
CK-2490

CENTRE 1.4km

2022 Inspection

Crossing Name Back Channel

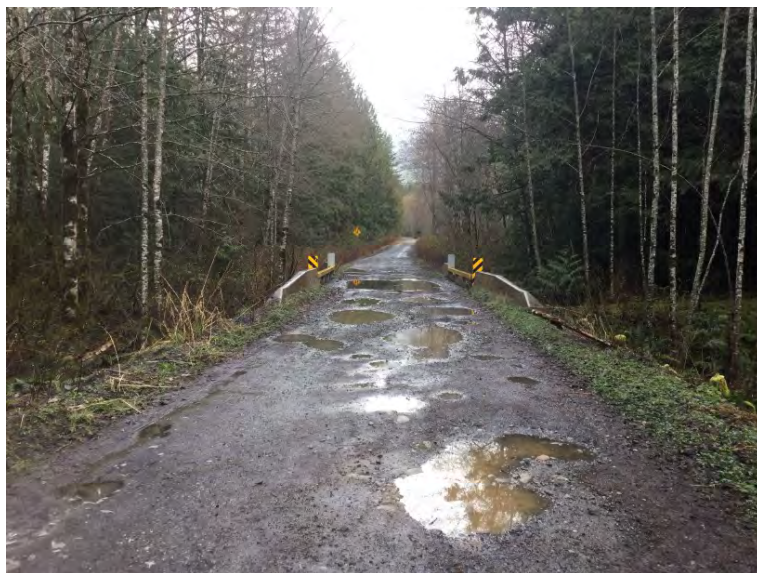
Approach from Left Bank when facing downstream

Road Surface **Fair** **Potholes at both approaches**

| Repair Item | Repair Description |
|---|---|
| 1 Approach. Approach surfacing grading. m. Priority:Low | |

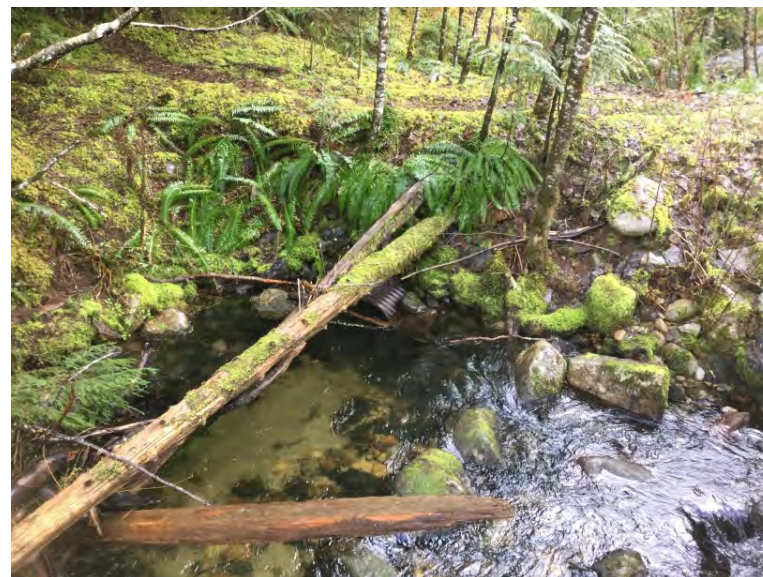
Partial flow staying on cutslope side of road flowing through CSP

| Repair Item | Repair Description |
|---|---|
| 2 Channel. Debris removal. # of sites/items. Priority:Medium | Remove debris at inlet of bridge and CSP |

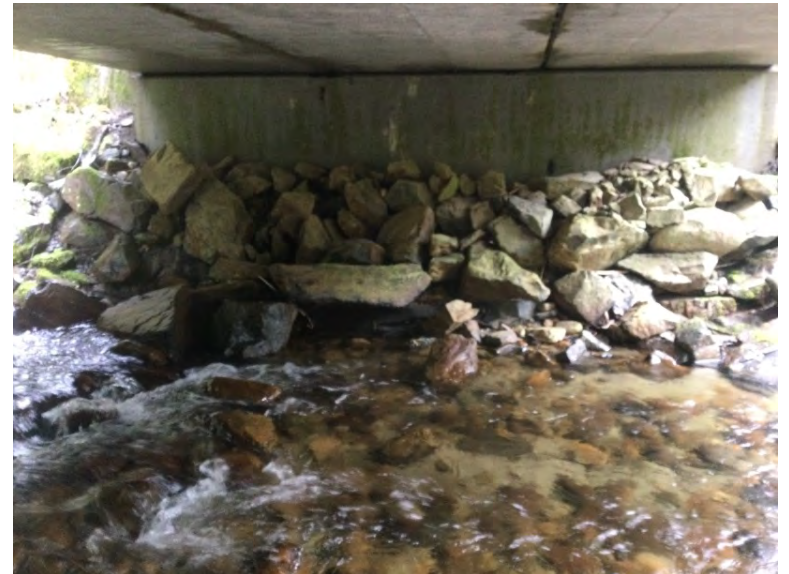
Left Bank Abutment when facing downstream

There does not appear to be much/any change to the riprap condition from the last inspection in 2019, continue to monitor the riprap condition at both abutments. Remove the debris noted at the inlet and grade approaches. The current load rating of L75 or 68 tonnes to continue.

Riprap **Fair** **Minor erosion noted with filter fabric visible at both abutments**

| Item | Monitor Description | Frequency |
|---|---|---|
| 1 | Riprap scour at both abutments | Routine Inspection |

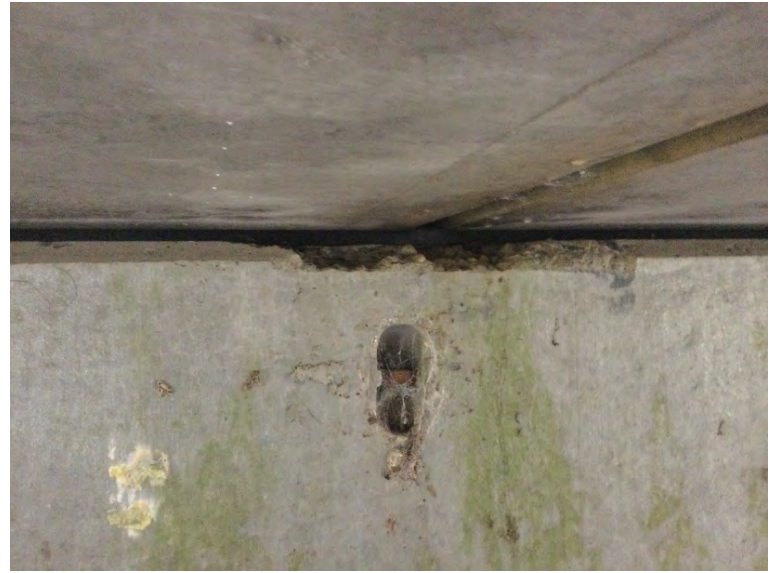
Small spall on left bank cap
