CK-2491  
CK-2491

CENTRE 1.5km

2022 Inspection

Crossing Name Chilliwack River

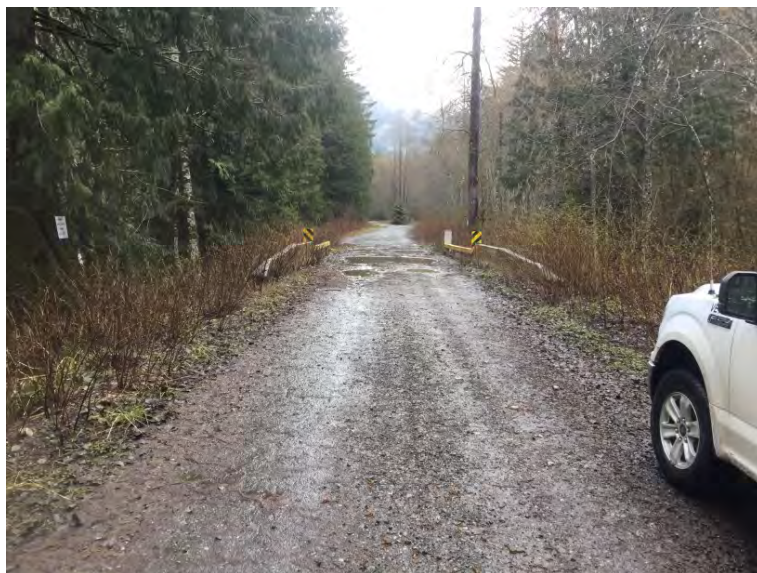
Approach from Left Bank when facing downstream

Potholes at both approaches

Brush and grade approaches. Replace missing Right Hand (RH) delineator. The current load rating of L75 or 68 tonnes to continue.

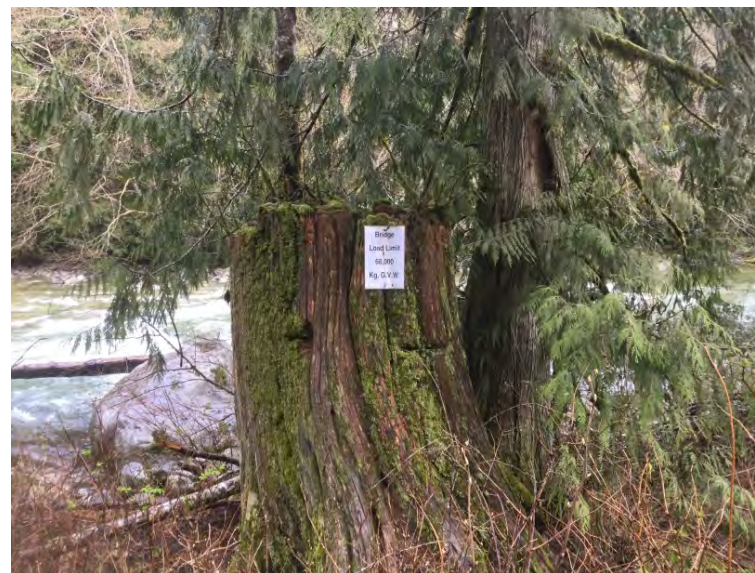
Load Rating Sign

L75 or 68 tonnes

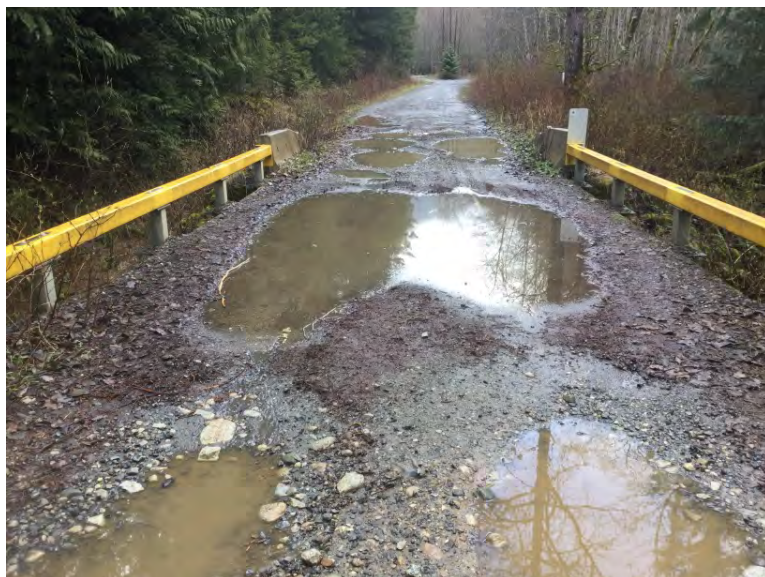
Running Surface      **Good**      Potholes at both approaches

Overall Deck Condition      **Good**

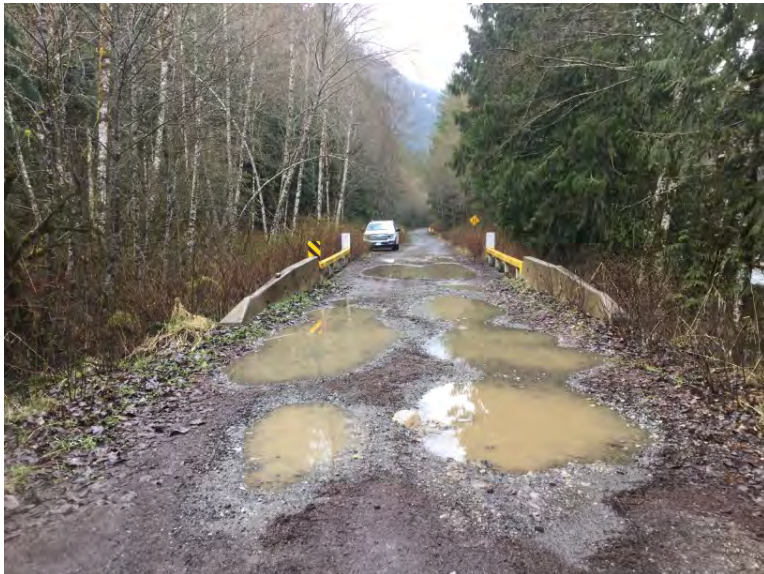
Approach from Right Bank when facing downstream

Delineator Missing  
Right ☐ 0 ☒ 1 ☐ 2

| Repair Item | Repair Description |
|---|---|
| 2 Structure. Delineator maintenance. . Priority:Low | Replace ing RH delineator at right approach |

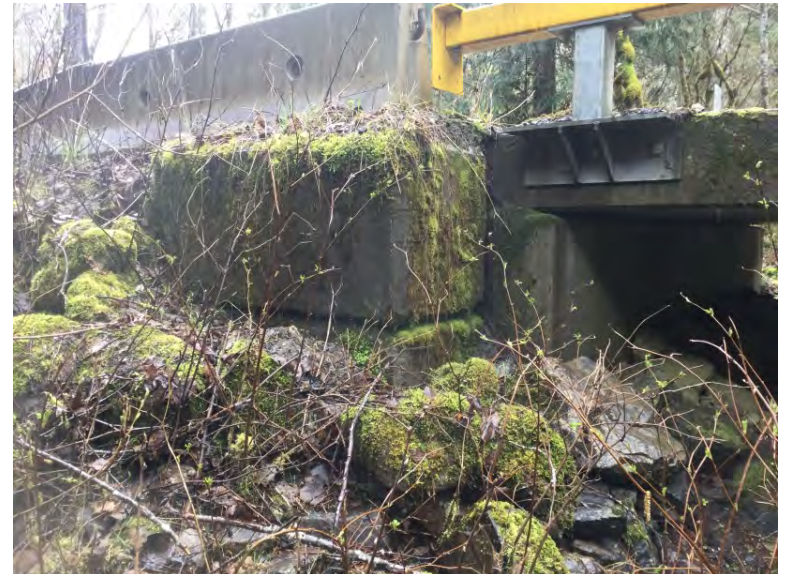
Typical wingwall

Wing Wall Good 2 high lock blocks at all 4 corners

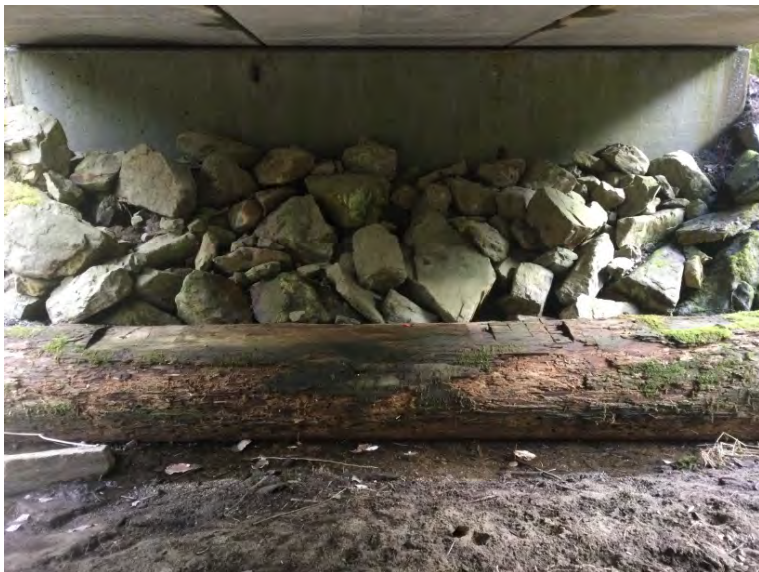
Left Bank Abutment when facing downstream

Caps or Sills Good

Fill Good
