CK-2492  
CK-2492

CENTRE 2.9km

2022 Inspection

Crossing Name Centre Creek

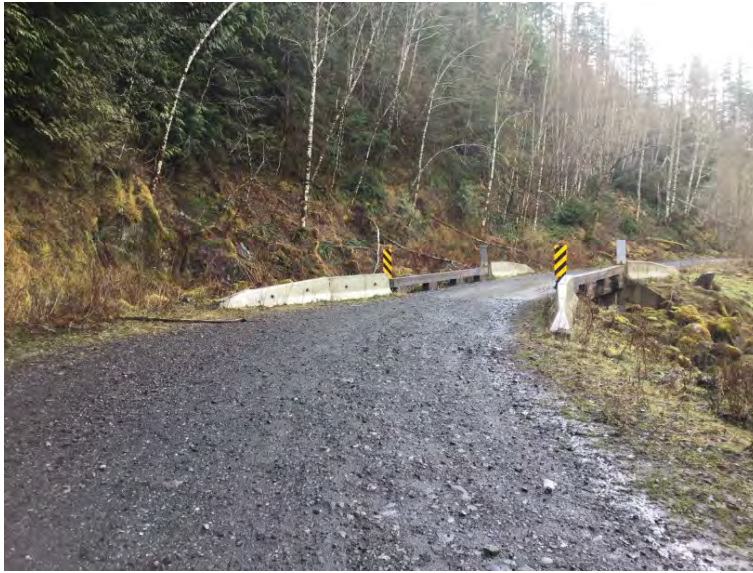
Approach from Right Bank when facing downstream

HC right approach

Potholes both approaches

1 Approach. Approach  
surfacing grading. m.  
Priority:Low

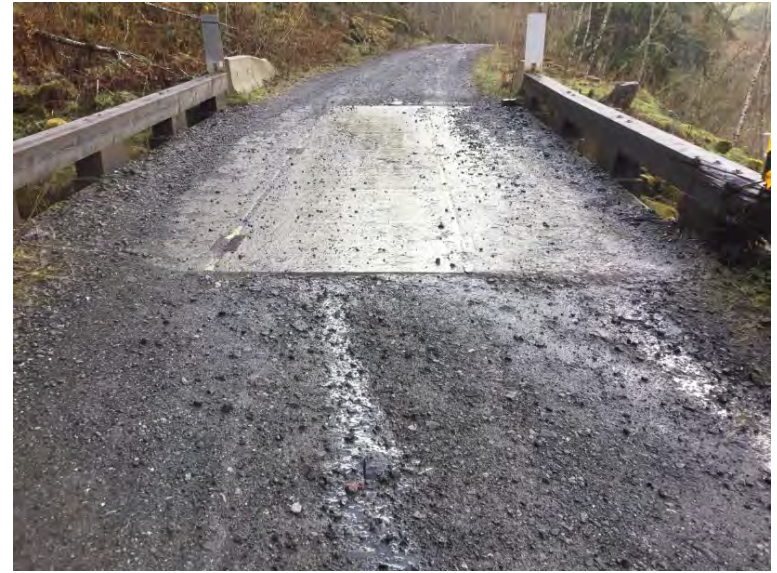
Deck

Running Surface      Fair      wearing at both approaches

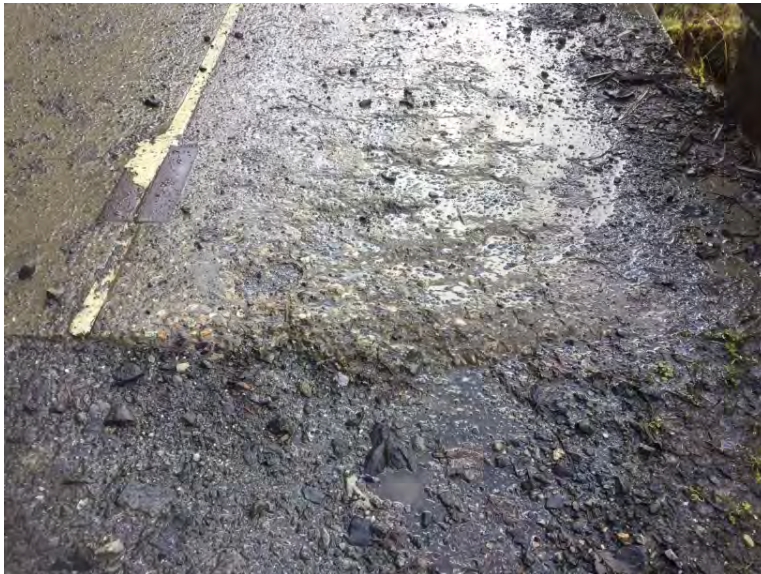
Downstream right bank slab wearing at end

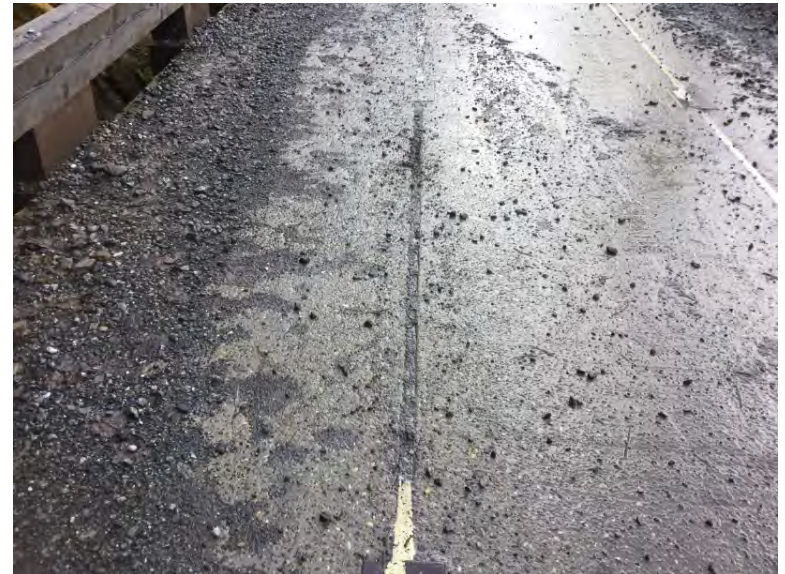
Missing some paraseal
