CK-2496  
CK-2496A

ENGLISH 2km

2022 Inspection

Crossing Name Side Creek

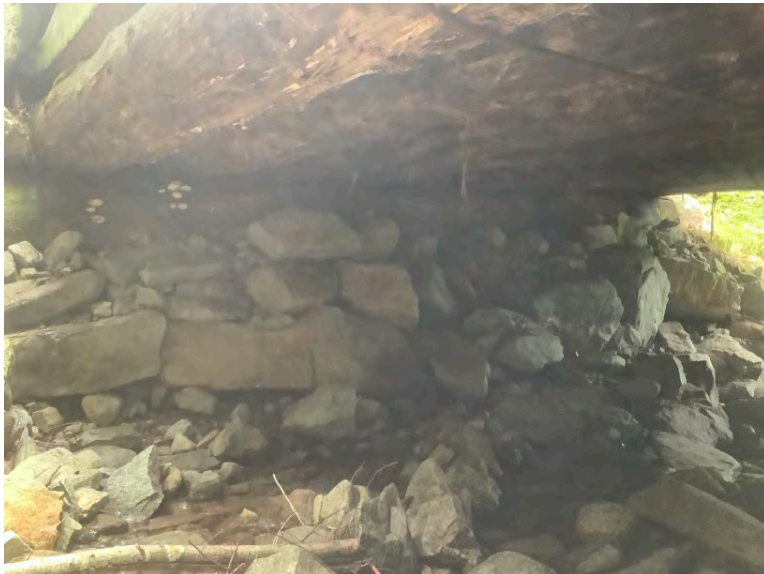
Left Bank Abutment when facing downstream

Comments Monitor sill logs for scour and undermining

| Item | Monitor Description | Frequency |
|---|---|---|
| 1 | Currently has full bearing on both sills, however scour appears it will eventually undermine both sill logs due to lack of riprap. | Anually |

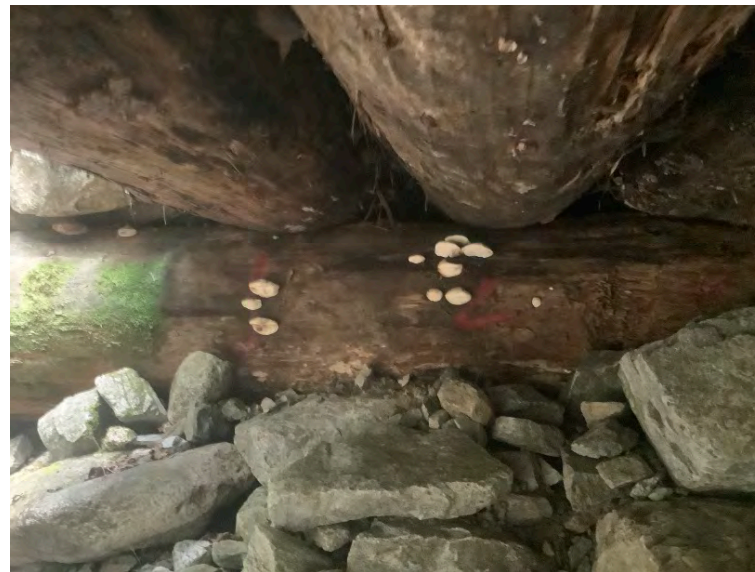
Caps or Sills **Fair** Fungus bodies in both sills

Fungus
