CK-2497  
CK-2497

ENGLISH 2.6km

2022 Inspection

Crossing Name Side Creek

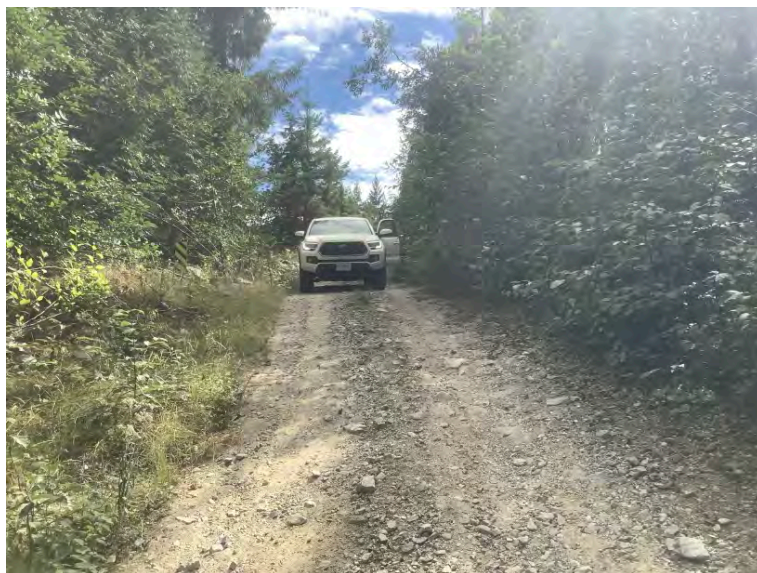
Approach from Left Bank when facing downstream

HC and sharp VC left approach. Steep grade throughout crossing

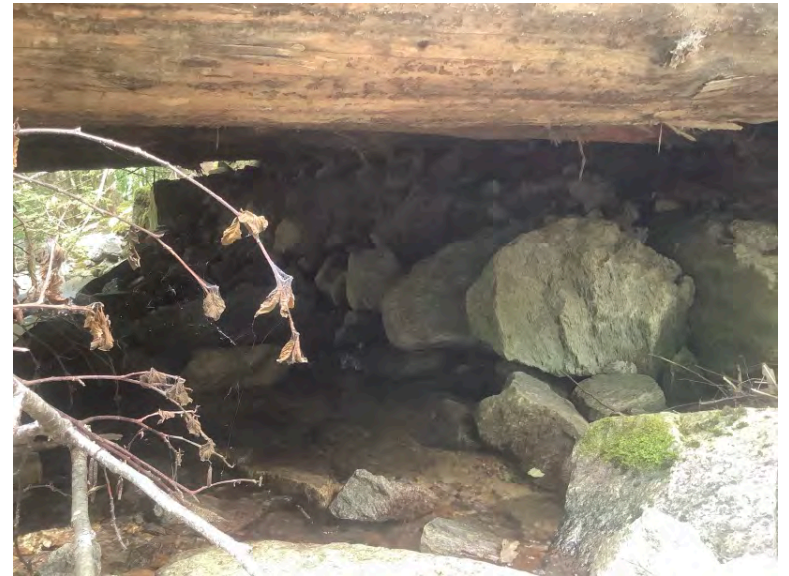
Right Bank Abutment when facing downstream

Single sill both banks with no signs of crushing

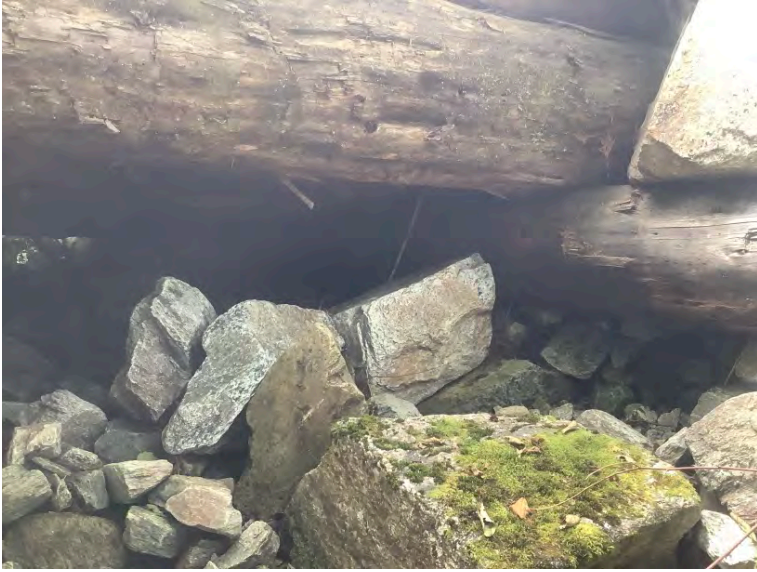
Left Bank Abutment when facing downstream

Scoured left bank and minimal rock protection remaining on right bank.

Comments Due to scour structure was down rated to L30 or 27 tonnes in 2021. Minimal to no additional scour noted so rating to stand until repairs completed.

| Repair Item | Repair Description |
|---|---|
| 1 Substructure. Timber caps and log sills. m². Priority:High | Repair scour under left bank log sill. |

| Item | Monitor Description | Frequency |
|---|---|---|
| 1 | Scour left bank sill. Appears to have little change from previous years inspection. | Anually |
