CK-2512  
CK-2512

CLEAR 14.7km

2022 Inspection

Structure Class Major Culvert

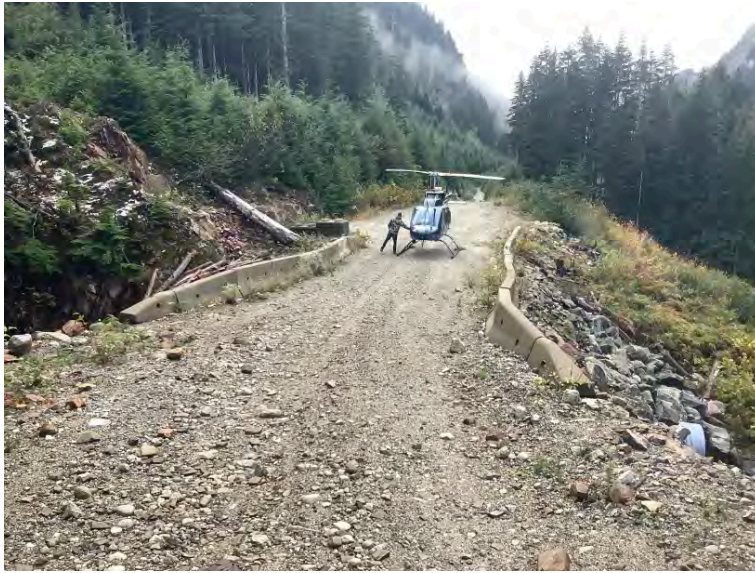
Approach from Right Bank when facing downstream

Vc right approach

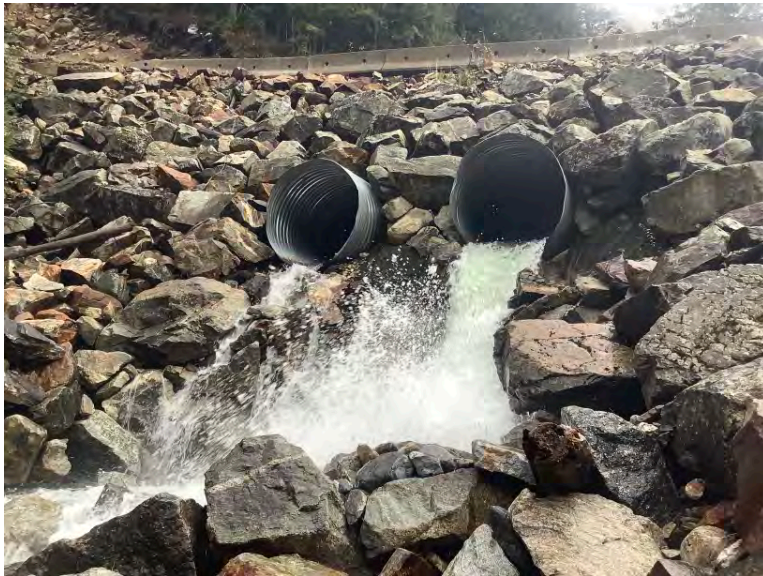
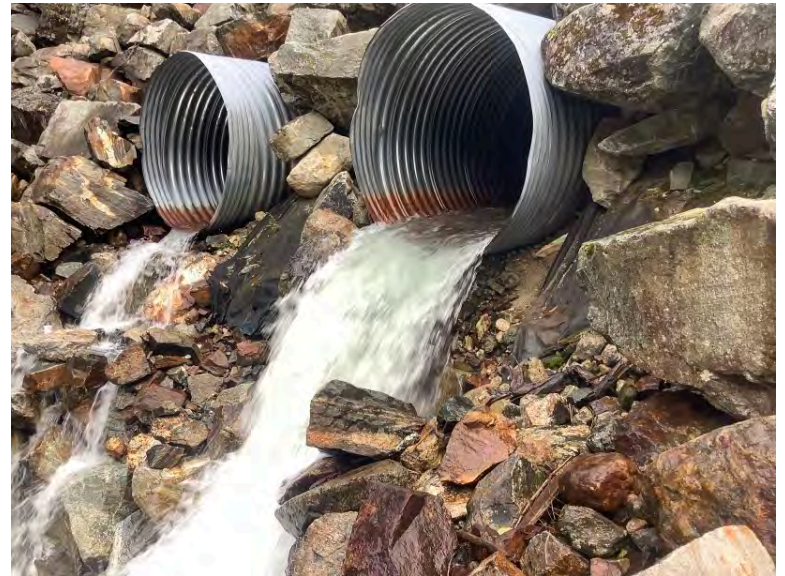
Coating Fair Outlet floor minor corrosion. Inlet is good condition still

Outlet Fair Riprap scour

| Item | Monitor Description | Frequency |
|---|---|---|
| 1 | Outlet scour | Anually |

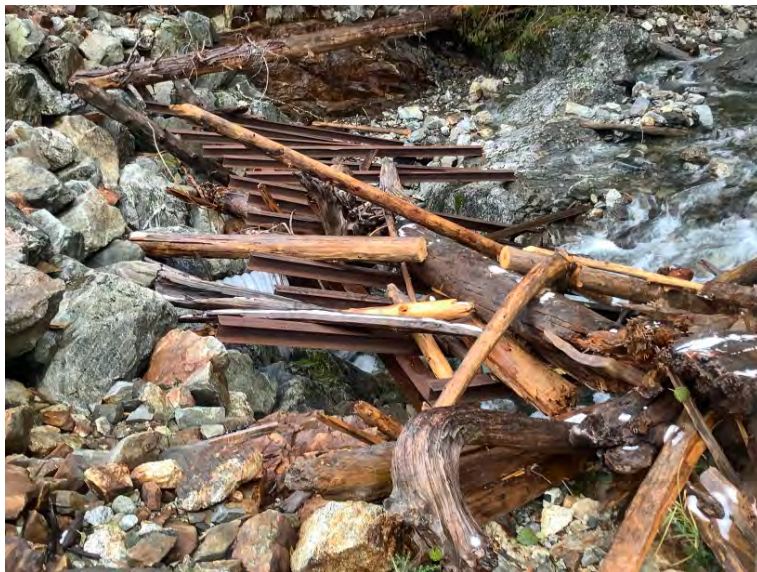
Trash rack

Trash Rack Good Monitor debris accumulation

Comments Sticks deposited 1.5m above inlet. Evidence of backwatering

| Repair Item | Repair Description |
|---|---|
| 1 Channel. Debris removal. # of sites/items.<br>Priority:Medium | Clean trash rack |

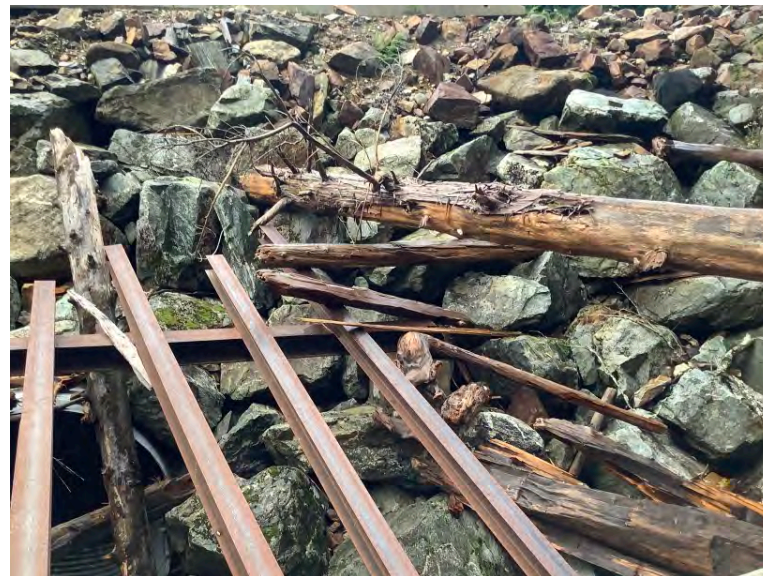
Backwatering elevation
