CK-2520  
CK-2520

## LOST CREEK km

2022 Inspection

Structure Class Major Culvert

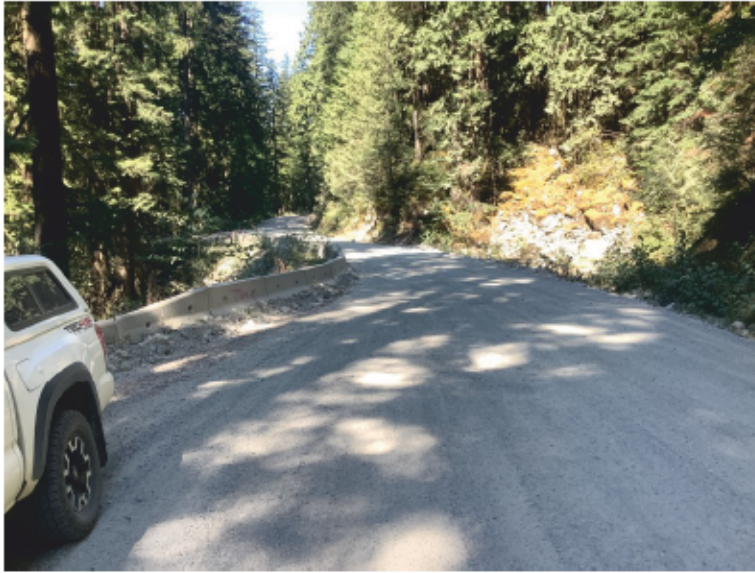
Approach from Left Bank when facing downstream

HC over culvert due to narrowing road running surface

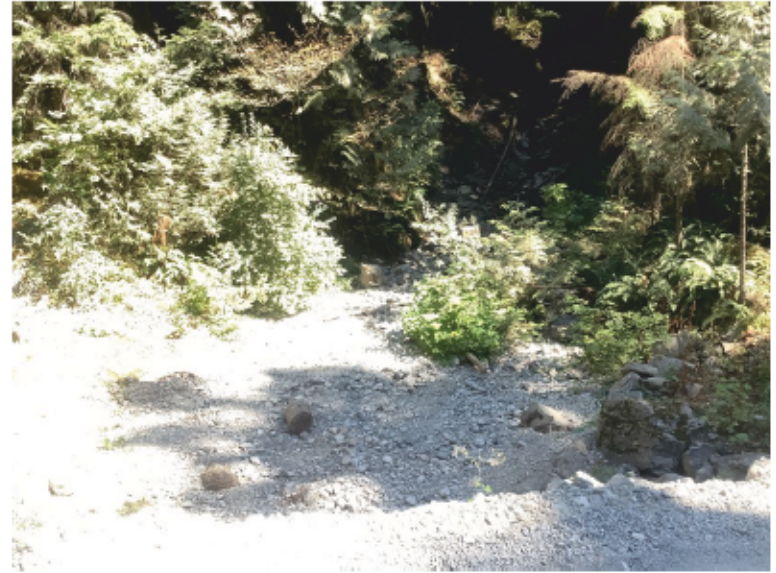
Upstream from Crossing

Comments Currently stream goes subsurface 30m upstream and is subsurface to the bottom of the armoured fill slope downstream of crossing

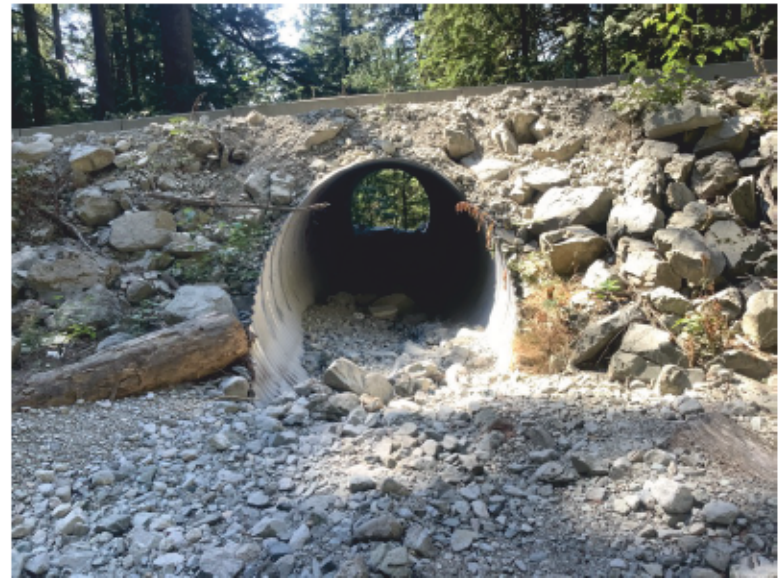
Inlet      Good

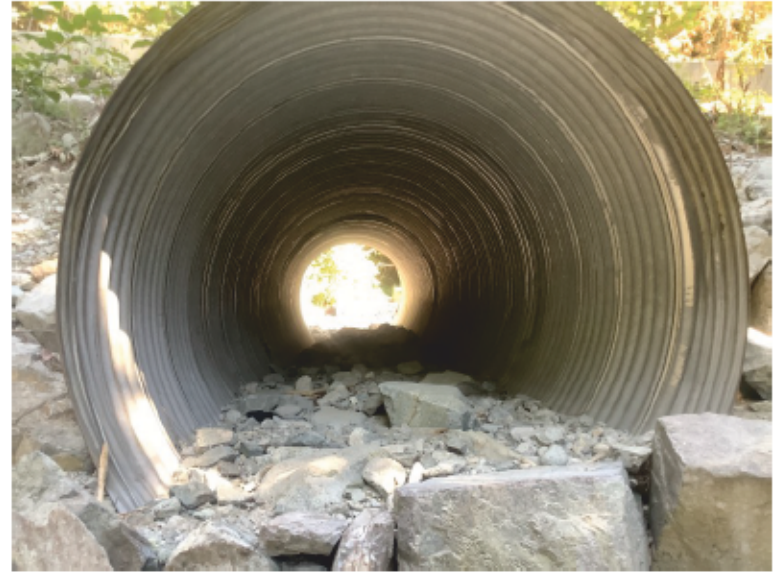
Outlet      Good
