CK-2523  
CK-2523

SQUEAH 0.4km

2022 Inspection

Structure Class Major Culvert

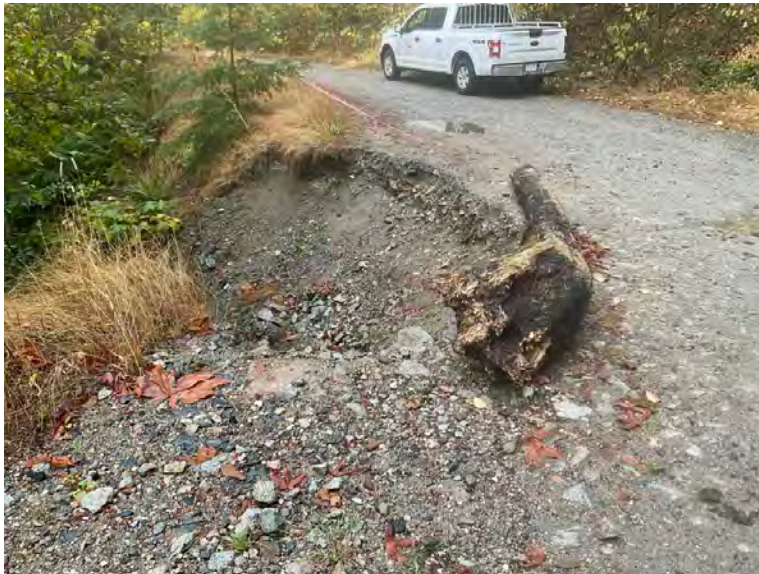
| Fill | Poor | Failed downstream right bank |

Erosion at downstream right bank

| Repair Item | Repair Description |
|---|---|
| 1 Approach. Approach fill repair. m³. Priority:High | Repair downstream right bank fill slope |

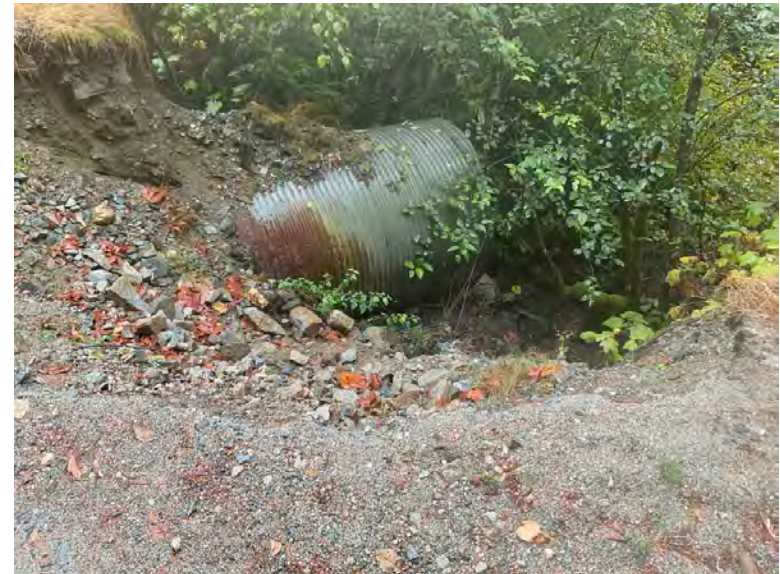
Erosion downstream right bank

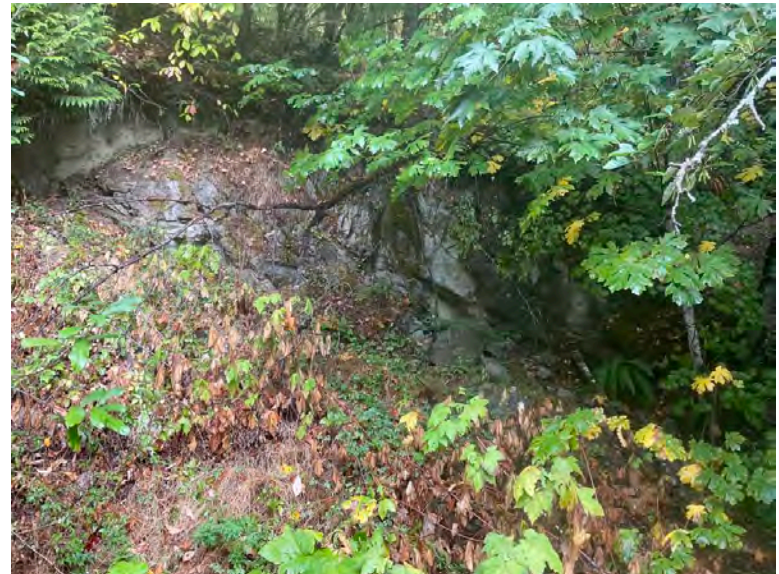
Rock noted upstream right bank

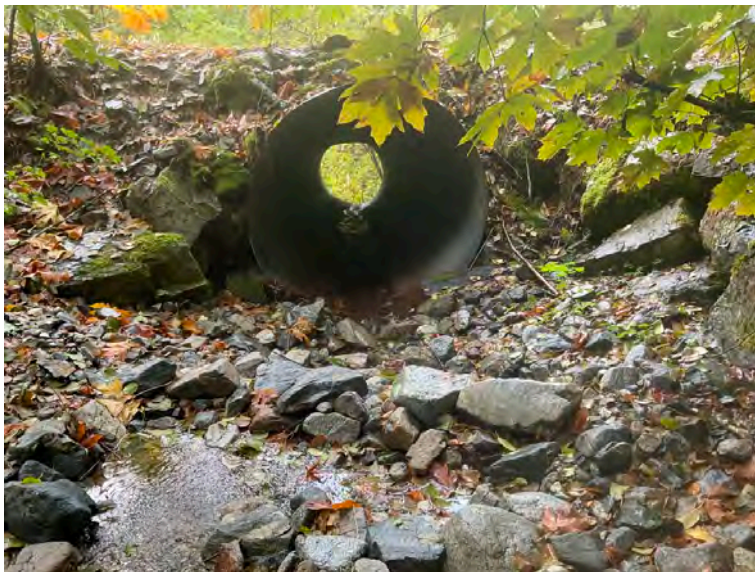
| Inlet | Fair |

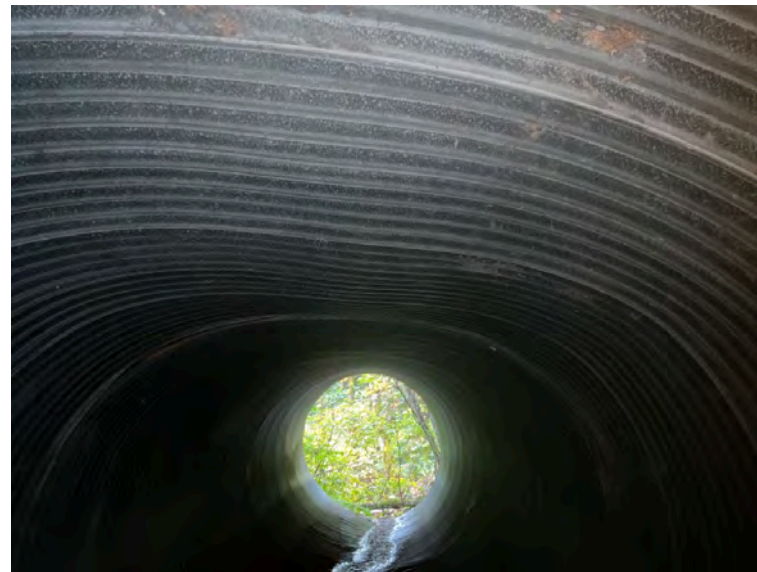
| Roof | Fair | Minor deformation noted at midspan |

Damage along roof

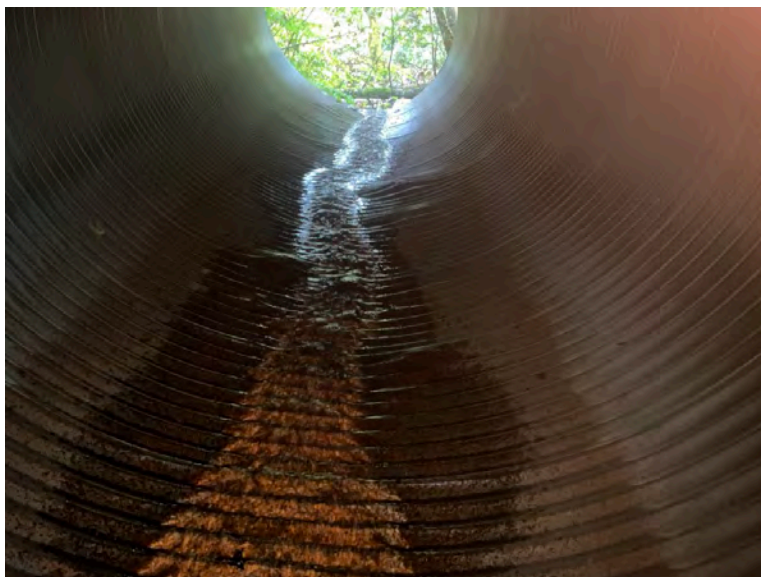
| Floor | Fair | Minor deformation noted throughout |

Damage along the floor

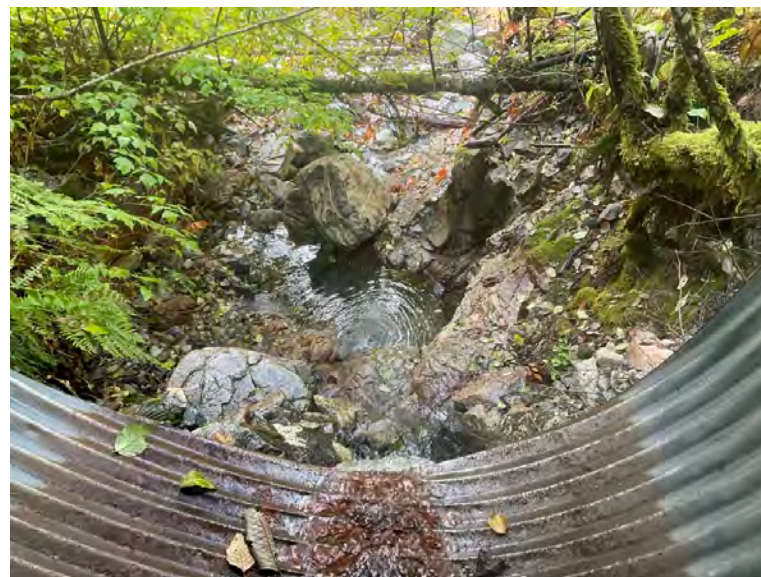
| Outlet | Fair | 2.5m drop into bedrock controlled pool |
