# BC Ministry of Forests, Lands, and Natural Resource Operations

## Log Stringer Bridge Inspection Report

| Site #: | CK-2524 | Structure Name: | CK-2524 | Road Name: | BIG SILVER | Inspection Date: | 2022/11/16 |
| KM: | 0.30 | User km: | 0.30 | Crossing Name: | Big Silver River | Next Inspection Date: | 2023/10/31 |

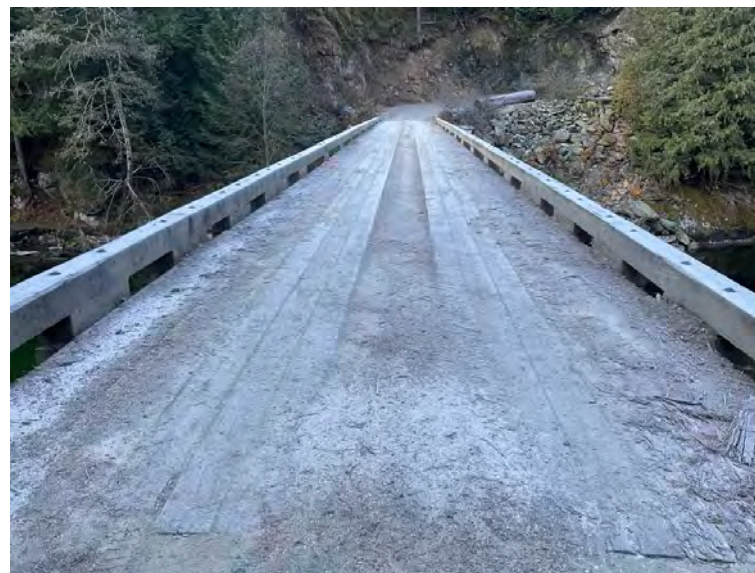
Deck

| Running Planks | Fair | Minor wear developing on wheel path |

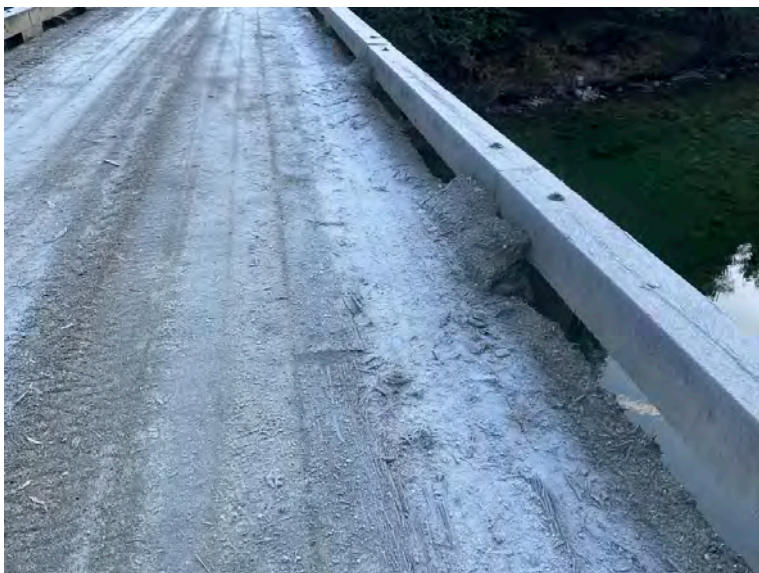
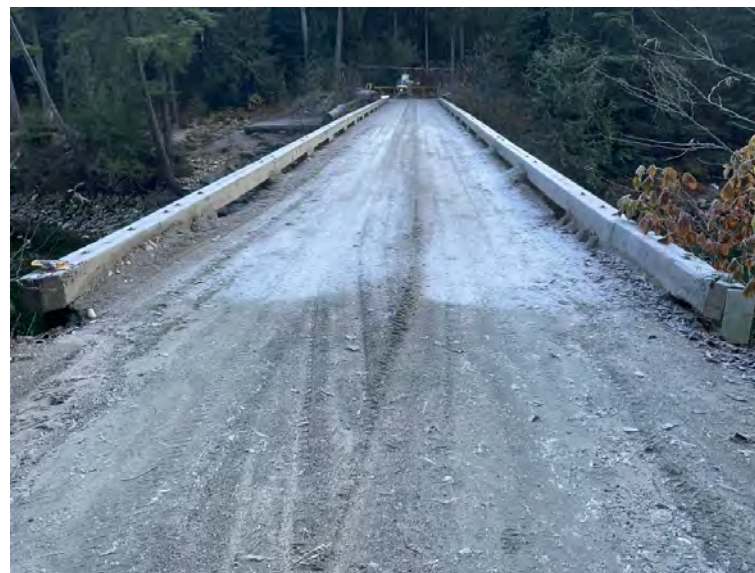
Sediment on deck

| # | Status | Priority | Estimate | Description |
|---|---|---|---|---|
| 5 | Suggested | Low | | Remove sediment from deck |

| PEng's Comment: | Remove sediment accumulations on the deck, brush approaches, and replace missing delineators. Monitor the right bank crib condition where the single tieback log has sheared; currently no apparent movement noted. Monitor the fill retention at the upstream right bank location. The current load rating of L100 or 91 tonnes to continue. |

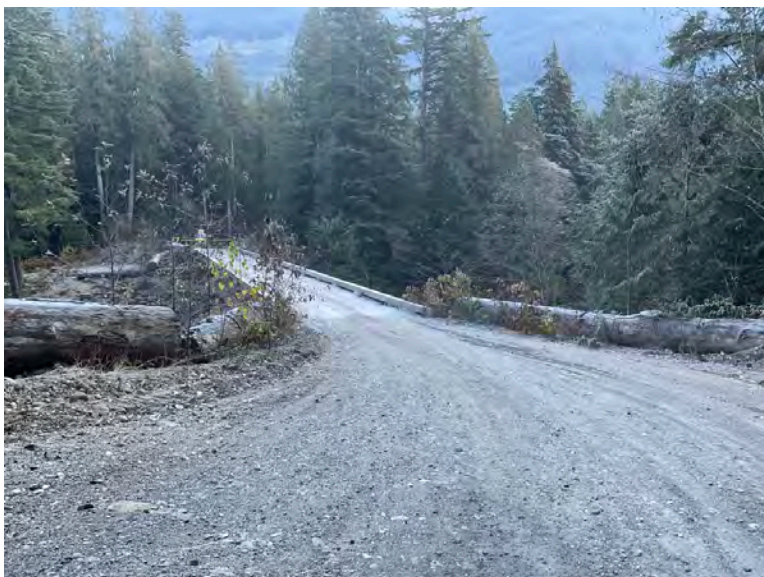
Approach from Right Bank when facing downstream

| Alignment | Fair | HC both approaches, VC right approach |

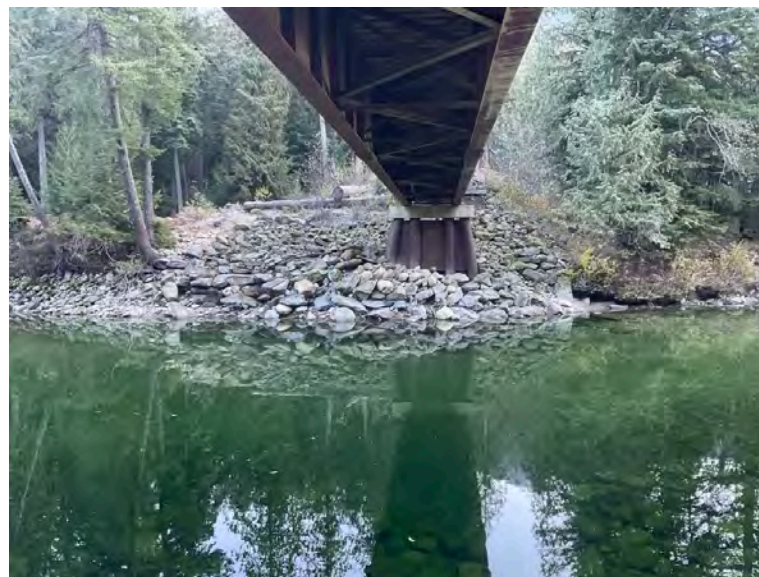
Right face of main span pier

| Piles or Posts | Good | 4 piles, upstream and downstream piles are battered |

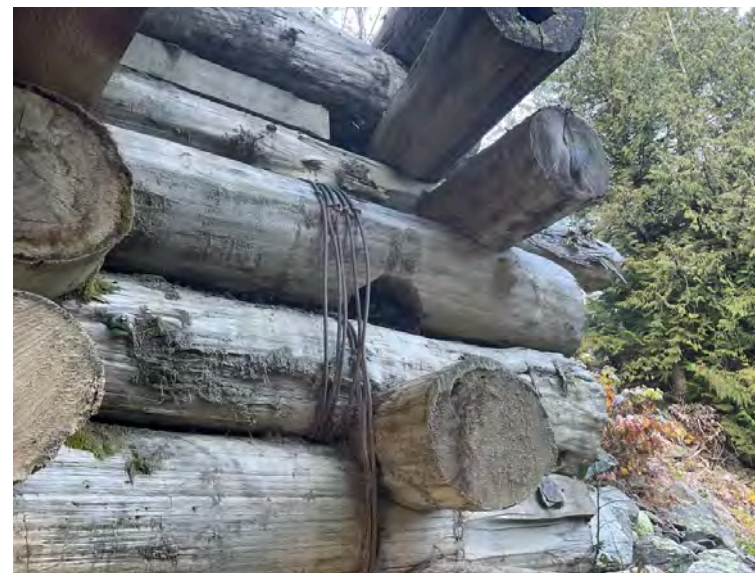
| Tie-backs | Fair | 1 sheared tieback end at right abutment, otherwise good condition |

| Inspector's Comment: | No shifting of face logs apparent with respect to the sheared tieback end at the upstream right bank abutment |

Right bank tieback end missing

| # | Description |
|---|---|
| 2 | Sheared tieback condition and fill retention at upstream right bank |

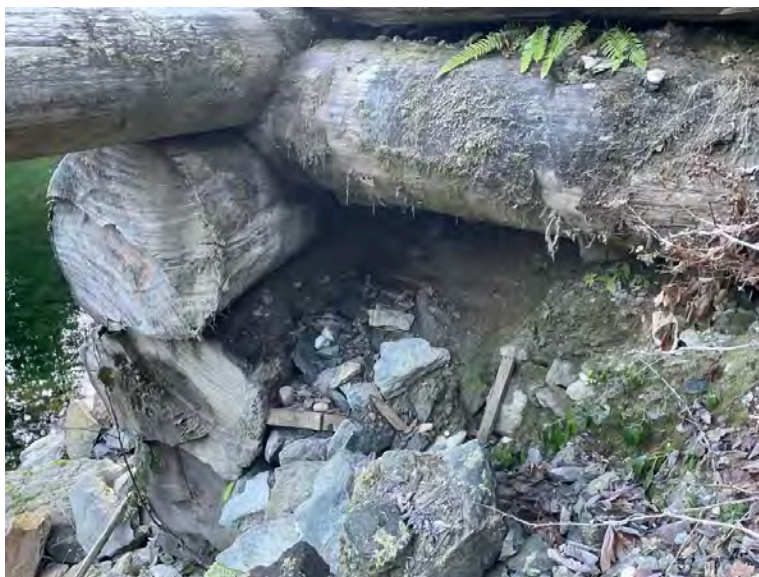
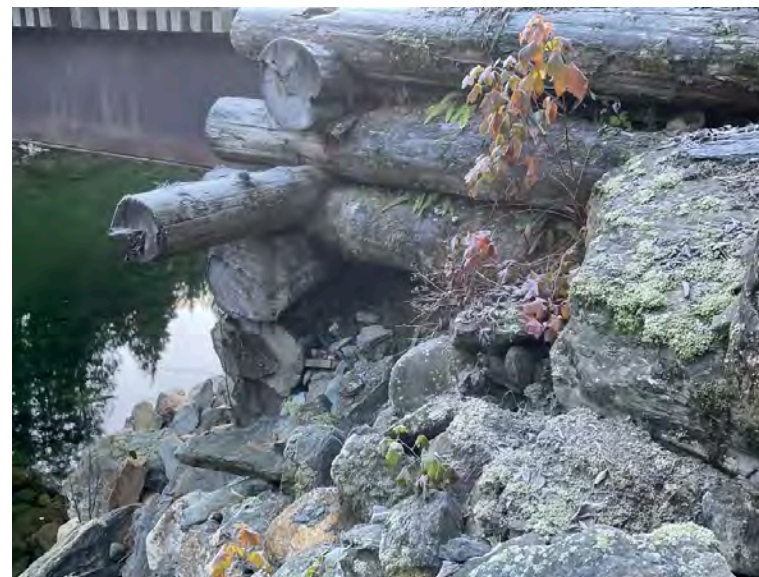
| Fill | Fair | Loosing fill upstream right bank |

Loosing fill at upstream right bank

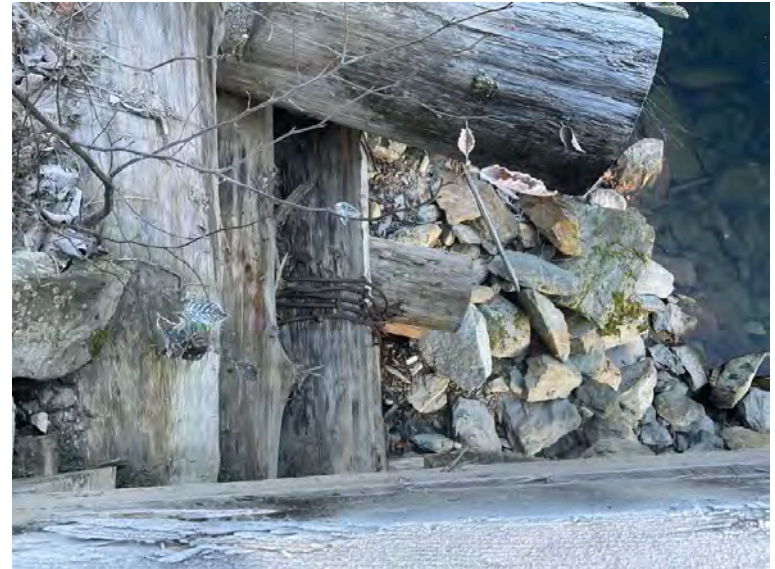
Missing tieback end

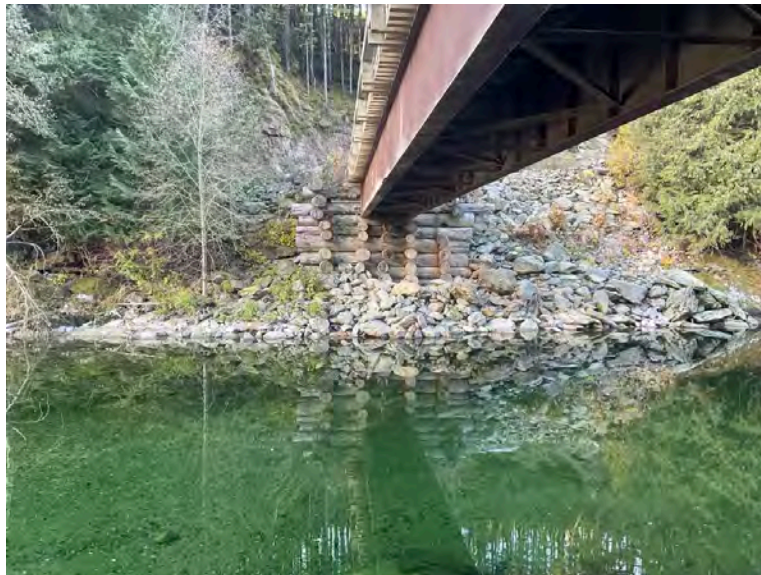
Right Bank Abutment when facing downstream

| Log/Timber Crib | Good | Right bank only, 6 large diameter cedar face logs |

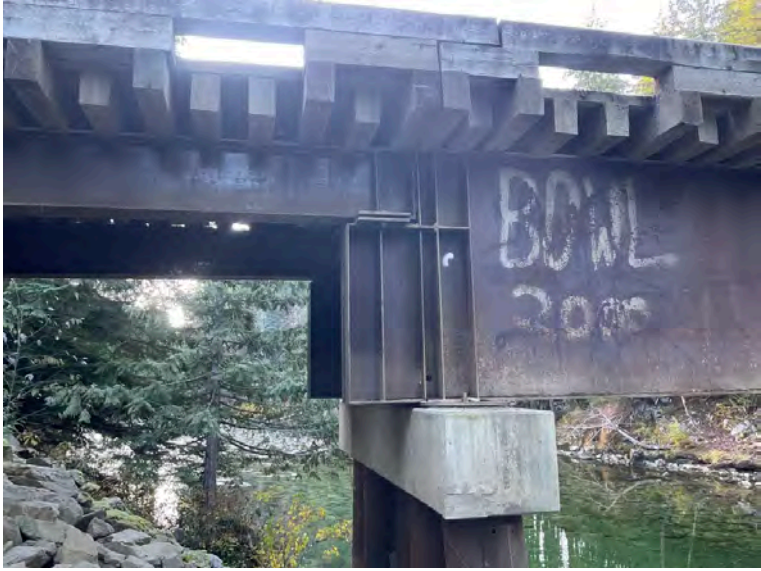
| Girders | Fair | light corrosion, modified for jump span seat |

Jump span seat
