## BIG SILVER 2.5km

2022 Inspection

Crossing Name Side Creek

Structure Class Temporary Bridge

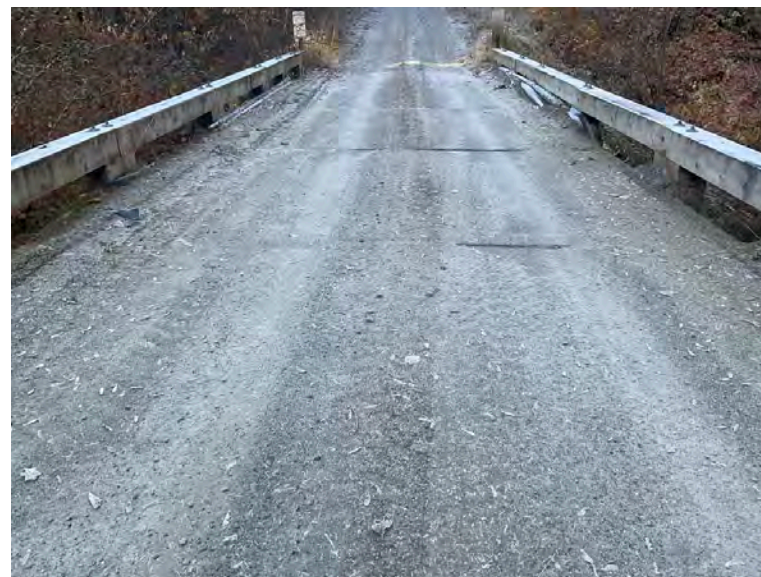
Running Surface      Fair      Sediment on deck

Deck

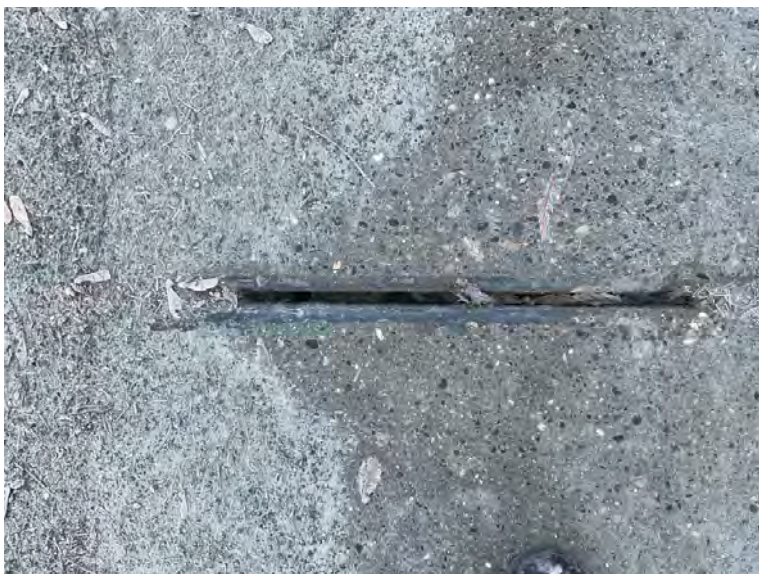
Deck Joints      Poor      Most joints have failed (non-existent)

No compression seal

- 1 Structure. Full Curb Replacement. .  
Priority:Medium
- 2 Approach. Area/sight line brushing. m².  
Priority:Medium
- 3 Structure. Clean Deck.  
Priority:Medium
- 4 Structure. Joint replacement. m². Priority:High
- 5 Structure. Concrete structural maintenance. m².  
Priority:Medium

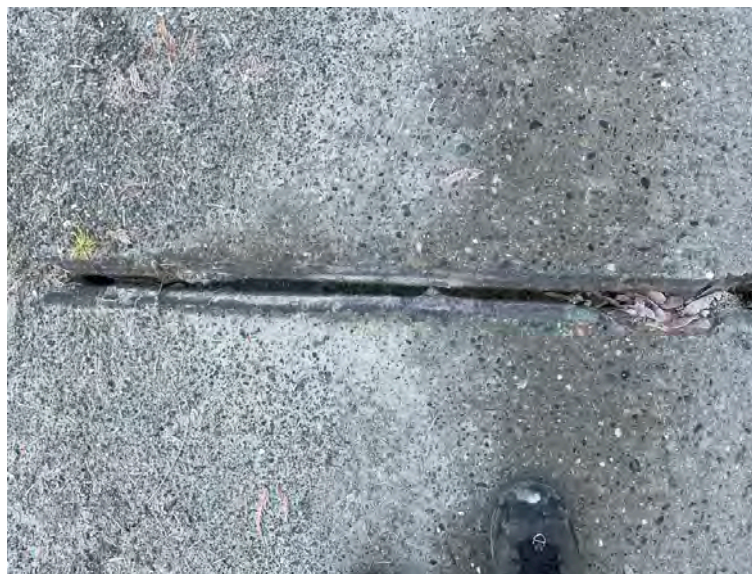
No compression seal

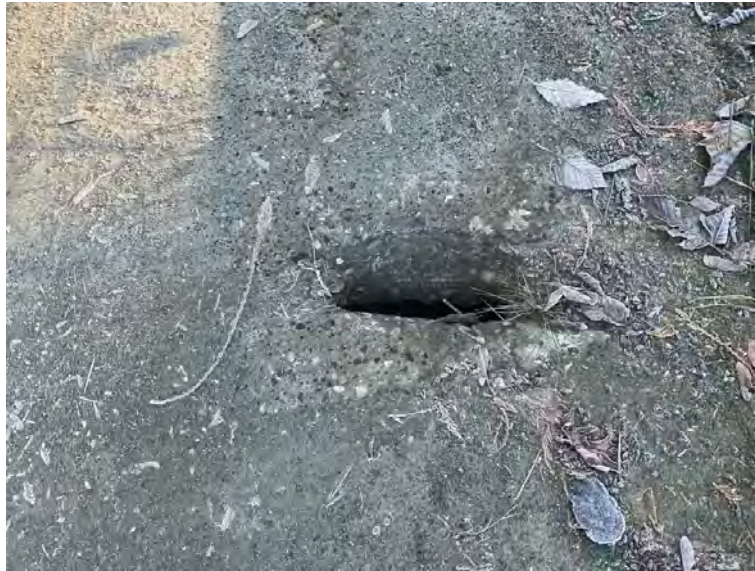
Concrete Deck      Fair      Damage noted on some panels

Downstream right bank concrete damage

Repair damage to all concrete deck panels as per the Concrete Repair Guide for Concrete Bridge Components MoFLNRO (2017). Replace all deck panel joints (poured sealant backed with okum). Replace the guardrail, risers and blocks. Remove the sediment and debris from the deck and brush approaches. Monitor the riprap condition at the right bank for further erosion. The current load rating of L75 or 68 tonnes to continue.

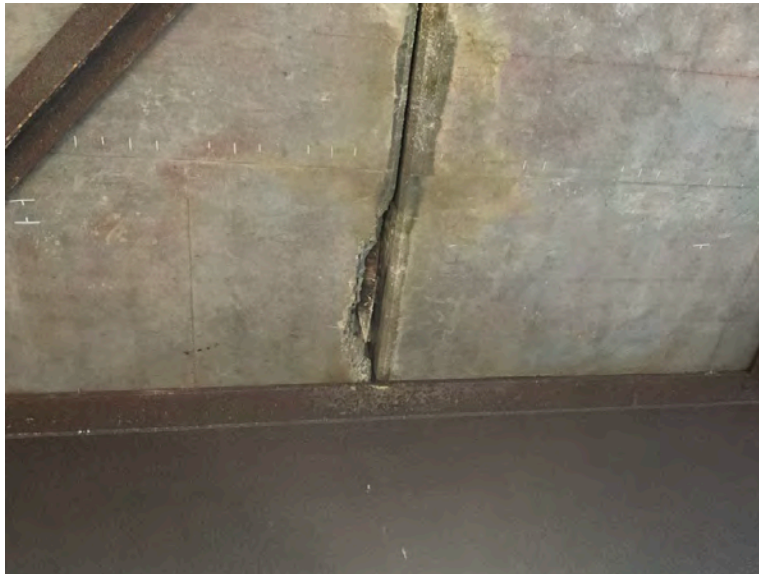
Upstream panel 1 right bank concrete damage

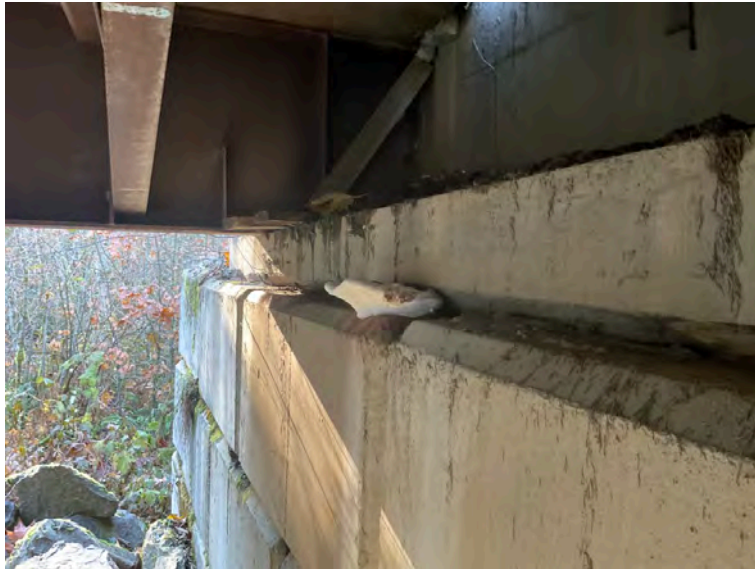
Caps or Sills Fair Fruiting body visible at right bank but still functional

Fruiting body on left bank timber sill

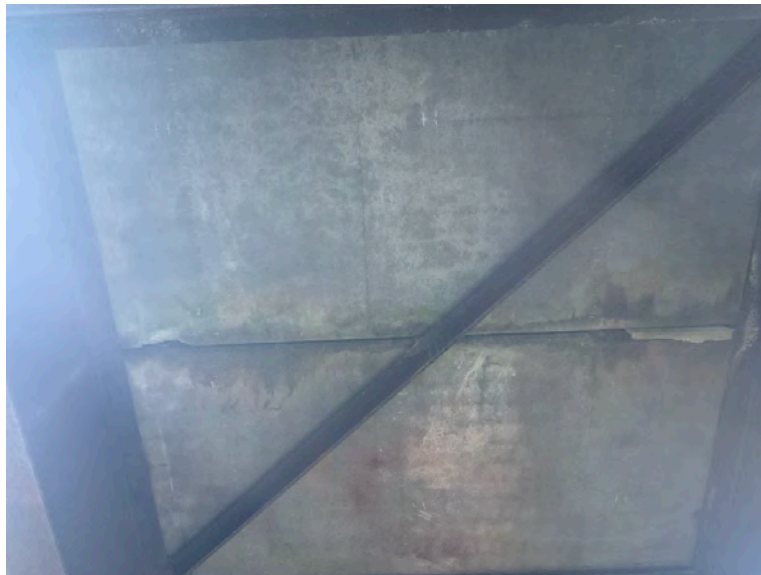
Concrete damage on panel 2 and 3

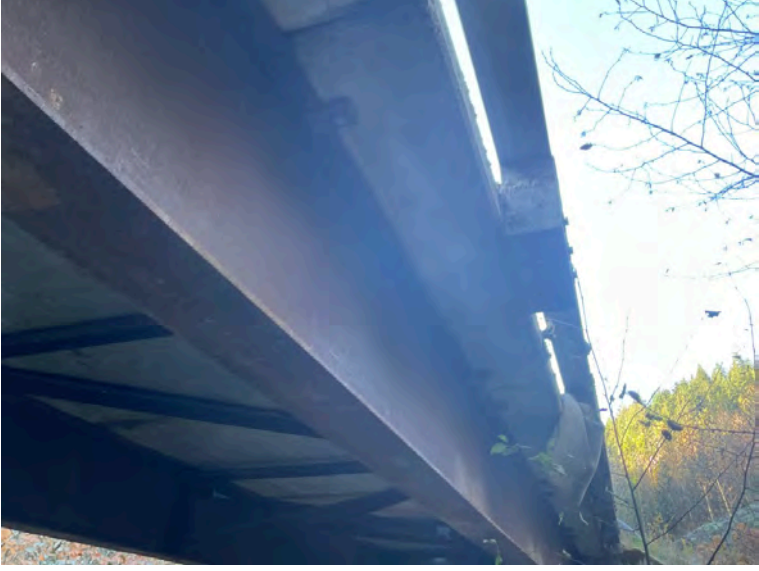
Deck to Girder Bolts      Good      Clips

Deck clips
