CK-2531  
CK-2531

HARRISON EAST 48.2km

2022 Inspection

Structure Class Major Culvert

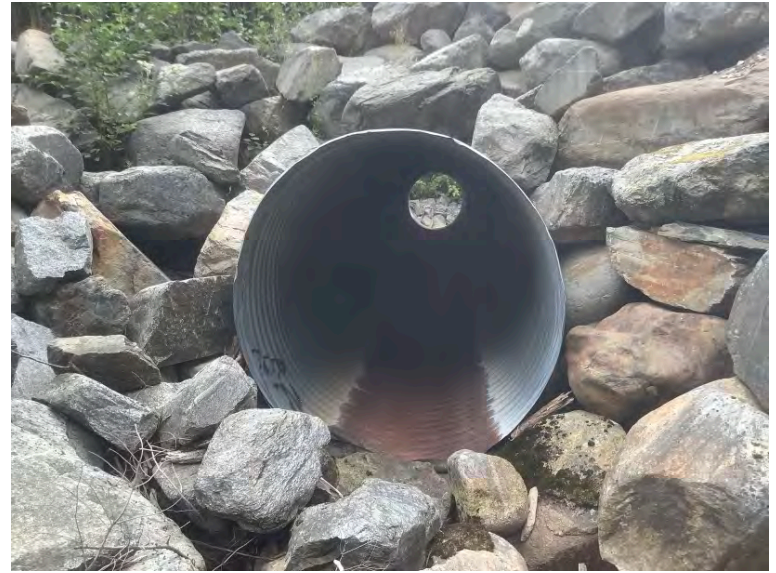
Inlet      Good

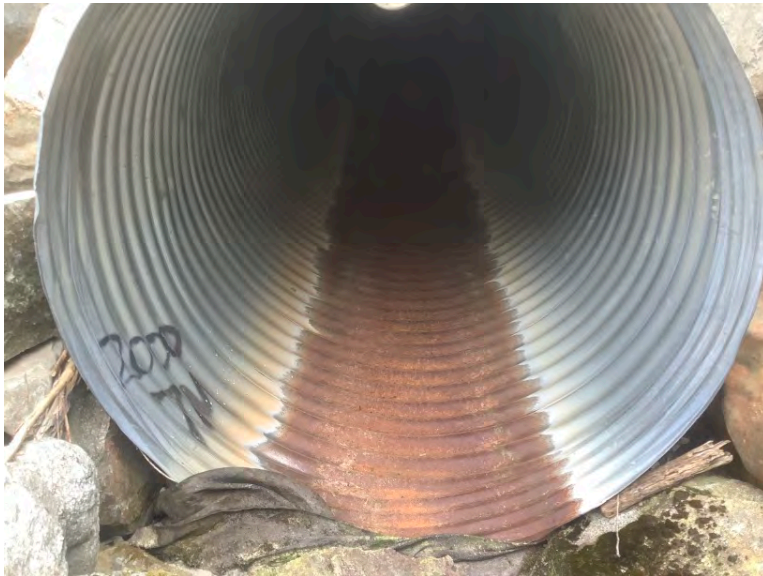
Culvert Floor

Coating      Fair      Floor rusting

Floor      Fair      Rusting

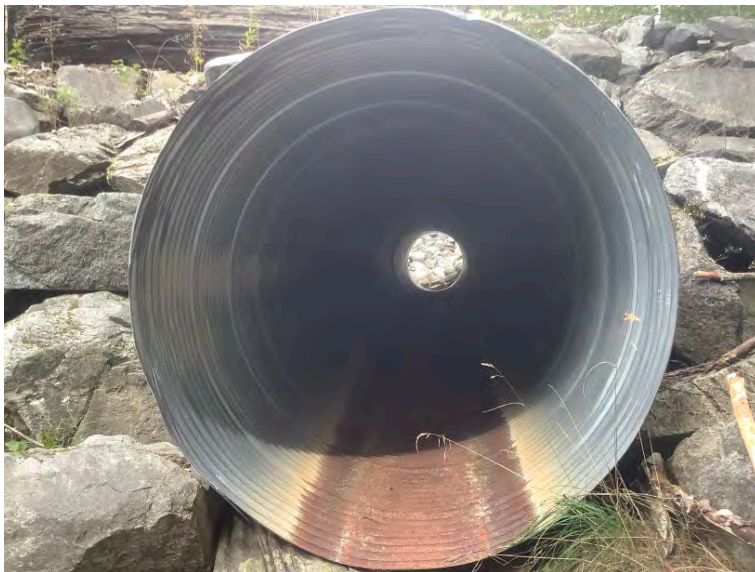
Outlet      Good

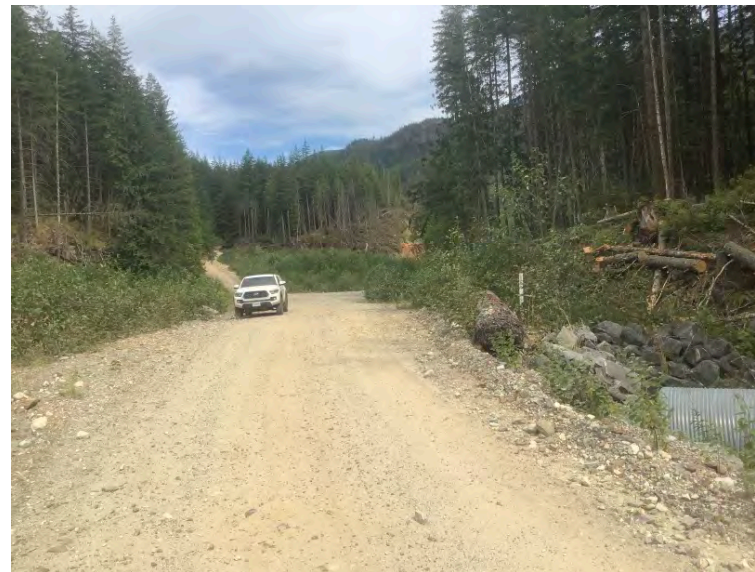
Running surface over culvert

Road Surface **Good**

Comments: should be inspected again in 2023, and ensure cover over pipe is measured in order to confirm load rating.
