CK-2537  
CK-2537

NORRISH 17000 1.8km

2022 Inspection

Load Rated by: MoF, M.Lowe, RPF, PEng, February 16, 2023  
Load Rating: 91 Tonnes GVW, L-100  
Next Inspection: September 1, 2025  
Comments: Recommend brushing approaches and installing signage.

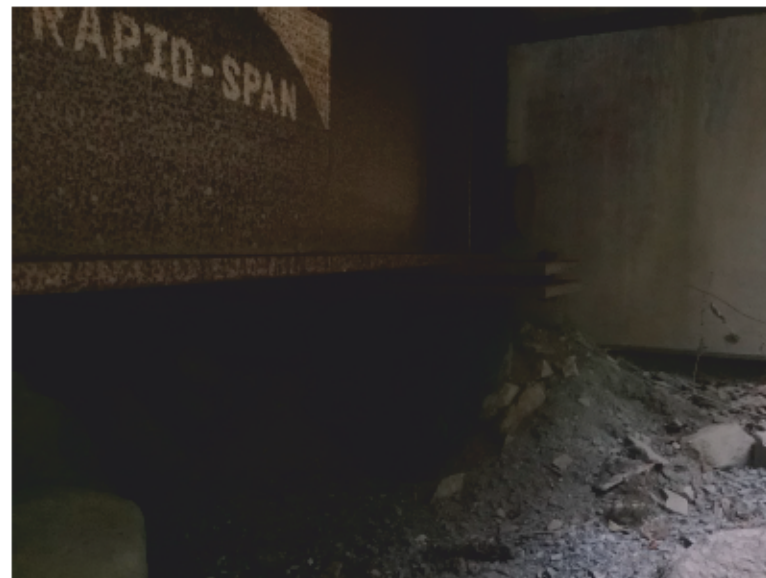
Bearing

Bearings Good

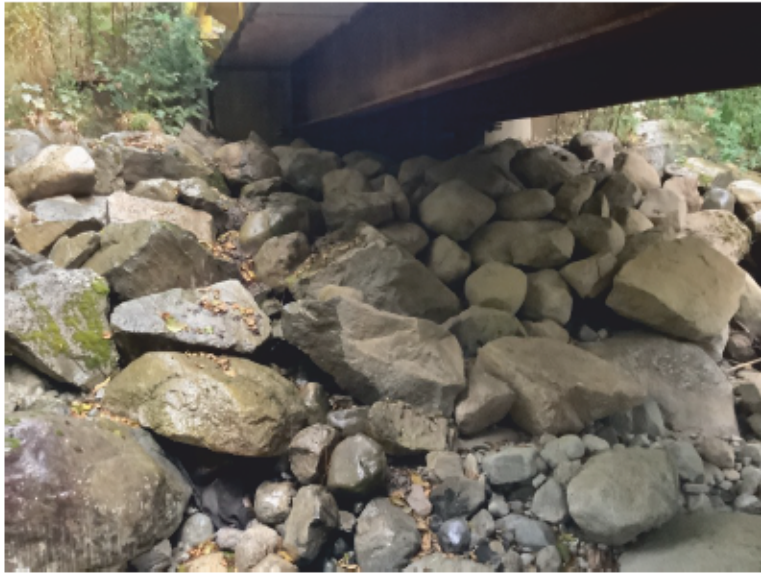
Left Bank Abutment when facing downstream

Riprap Fair Appears some has shifted. Still appear stable

| Item | Monitor Description | Frequency |
|---|---|---|
| 1 | Riprap | Routine Inspection |
