CK-2539  
CK-2539

## HARRISON EAST 20km

2022 Inspection

Load rated by: MoF Sasha Ward RPF, P.Eng Feb 15 2023

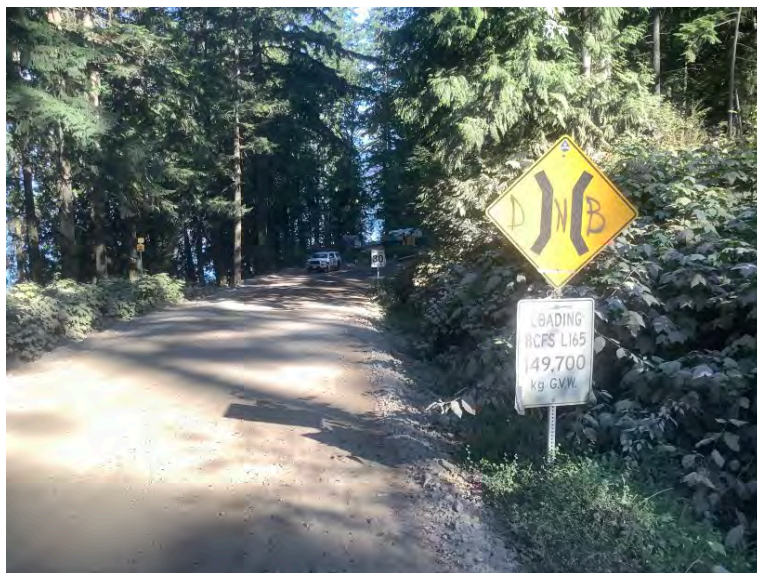
Load Rating Sign

Posted Load Rating

149700

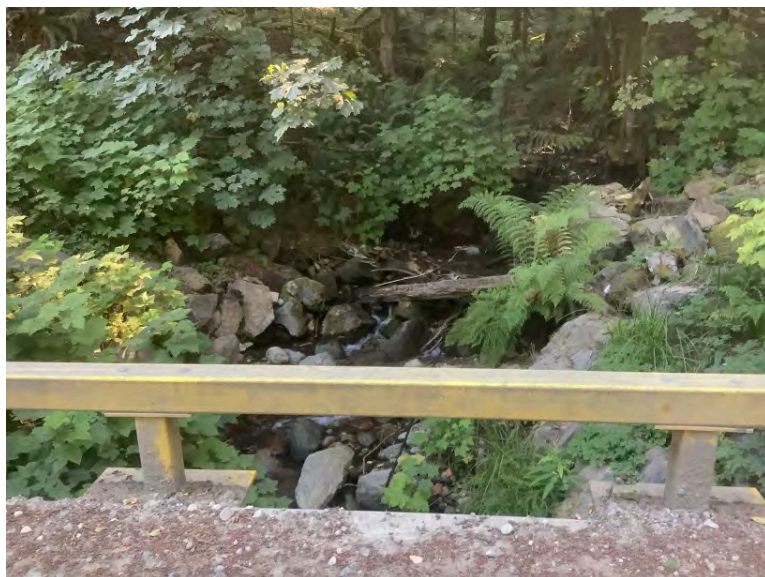
Upstream from Crossing

Minor around structure.

| Repair Item | Repair Description |
|---|---|
| 1 Approach. Area/sight line brushing. m². Priority:Low | Upstream brushing around structure. |

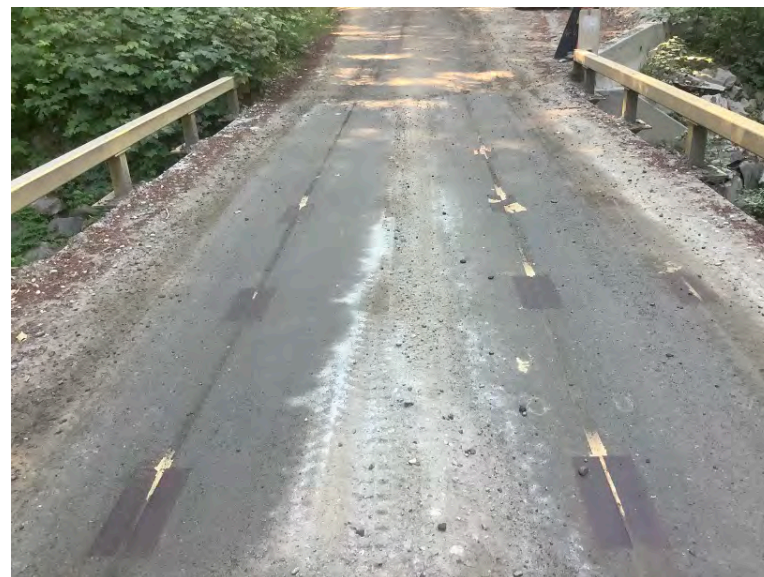
Concrete Deck    **Good**    Minor sediment on deck

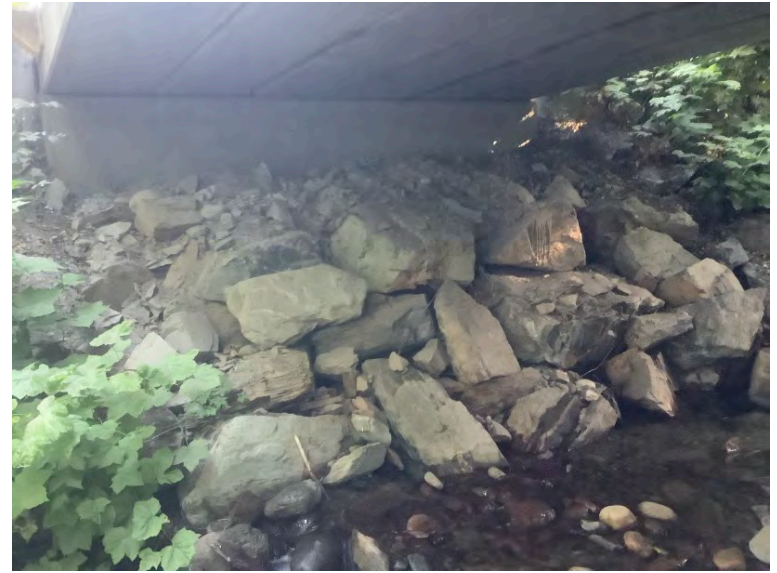
Right Bank Abutment when facing downstream

Riprap Fair

Oversteepened but appears stable

| Item | Monitor Description | Frequency |
|---|---|---|
| 1 Oversteepened riprap | | Routine Inspection |
