CK-2547  
CK-2547

EIGHT MILE km

2022 Inspection

Structure Class Temporary Bridge

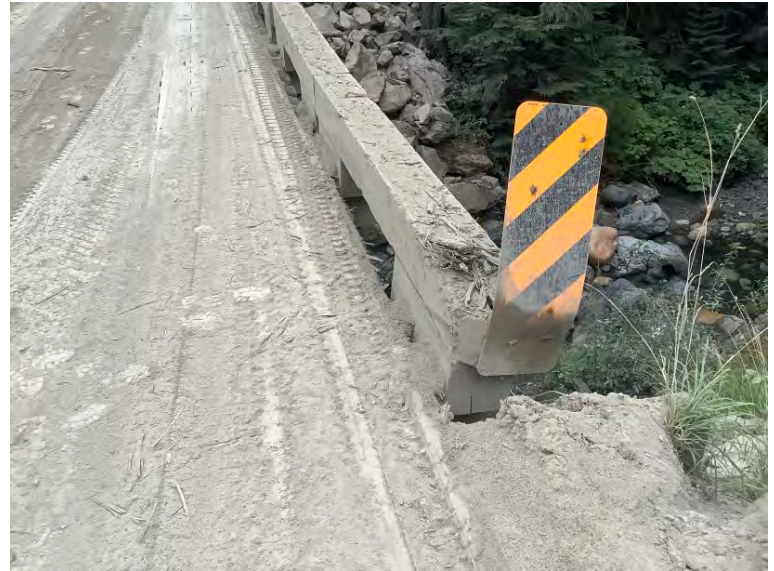
Impact of rail, downstream right. Rail still solid and not loose

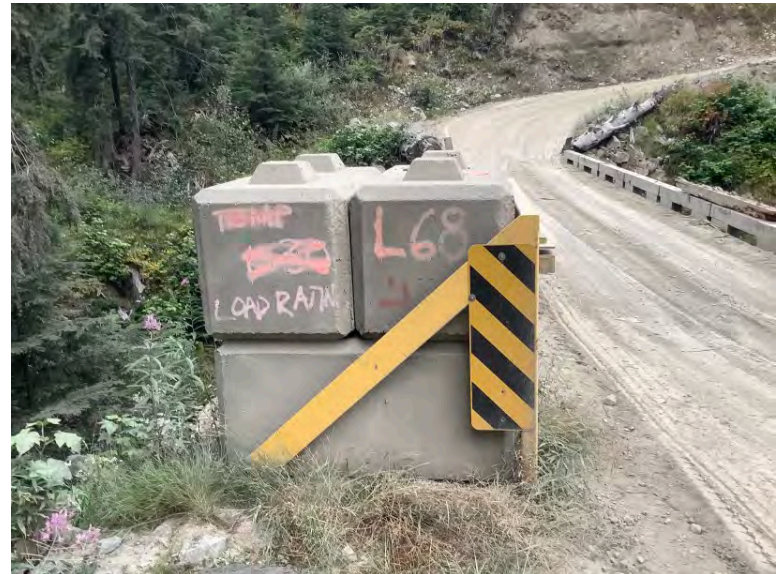
Comments: post load rating, painted load rating is incorrect

L68 painted on lock block

Load Rating Painted on lock block

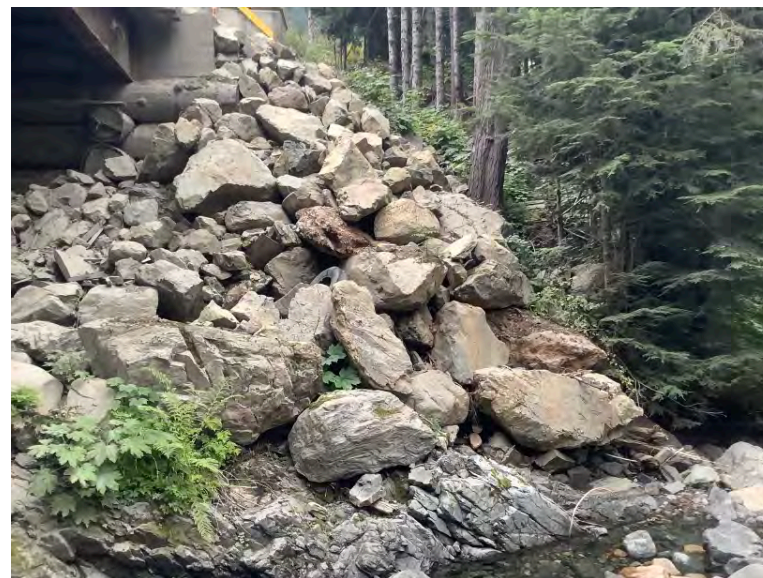
Downstream left has rolled off shoulder. Relocate, also relocate downstream right

Downstream left fill slope repair

| 1 Approach. Approach fenders (re-Install). # of units.<br>Priority:Medium | Re set guidelogs |
