CK-2551  
CK-2551

PURCELL 3.1km

2022 Inspection

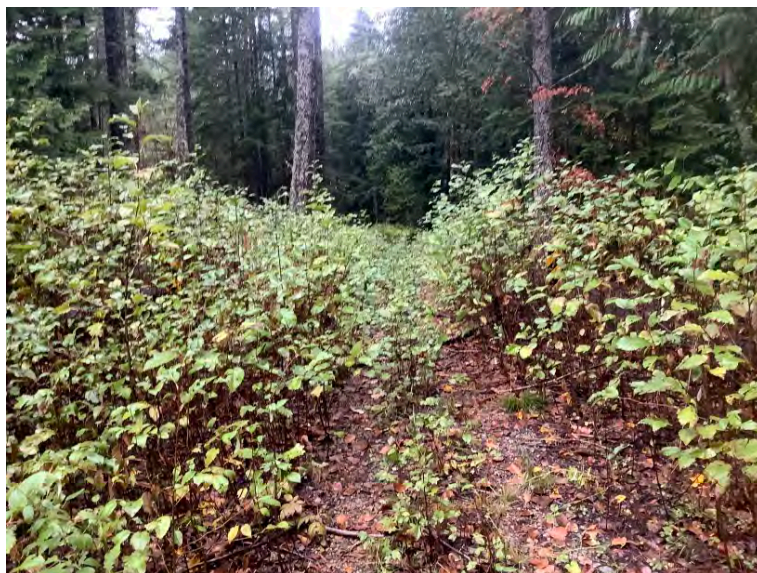
Approach from Left Bank when facing downstream

HC and vc left approach

Brushing Required Y

Vegetation up to 1.2m growing out of road prism

| Repair Item | Repair Description |
|---|---|
| 3 Approach. Brush. Priority: High | Brush approaches prior to use |

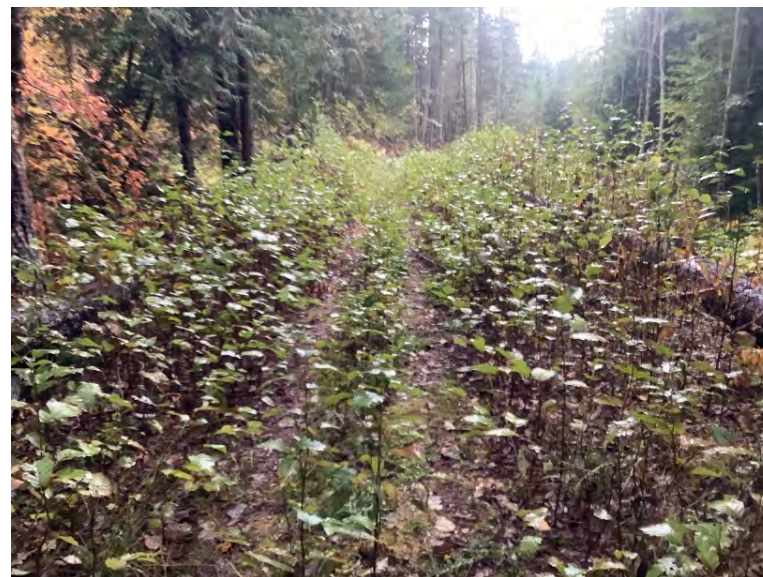
Approach from Right Bank when facing downstream

Bridge Ahead Signs  
Missing

| Repair Item | Repair Description |
|---|---|
| 1 Structure. Add Load Rating Signs. # sites. Priority:Low | Install bridge ahead signs as well. Low due to access to site. |

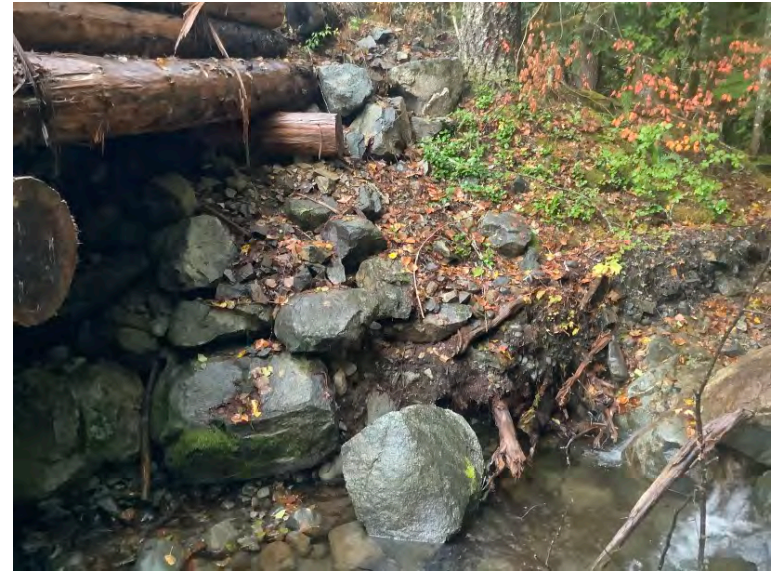
Right Bank Abutment when facing downstream

Right bank on mud sills

Steep. Right bank upstream has begun to scour and movement of large rocks. Further scour puts upstream, end of silllog at risk. Left bank large rocks beginning to scour, toe appears perched

Comments Upstream right riprap, failure will result in undermining of sill log.

Repair/replace the damaged riprap at the upstream right bank location and monitor for future scour. Brush approaches and post bridge ahead signs.

| Repair Item | Repair Description |
|---|---|
| 2 Structure. Add riprap Priority: HIGH | Repair/replace upstream right bank riprap |

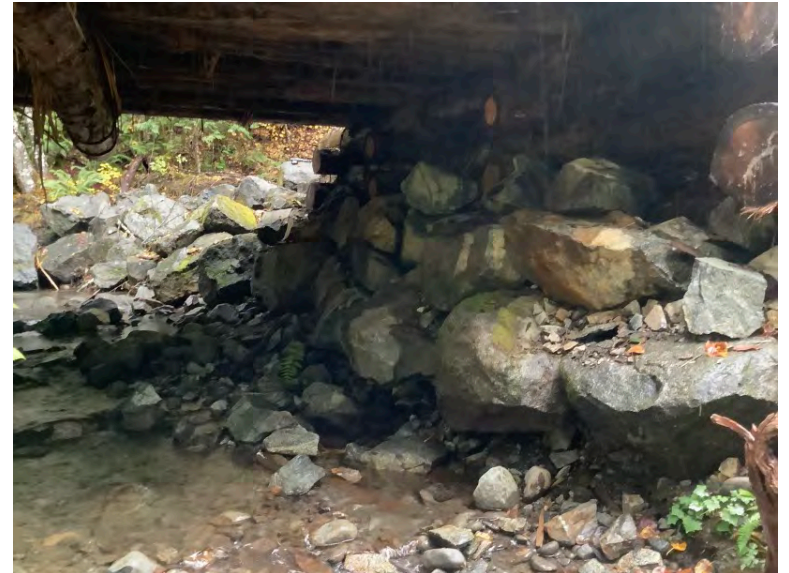
Left Bank Abutment when facing downstream

3 high open crib. Left bank only.

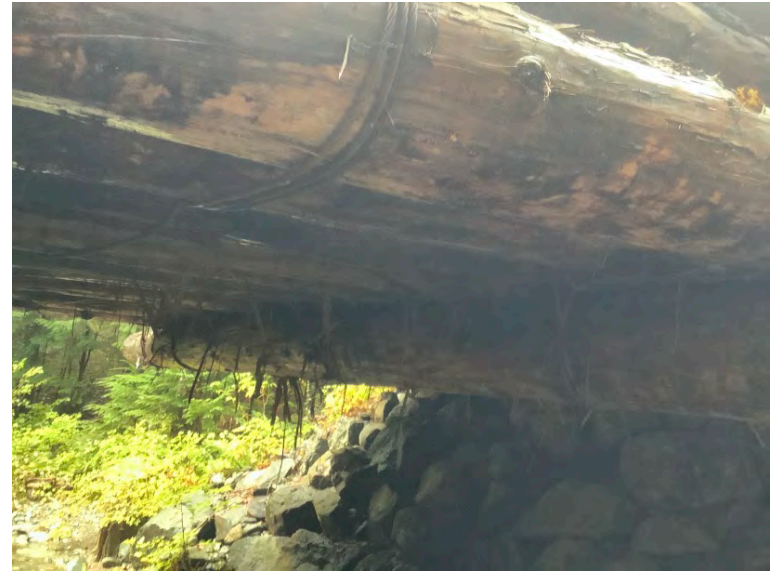
Stringers

The needle beam is not tight to all stringers and ineffective. Limit loading to BCL-625 or 64 tonnes and post load rating signs. In order to increase the load limit I recommend re-lashing the needle beam to all stringers and the structural guard log, ensuring effective shims are installed between the needle beam and stringers. Contact the Coast Engineering Group for further clarification and requirements if this option is requested.

Needle Lashing/  
Shimming **Poor** Loose, can swing by hand

| 1 | Fd | Y | 480 | 8 | Good | Spot checked, all stringers in good condition. |

Load rating to continue as previous inspection. Lash and shim needle beam to bring to I100 of required as specified in previous report.
