CK-2552  
CK-2552

PURCELL 3.6km

2022 Inspection

Structure Class Temporary Bridge

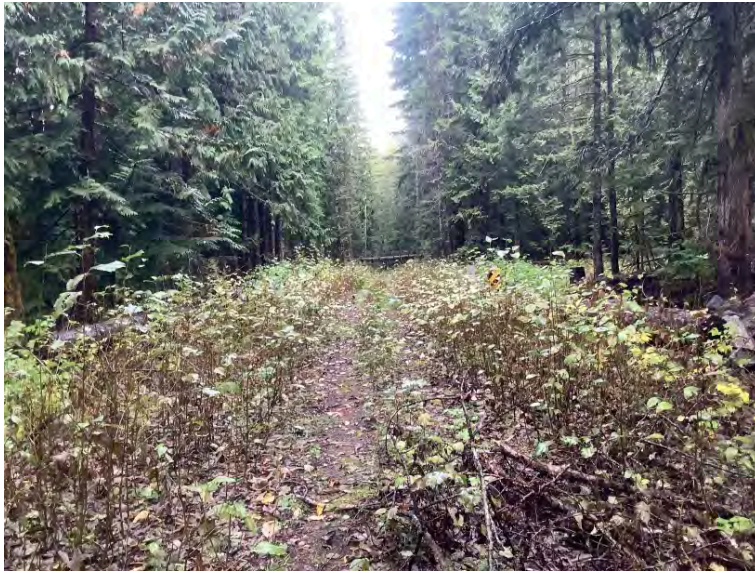
Approach from Left Bank when facing downstream

Bridge Ahead Signs  
Missing ☒ 0 ☐ 1 ☐ 2 Left approach missing hardware

Road Surface **Good** Surface is good beneath vegetation growing out of running surface

| Repair Item | Repair Description |
|---|---|
| 1 Approach. Bridge Ahead<br>Signs. # of signs.<br>Priority:Low | Install hardware and post load rating |
| 2 Approach. Brush.<br>Priority: Medium | Brush approaches |

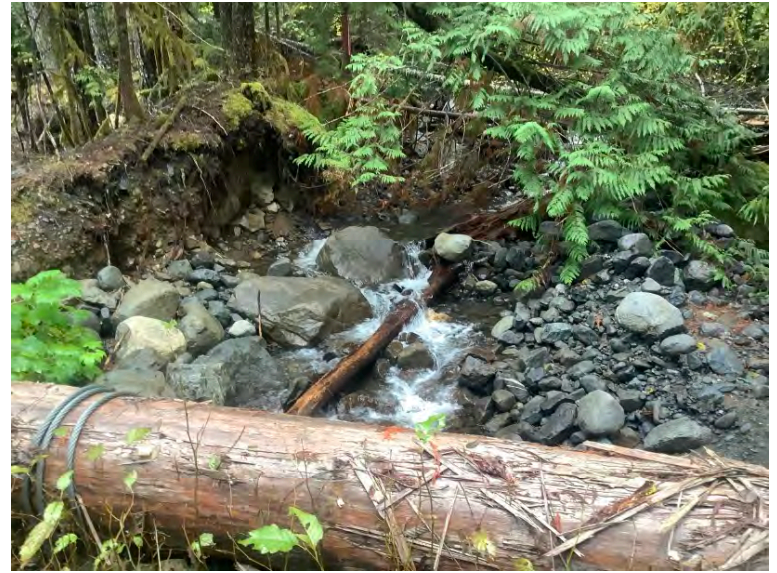
Upstream from Crossing

Appears structure plugged, and released prior to failing. Rock in lashing of needle beam. Deposited Material remains upstream left and downstream right

Riprap **Fair** Oversteepened . Upstream left and downstream right riprap covered deposited material monitor downstream left riprap.

| Item | Monitor Description | Frequency |
|---|---|---|
| 1 | Aggradation of channel up and downstream, | Routine Inspection |

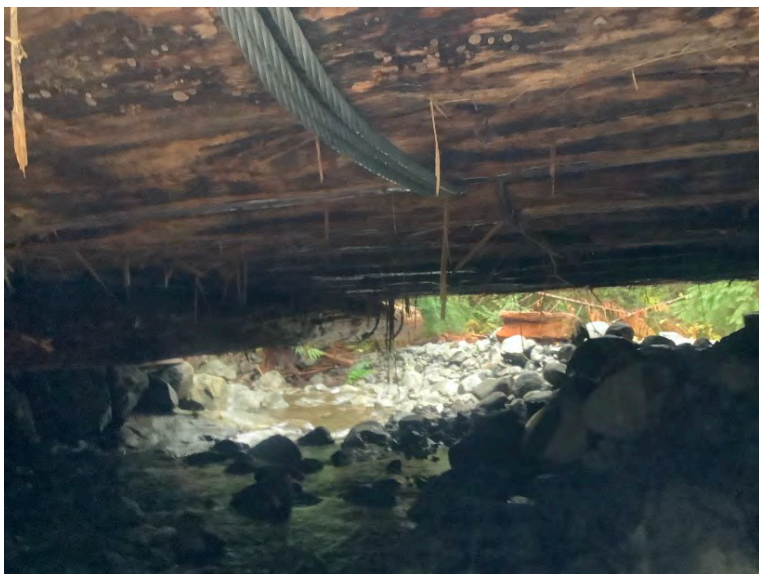
Stringers

| 1 | Fd | Y | 560 | 10 | Good | All stringers in good condition. Drilled |
