CK-2554  
CK-2554

STAVE 29.6km

2022 Inspection

Crossing Name Stave side channel

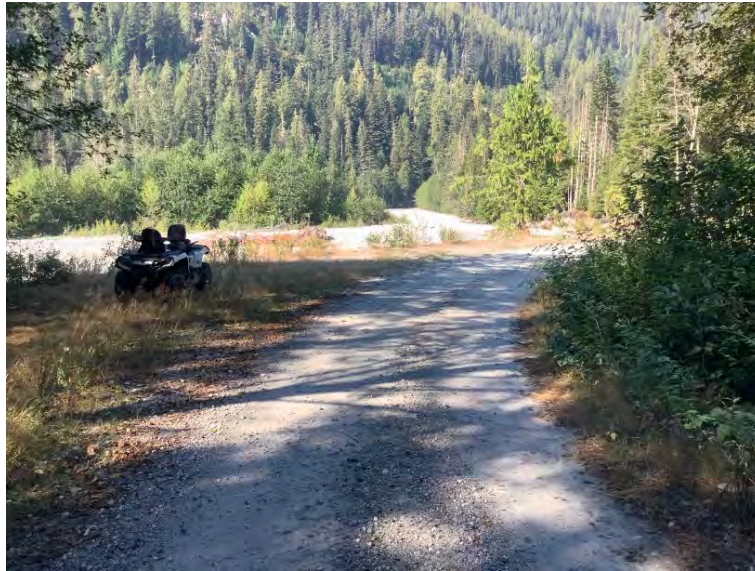
Approach from bridge deck of Right bank approach when facing downstream

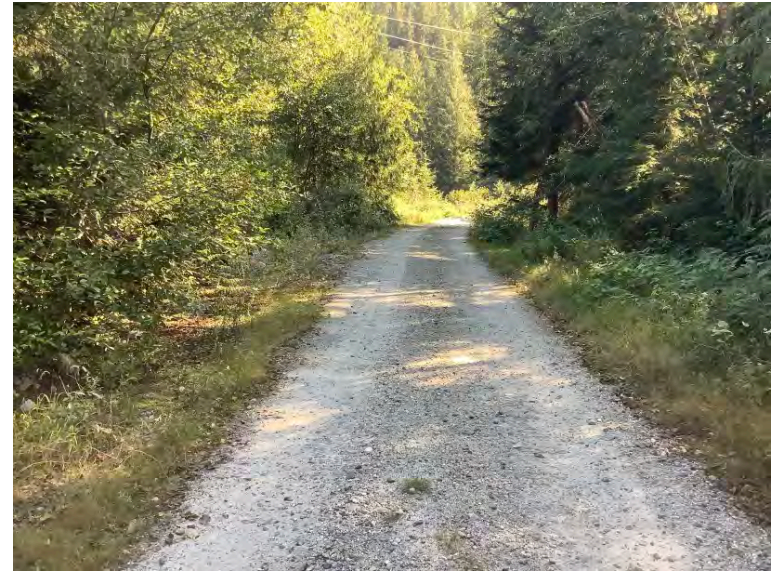
Approach from bridge deck of Left bank approach when facing downstream

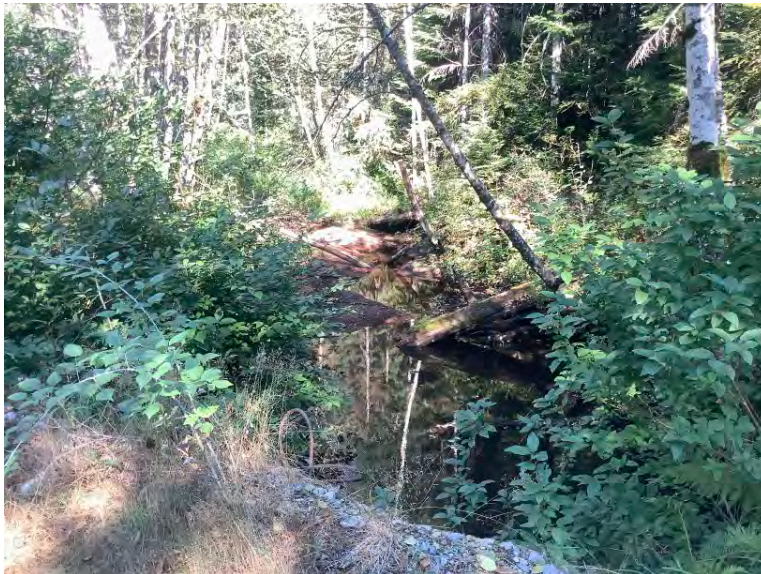
Upstream from Crossing

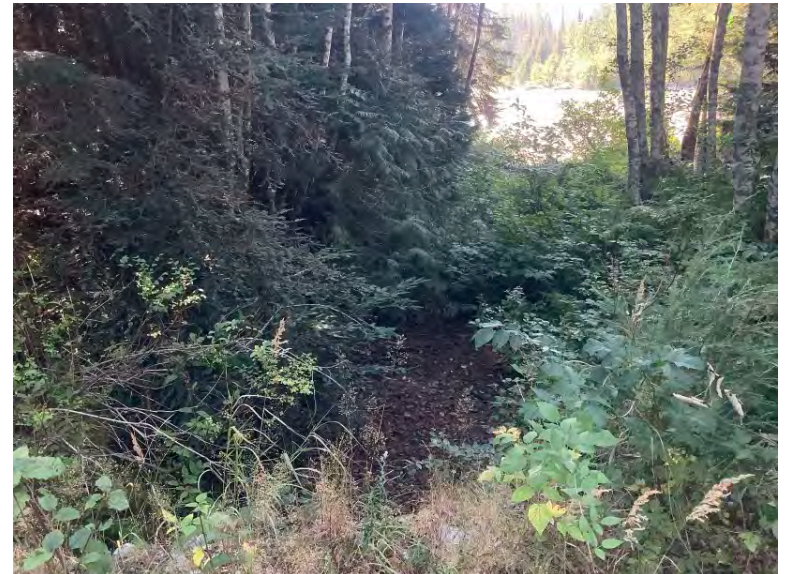
Downstream from Crossing

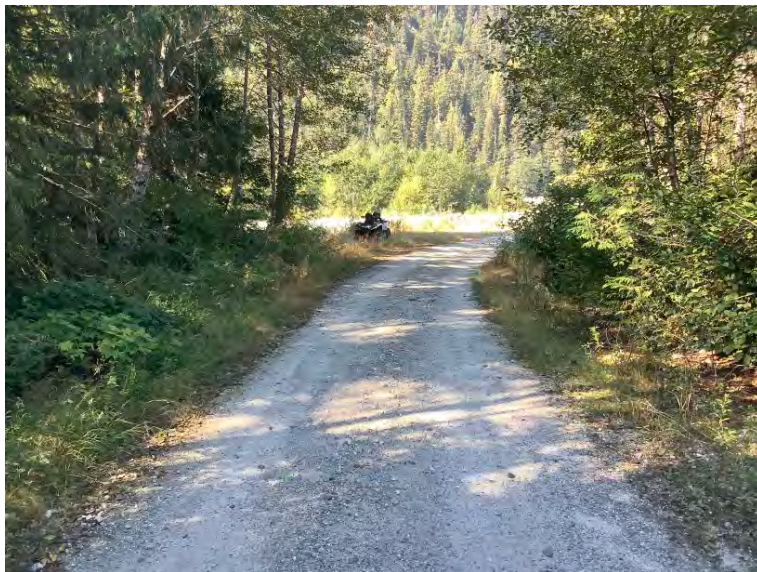
Approach from Left Bank when facing downstream

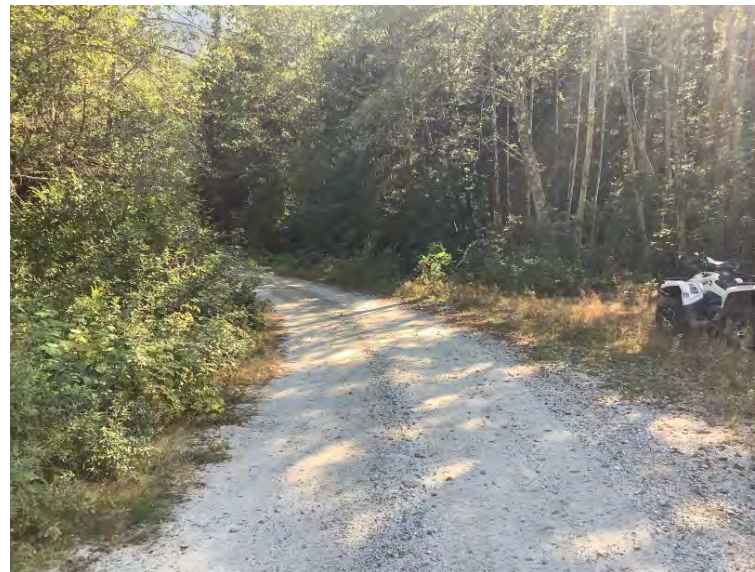
Approach from Right Bank when facing downstream

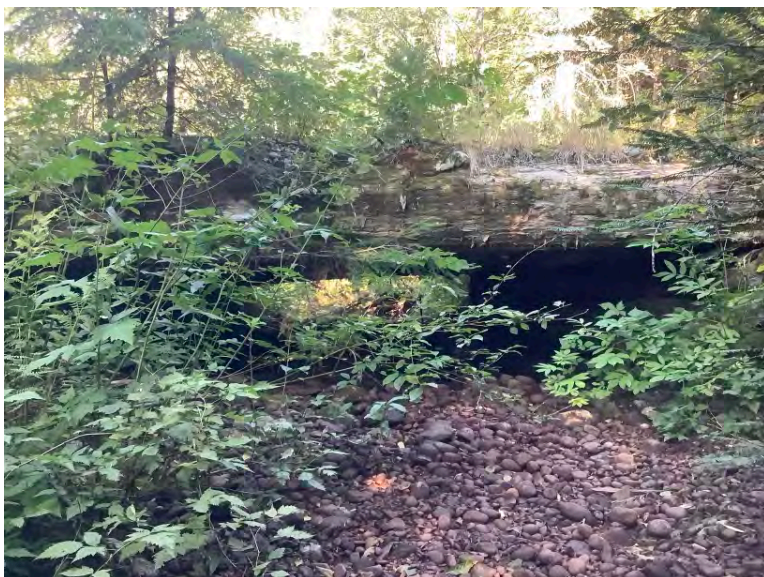
Downstream Profile

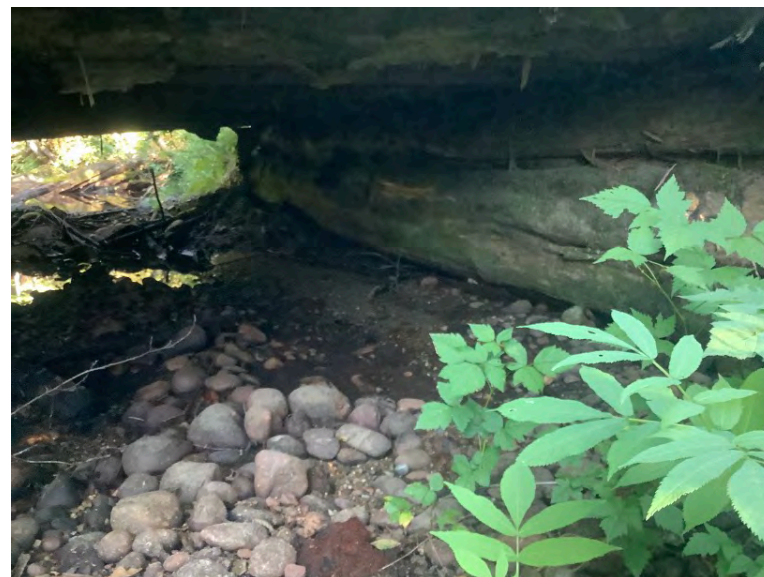
Oversized large diameter single sills. No riprap in front of sills.

Left Bank Abutment when facing downstream

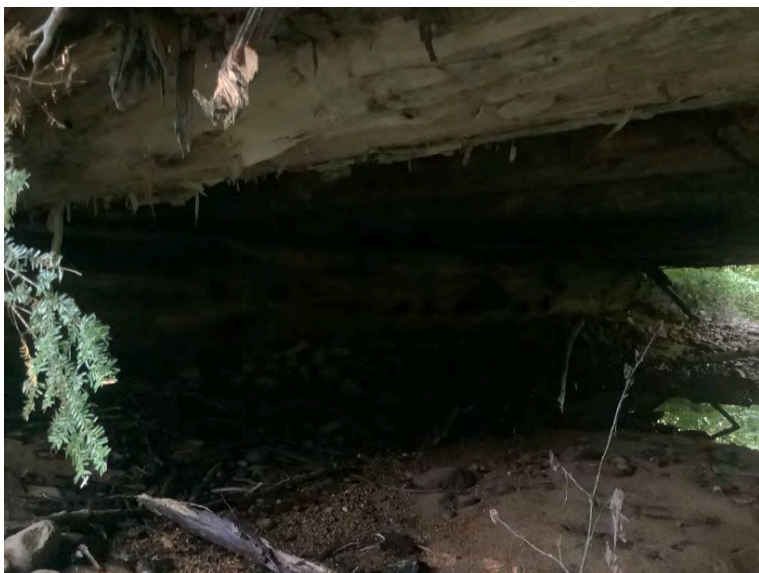
Right Bank Abutment when facing downstream

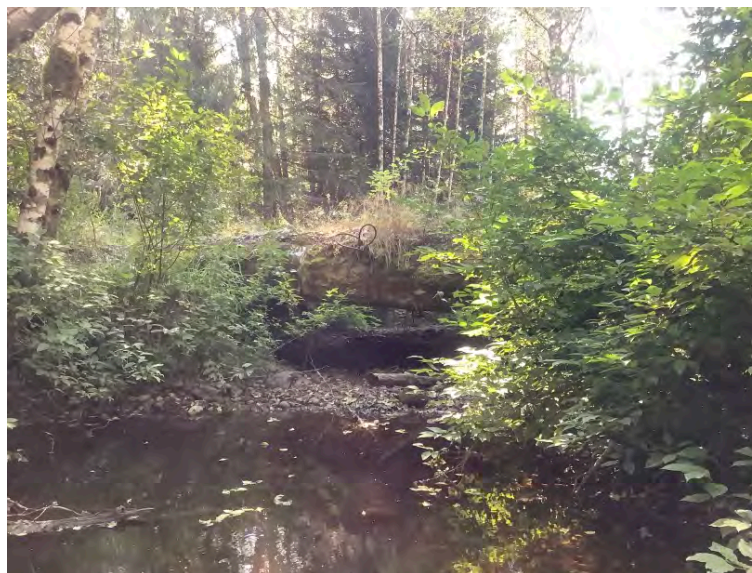
Upstream Profile
