CK-2555  
CK-2555

GARNET 7600 0.4km

2022 Inspection

Structure Class Permanent Bridge

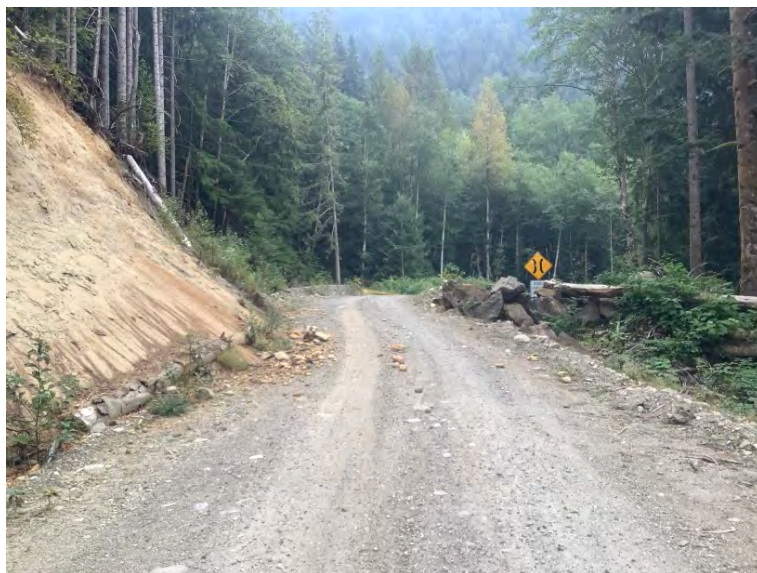
Approach from Right Bank when facing downstream

Potholes each end, woods has impact with ballast wall resulting in minor damage.

| Repair Item | Repair Description |
|---|---|
| 1 Approach. Approach surfacing grading. m. Priority:Low | To limit further damage to ballast wall |

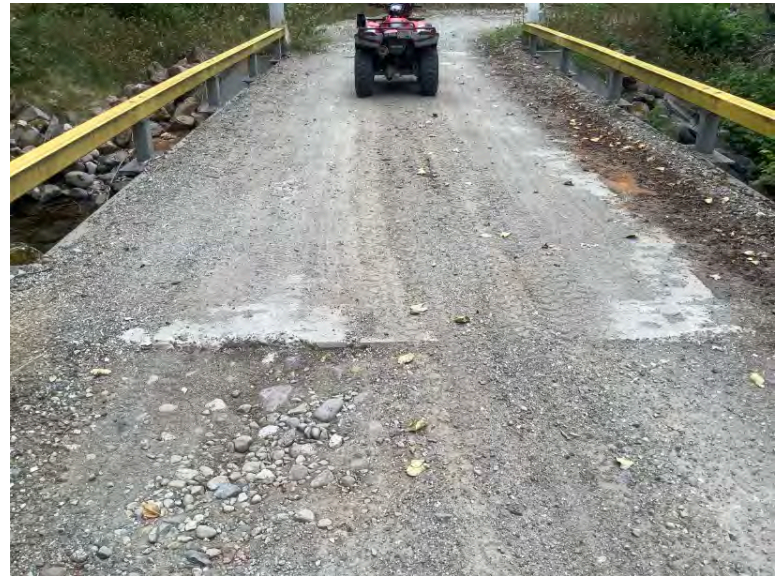
Concrete Deck Good Completely covered in sediment.

Load rated by: MoF Sasha Ward RPF, P.Eng Feb 15 2023  
Load rating: 91 tonnes, L100  
Comments: grading of approaches required to fill potholes,  
sweep sediment off of bridge deck  
Next inspection: 2024
