CK-2556  
CK-2556

GARNET 7600 0.6km

2022 Inspection

Crossing Name Garnett Creek

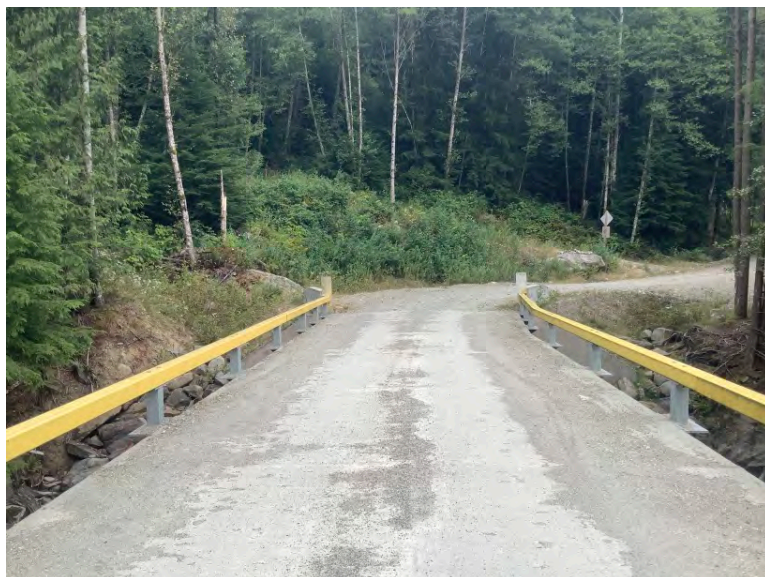
Approach from bridge deck of Left bank approach when facing downstream

Comments: must improve grading practices on approaches as bridge ends have sustained considerable damage in a short time

| Repair Item | Repair Description |
|---|---|
| 2 Approach. Approach surfacing grading. m. Priority:Medium | To limit impact on ballast walls |

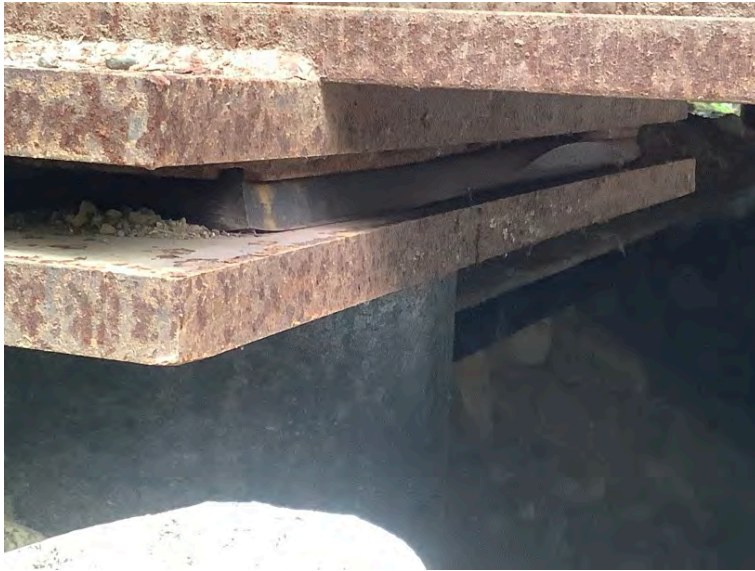
Bearing

Bearings Fair Bulging

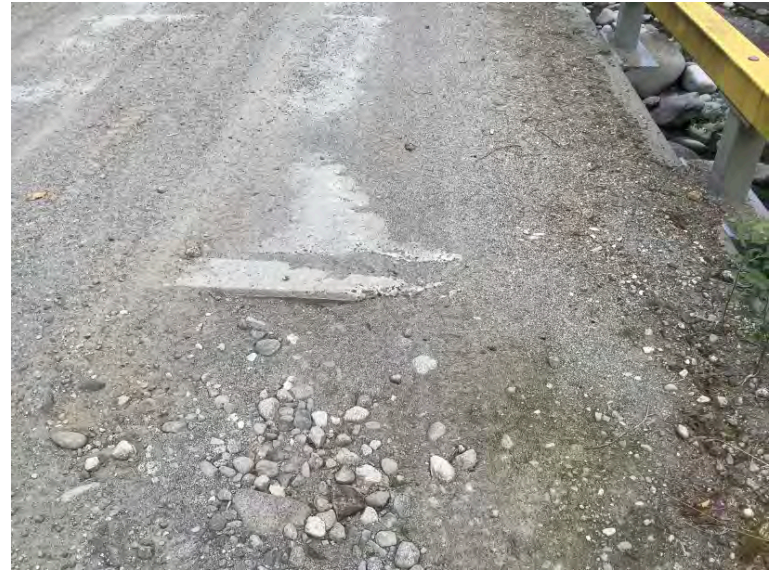
Ballast Wall Fair Impact on each ballast wall from tracked machines. Paraseal joints at both ends have failed.

| Repair Item | Repair Description |
|---|---|
| 1 Structure. Joint replacement. m². Priority:Low | Replace paraseal joint both ends. |
| 3 Structure. Concrete structural maintenance. m². Priority:Medium | Repair ballast walls. |

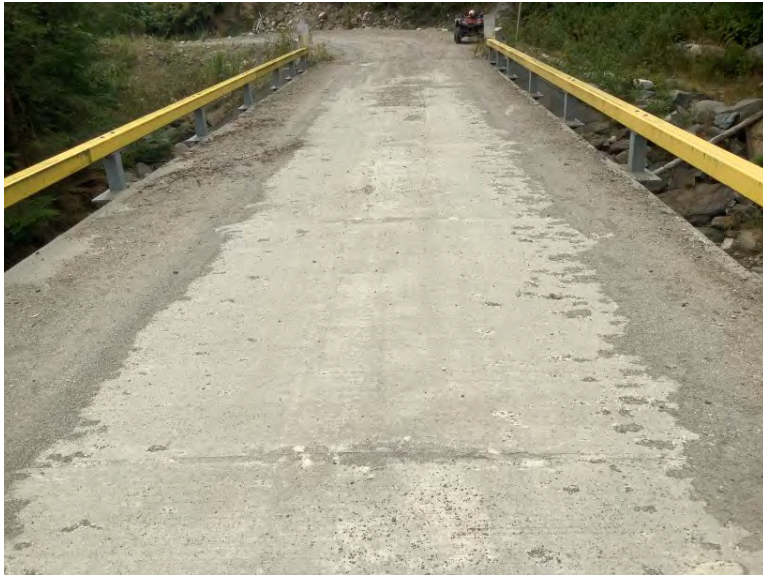
Concrete Deck      Fair      Damage from tracked machines with ice picks walking across.
