CK-2559  
CK-2559

## MOUNT THURSTON 0km

2022 Inspection

Crossing Name Pedestrian Bridge

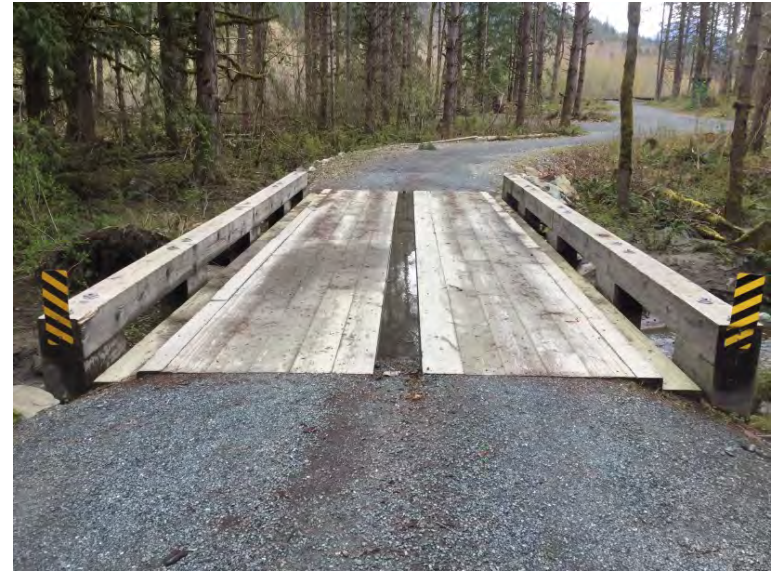
Deck

Good

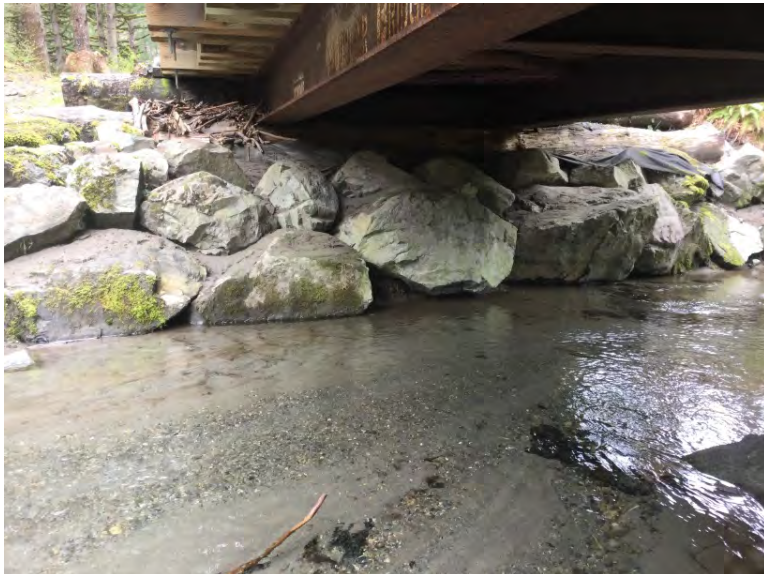
Left Bank Abutment when facing downstream

Single log sills

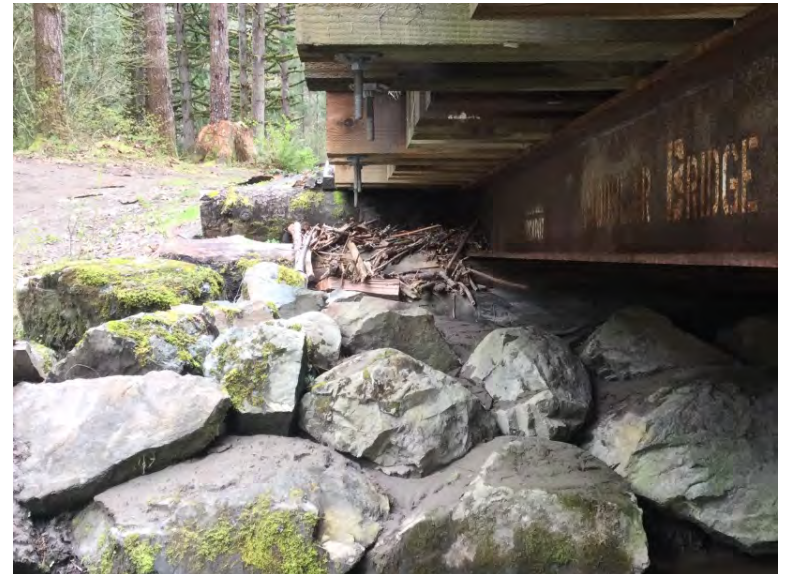
Evidence that water levels approached under side of girder elevation - likely in the November 2021 storm event

Evidence of stream height

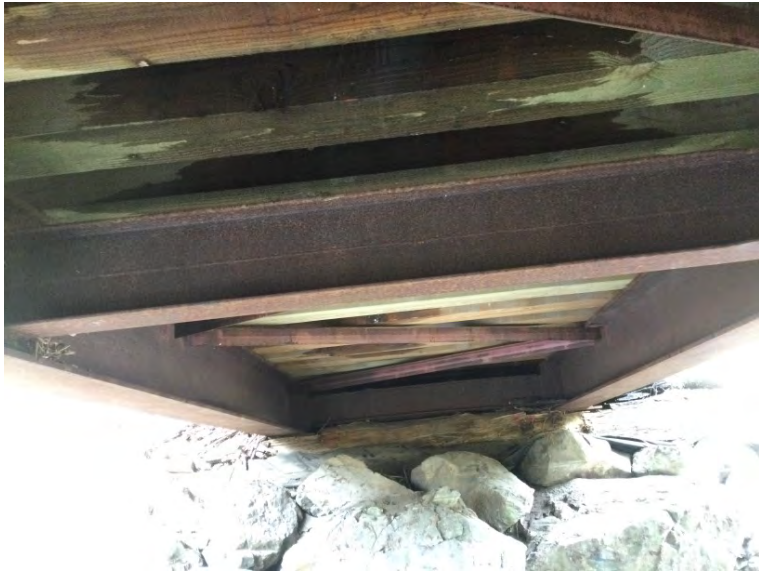
Superstructure

Girders Fair

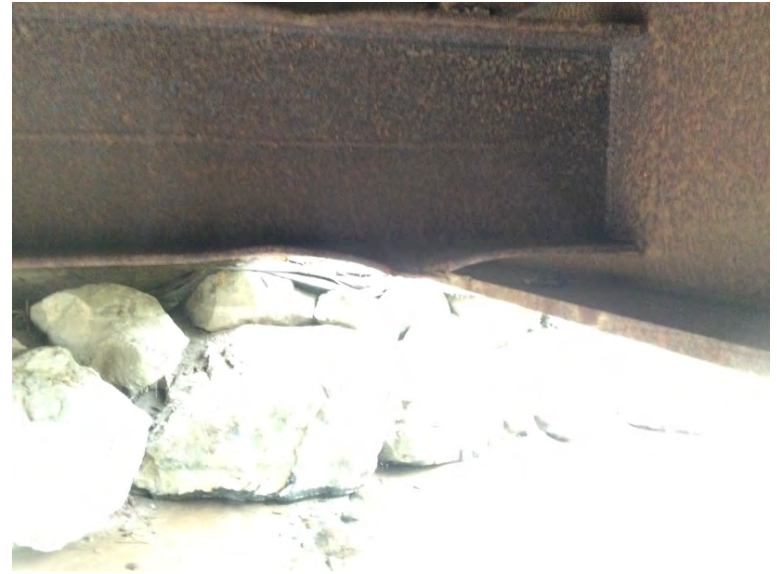
Bracing Fair

Minor damage to center span bracing

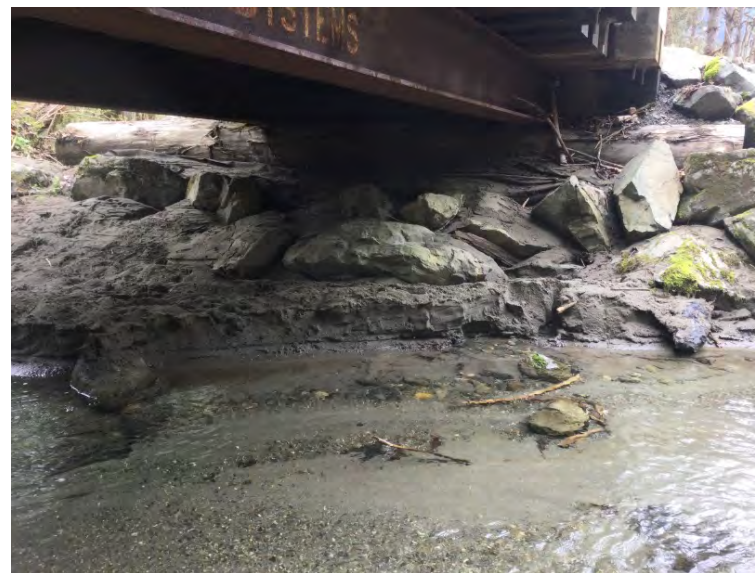
Right Bank Abutment when facing downstream

Timbers right bank, log left bank
