CK2477  
CK-2477

NAHATLATCH 39.8km

2022 Inspection

Crossing Name Nahatlatch Creek

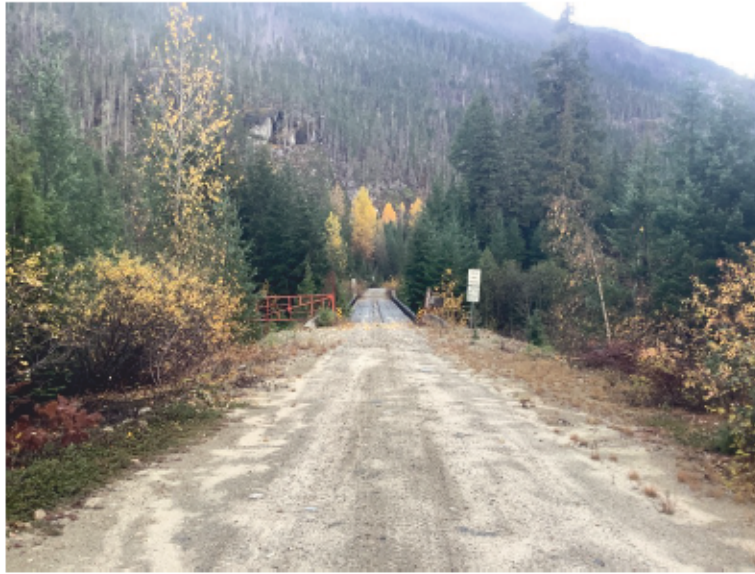
Approach from Left Bank when facing downstream

Brushing Required **Y** Minor around structure

1 Approach. Area/sight line  
brushing. m². Priority:Low

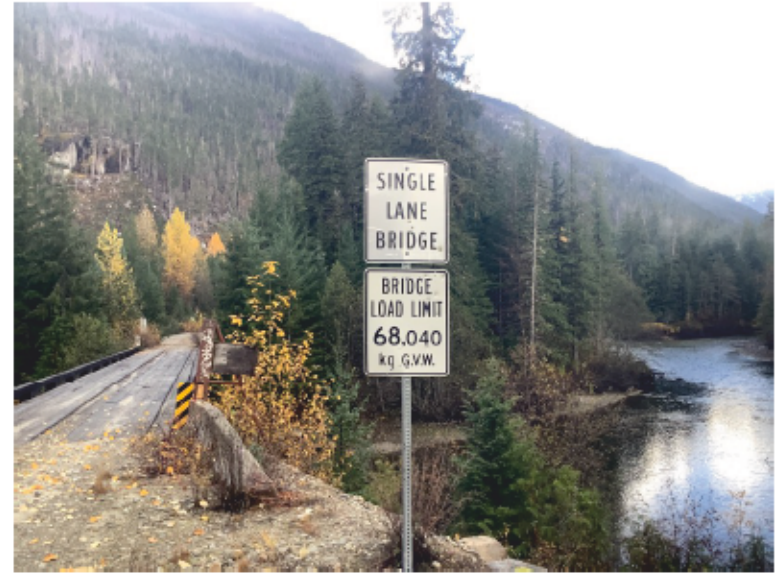
Load Rating Sign

Previous inspection stated load rating signs can get increased.

Posted Load Rating **68040**

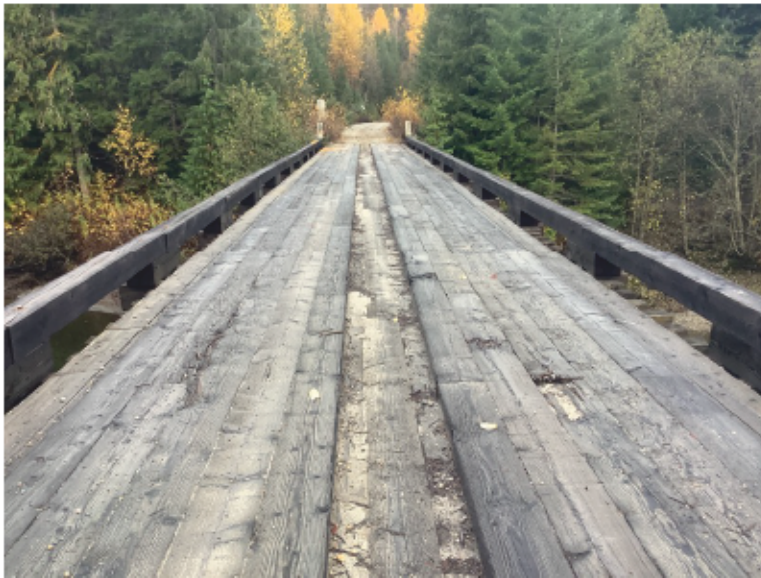
Running Planks      Fair      Some wear

Overall Deck Condition      Fair

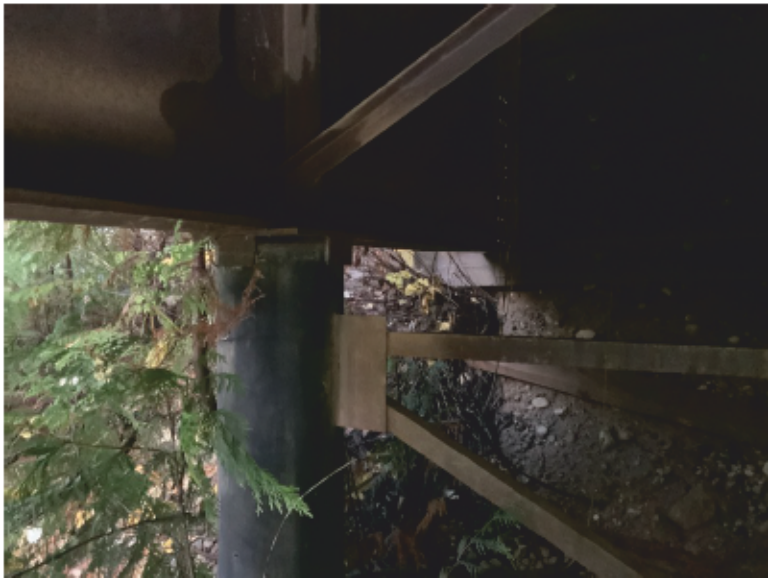
Bearing

Bearings **Fair** Thin rubber pads

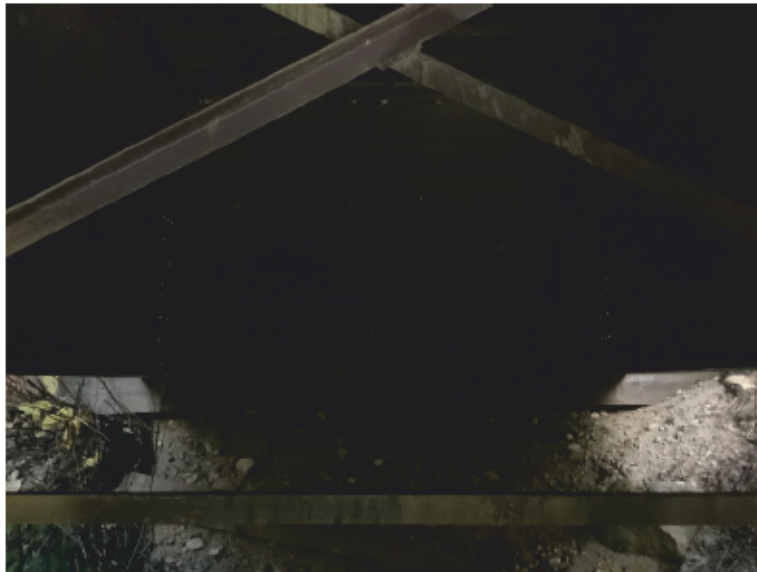
Ballast Wall **Fair** Treated Timbers, reinforced between girders. Mis aligned at downstream end

Item Monitor Description Frequency  
1 Ballast wall condition Routine Inspection
