CK2479  
CK-2479

GRIZZLY 2.1km

2022 Inspection

Crossing Name Grizzly Creek

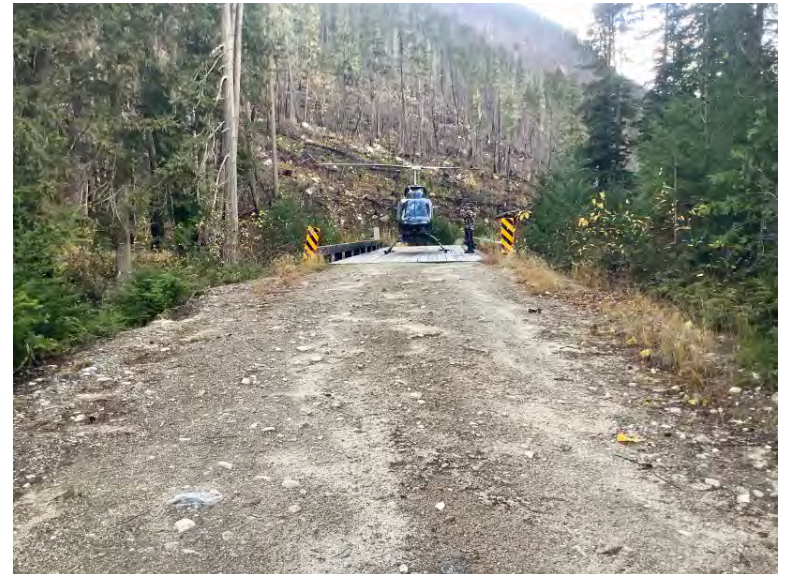
Approach from Right Bank when facing downstream

No fenders on right approach

| Repair Item | Repair Description |
|---|---|
| 1 Approach. Approach fenders (install). # of units.<br>Priority:Low | Right bank fenders |

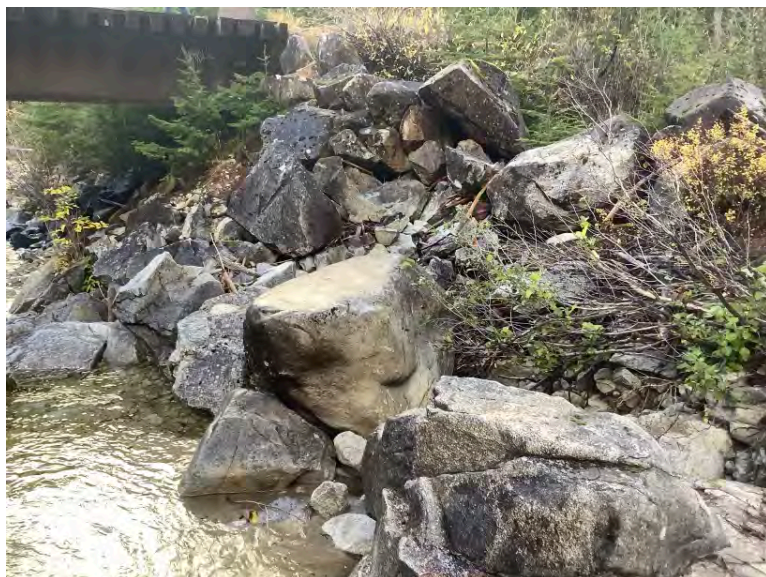
Right Bank Abutment when facing downstream

Right bank is beginning to mobilize

| Item | Monitor Description | Frequency |
|---|---|---|
| 1 | Right bank riprap | Routine Inspection |

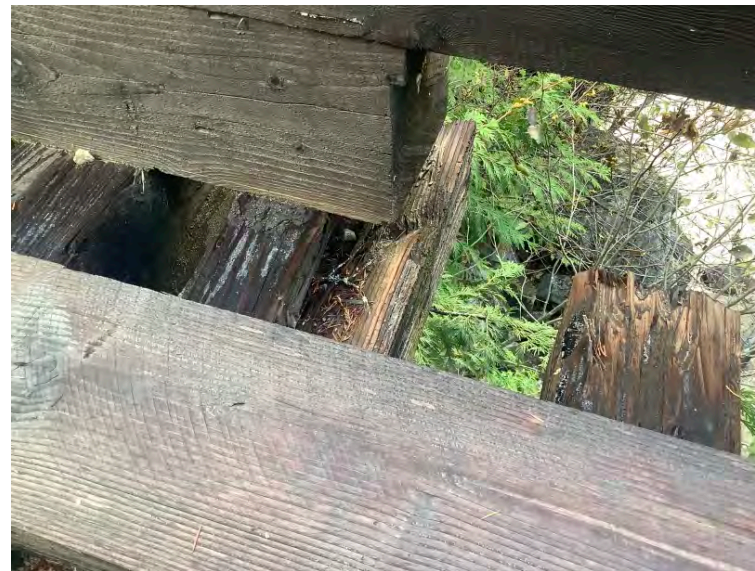
Ties      Fair      Same random damage. Noted previous inspection, likely from removing old sub deck

Damaged cross tie end

| Repair Item | Repair Description |
|---|---|
| 2 Structure. Minor redecking (wearing surface). m.<br>Priority:Medium | Fasten all deck planks to cross ties |

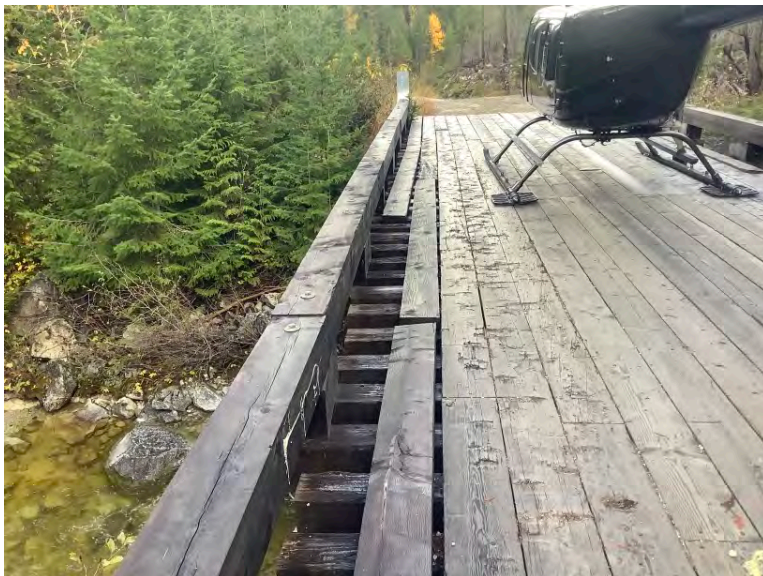
Running Planks      Fair      Not installed tight together. Outside strip not nailed to below

Loose planks

Comments: replace fenders, ensure outside deck planks are secured to cross ties
