CK-2460  
CK-2460

HORNET 0.6km

2023 Inspection

Structure Class Temporary Bridge

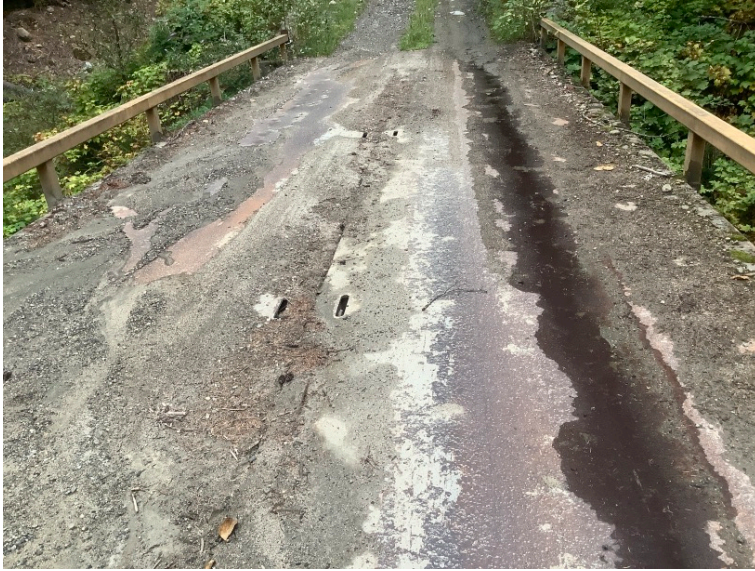
Steel Deck Plate      Fair      Deformation in tracking locations

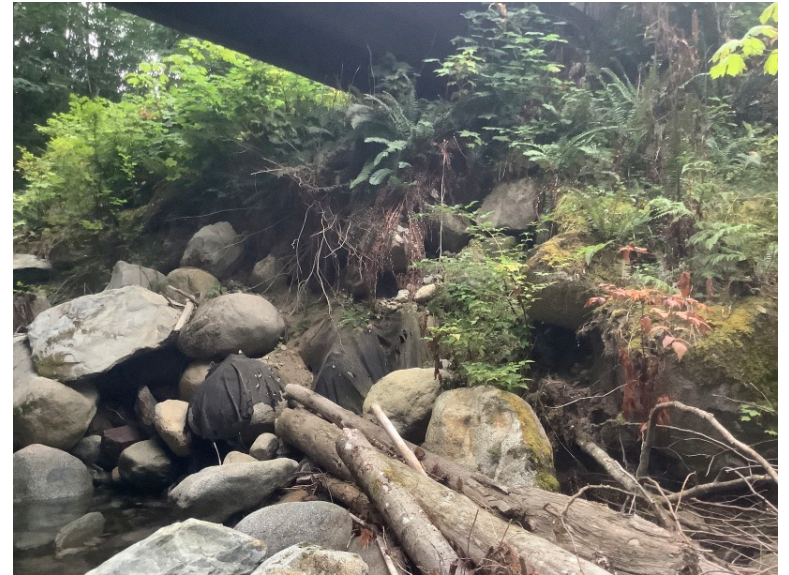
Left Bank Abutment when facing downstream

Almost fully scoured away on both abutments

Comments Both abutments require riprap. Almost fully washed away on both sides. Bridge bearing is set far back and currently safe. Recommend remedial works to limit risk to further fill loss.

| Repair Item | Repair Description |
|---|---|
| 1 Channel. Add Riprap (placed). m <sup>3</sup> . Priority:High | |

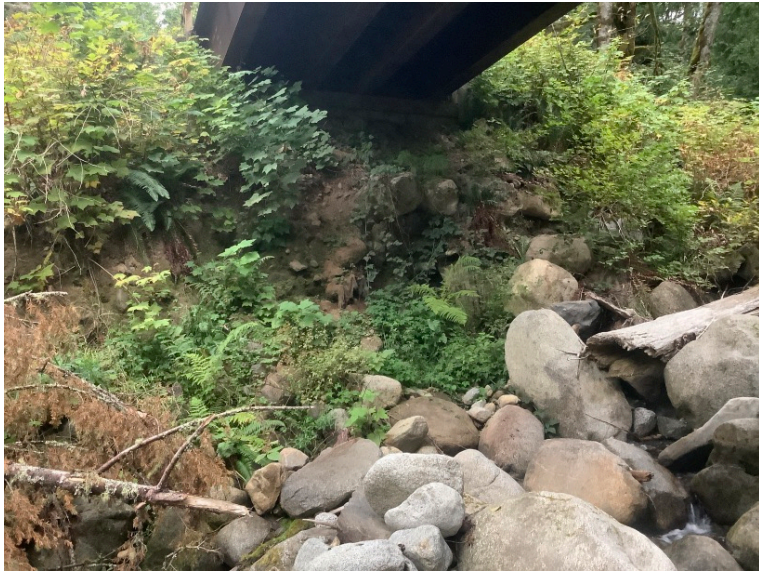
Right Bank Abutment when facing downstream

Cap beam with integrated ballast walls. Right bank has spalls

| Item | Monitor Description | Frequency |
|---|---|---|
| 2 | Spalled concrete along top edge of right bearing cap beam | Routine Inspection |
