# RWC-1001 2023 Inspection

Army 0.5km

## Retaining Wall Inventory Data

## Retaining Wall Inspection Report

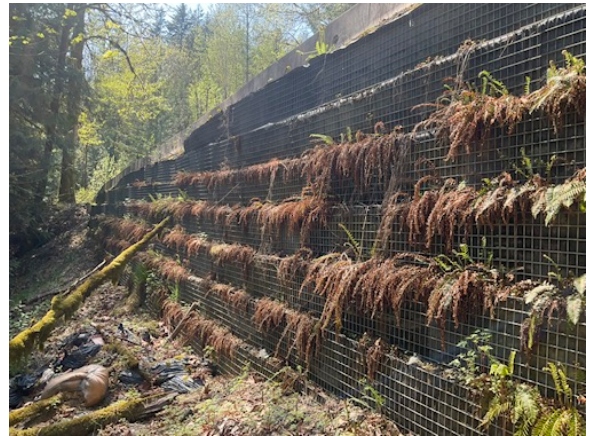
| | Rating | Comments |
|---|---|---|
| Retaining Wall Structure | Good | Well founded GRS wall utilizing galvanized welded wire mesh and geotextile facing. No failed elements observed however there are lots of ferns growing from the wall. |

Face if and ferns. Well founded.

| Item | Status | Priority | Description | Ministry Engineer Comment |
|---|---|---|---|---|
| 1 | Suggested | Medium | Clean garbage and remove ferns. | |

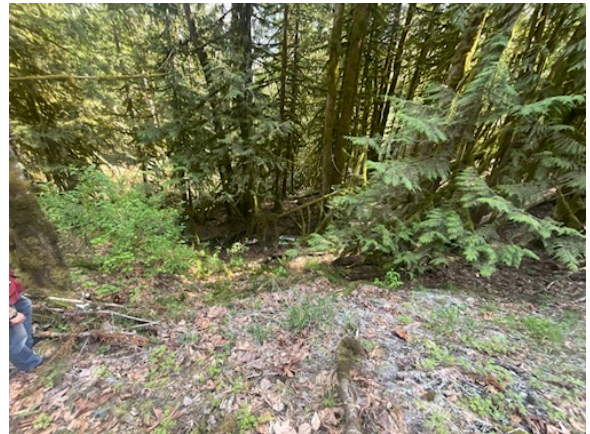
| | Rating | Comments |
|---|---|---|
| Downslope | Good | No signs of instability however popular location for garbage. |

Down slope garbage. Competent material below.

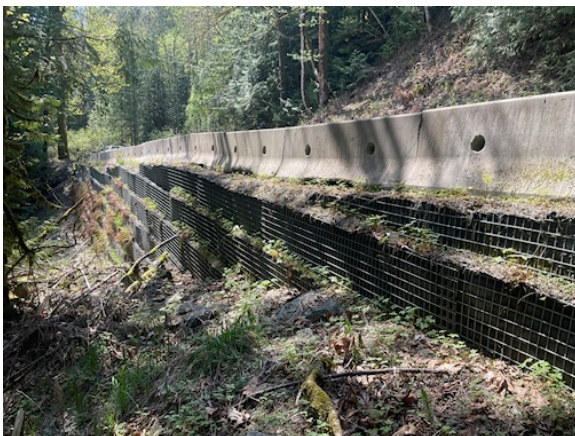
Geotextile and wwm in good shape. Minor bulging but not severe.  
Bulging exists where wwm not tied back because cut.
