# RWC-1002 2023 Inspection

Bench 2.2km

## Retaining Wall Inventory Data

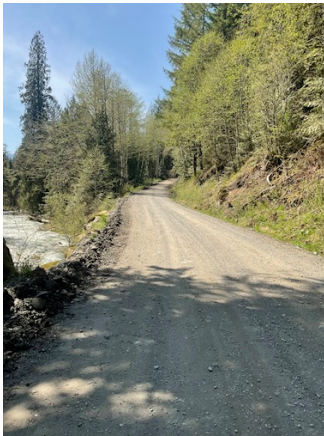
| | Rating | Comments |
|---|---|---|
| Traffic Barrier | Poor | Does not exist. |

From town approach, no barrier.

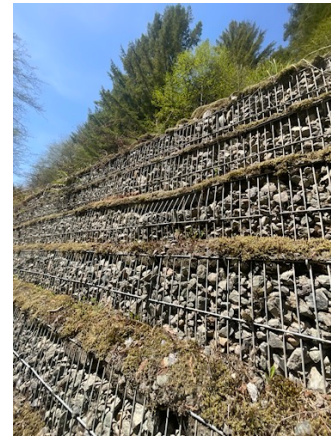
| | Rating | Comments |
|---|---|---|
| Retaining Wall Structure | Good | Well performing wall with cobbles behind welded wire mesh facing rather than geotextile behind the mesh. |

Wall facing

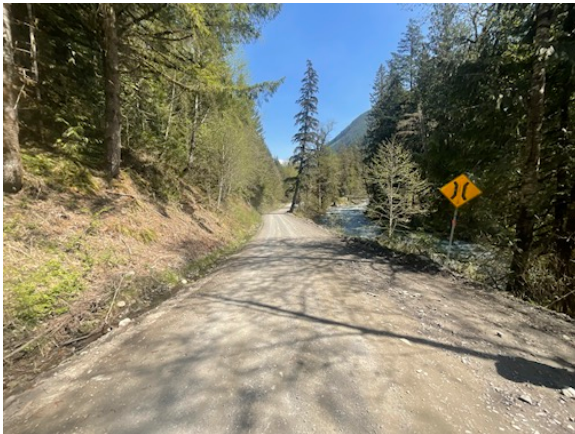
| | Rating | Comments |
|---|---|---|
| Signage Delineators | Fair | Sign indicating single lane coming from woods. |

From woods and sign

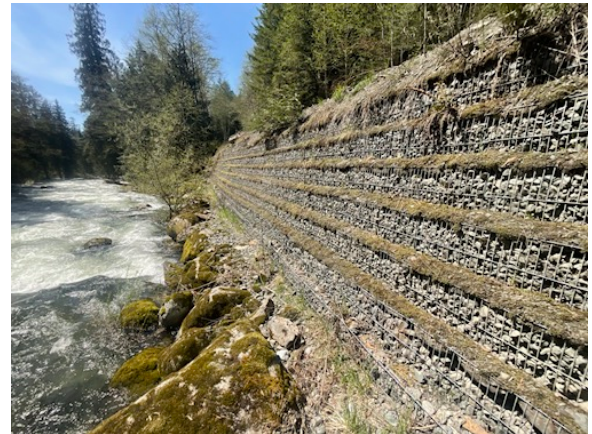
| | Rating | Comments |
|---|---|---|
| Foundation Material | Good | |

Good foundation

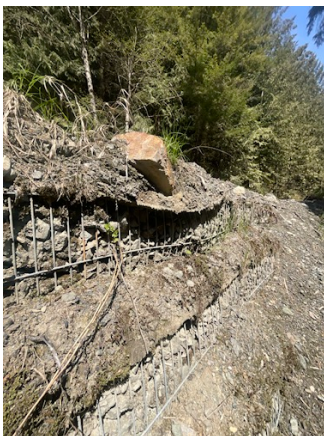
| | Rating | Comments |
|---|---|---|
| Wall Movement Indicators | Fair | Some bulging noted mid way up wall. Potentially some fill eroded out of mesh and resulted in this. Foundation appears solid. |

Some bulging upper 2

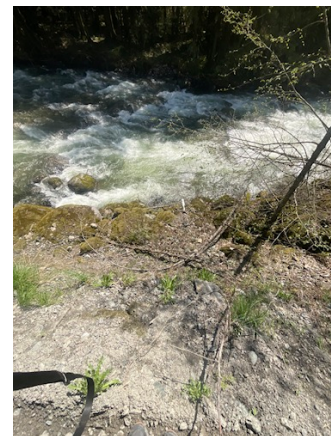
| | Rating | Comments |
|---|---|---|
| Drainage System | Good | PVC drainage pipe at base of wall draining into foley creek. |

Horizontal drain hole at base
