# RWC-1003 2023 Inspection

Bench 16km

## Retaining Wall Inventory Data

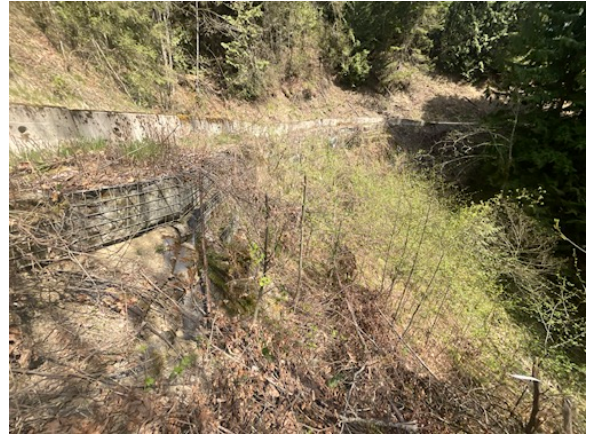
| | Rating | Comments |
|---|---|---|
| Retaining Wall Structure | Poor | Sides of structure are missing wire mesh facing and the Geotextile is allowing the fill to spill out. |
| Wall Movement Indicators | Fair | Side of wall on woods end is spilling out fill with failed wire mesh. |

Geofabric at woods side has no wwm re enforcement and is failing.

| Item | Frequency | Description | Ministry Engineer Comment |
|---|---|---|---|
| 1 | 2 years | Monitor side where welded wire mesh is not present to hold wall | Daniel Stein |

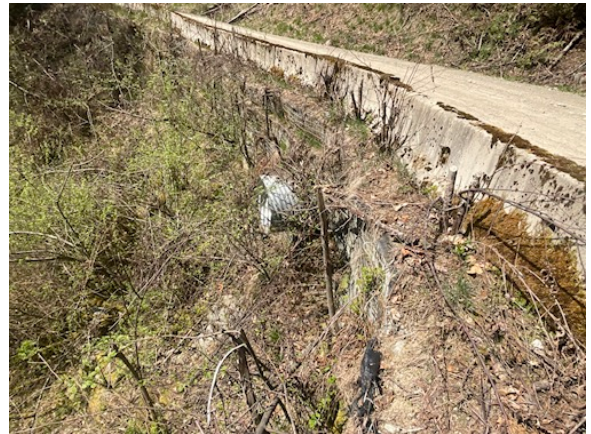
| | Rating | Comments |
|---|---|---|
| Foundation Material | Good | No signs of deformation in the wall or indications of sagging however there is much vegetation at base of wall and it can't be fully assessed. |

Foundation looks ok but erodible material. Sagging facing indicates this.

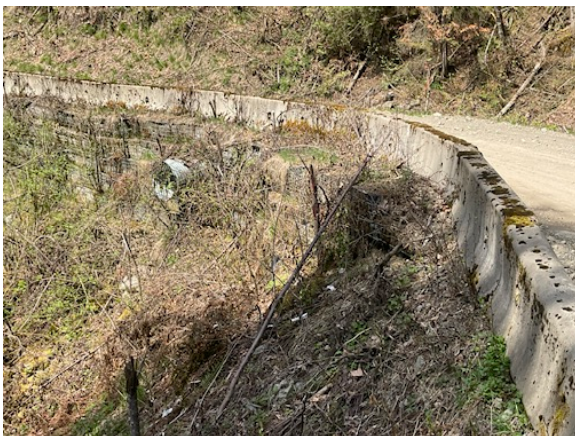
Wall given a fair rating because side of wall is compromised with no wire mesh as well as slight bulges in mesh near culvert. Foundation doesn't appear to be failing but vegetation makes it hard to tell.

Outlet and some bulging wwm facing
