# RWC-1005 2023 Inspection

Garnet 5.1km

**Retaining Wall Inspection Report**

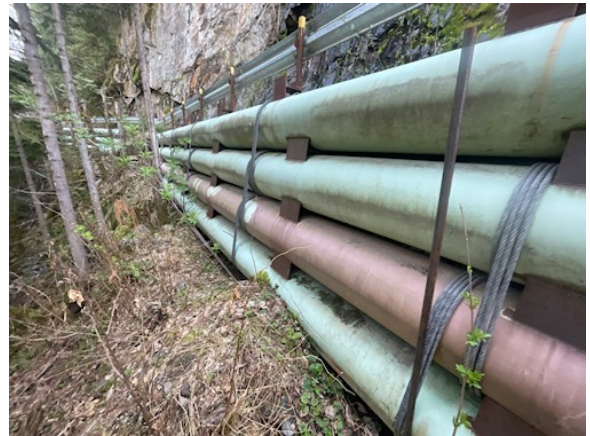
| | Rating | Comments |
|---|---|---|
| Retaining Wall Structure | Good | 4 500 mm diameter steel pipes anchored back to bed rock laced together with steal rope. |

Steel pipe and cable leash facing

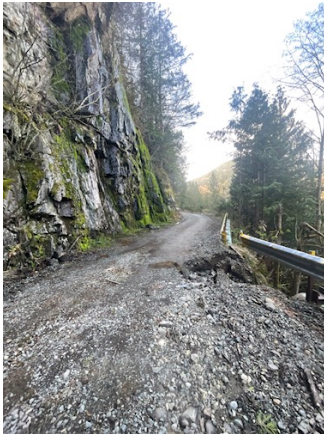
| | Rating | Comments |
|---|---|---|
| Surface Drainage | Poor | No high side ditch therefor water flowed beside the wall resulting in an erosion channel |
| Road | Fair | Excellent except where washout between walls. |

Approach from woods, erosion washout visible

| Item | Status | Priority | Description | Ministry Engineer Comment |
|---|---|---|---|---|
| 1 | Suggested | | Install ditch so water drains under cutslope. | |

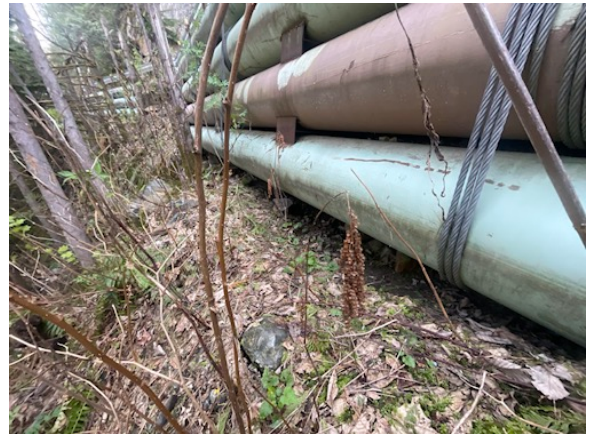
| | Rating | Comments |
|---|---|---|
| Foundation Material | Good | No erosion in foundation or signs of settling. |

Competent foundation

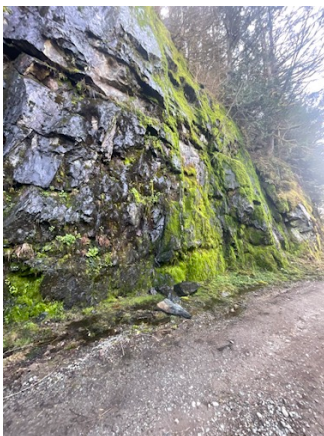
| | Rating | Comments |
|---|---|---|
| Upslope | Poor | Evidence of rock fall. No stopping sign in place. |

Rock fall debris

| Item | Status | Priority | Description | Ministry Engineer Comment |
|---|---|---|---|---|
| 2 | Suggested | | Rock scaling | |
