# RWC-1006 2023 Inspection

Garnet 5.11km

Structure Number RWC-1006

**Retaining Wall Inspection Report**

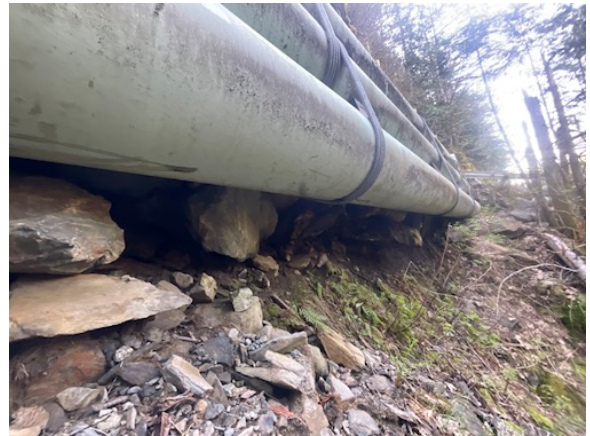
| | Rating | Comments |
|---|---|---|
| Foundation Material | Poor | The fill being retained is undercut me could easily erode out the bottom of the wall. |

| | Rating | Comments |
|---|---|---|
| Downslope | Poor | Whatever was keying in the foundation is failed downslope. |

Foundation being undermined with coarse road fill visible.

| Item | Frequency | Description | Ministry Engineer Comment |
|---|---|---|---|
| 1 | 1 year | Monitor foundation and check for subsidence. | |

Annual inspection recommended due to eroding and overhung foundation

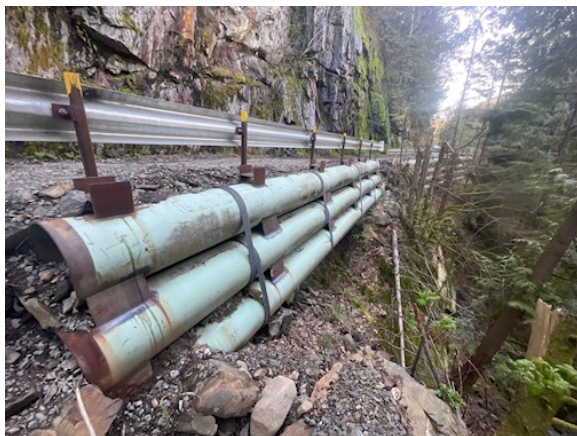
| | Rating | Comments |
|---|---|---|
| Wall Movement Indicators | Good | The structural elements like the cables and pipes are not in question, but they will have nothing to retain if the fill erodes from under. |

Wall facing (pipe and cable leash) with steel guard rails
