# RWC-1008 2023 Inspection

Garnet 5.4km

Structure Number RWC-1008

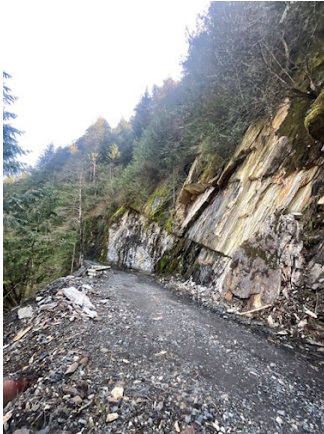
| | Rating | Comments |
|---|---|---|
| Upslope | Poor | Adverse rock structures and failures. Signs of recent rockfall with hang fire left behind. |

Approach from town and recent rock fall

| Item | Status | Priority | Description | Ministry Engineer Comment |
|---|---|---|---|---|
| 1 | Suggested | | Rock scalers should scale this cut bank especially above recent rock fall | |

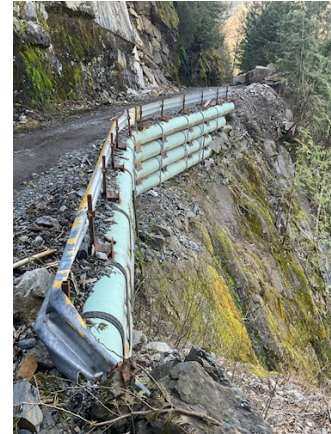
Wall founded on bedrock

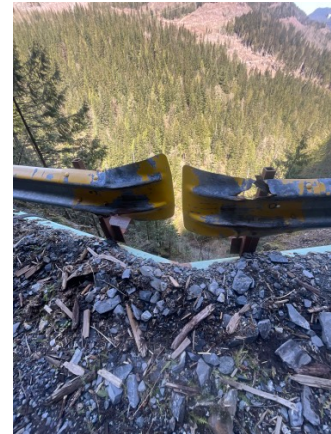
| | Rating | Comments |
|---|---|---|
| Traffic Barrier | Good | Some damage but still adequate. |

Guard rail damage

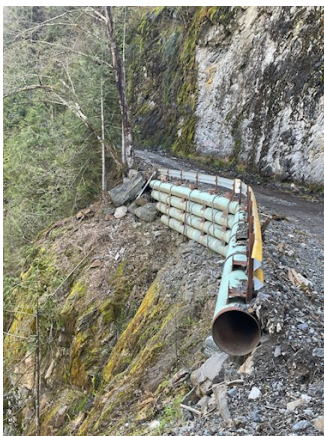
Wall founded on bedrock
