# RWC-1009 2023 Inspection

Garnet 5.5km

## Retaining Wall Inventory Data

Structure Number RWC-1009

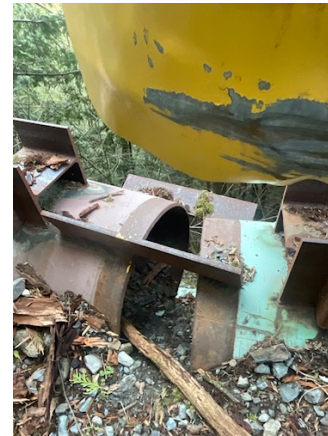
Pipe welded together

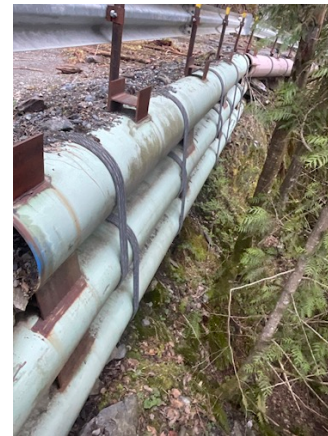
| | Rating | Comments |
|---|---|---|
| Foundation Material | Poor | Foundation is steeply dipping bedrock such that the fill will erode down at some point. Bottom pipe is overhung. |

Woods side facing questionable foundation

Must continue to monitor foundation erosion and cut bank condition / rock falls.

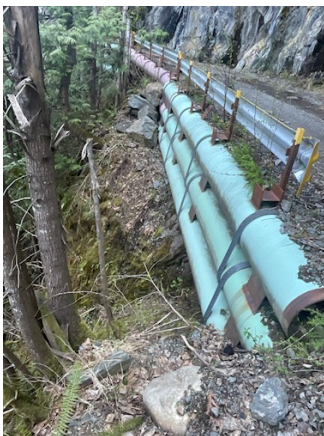
Wall facing with questionable foundation

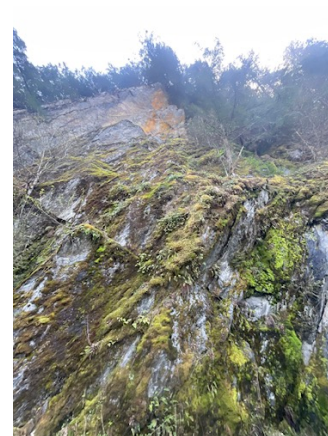
| | Rating | Comments |
|---|---|---|
| Upslope | Poor | Many overhangs and impending rock falls. Adverse structural conditions observed. |

Cut bank has shown many signs of failure with the road prism peppered with large divots and rock fall debris.

Rock fall hazard from above.

| Item | Status | Priority | Description | Ministry Engineer Comment |
|---|---|---|---|---|
| 1 | Suggested | | Cut bank should be scaled if use increases. | |
