# RWC-1010 2023 Inspection

Hunter 4.1km

Structure Number RWC-1010

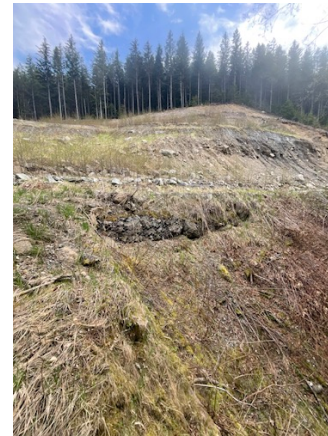
| | Rating | Comments |
|---|---|---|
| Foundation Material | Poor | Erodible channel. Looks to be some sag under middle gabion. |

Gabions on steep foundation

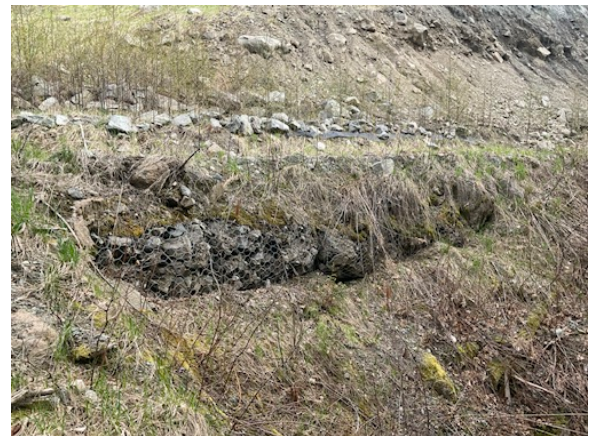
Foundation on gabions appears to be eroding and this wall should be inspected annually.

Gabion gravity wall showing some undermining.

Erosion at base

| Item | Frequency | Description | Ministry Engineer Comment |
|---|---|---|---|
| 1 | 1 year | Monitor annually | |
