# RWC-1011 2023 Inspection

Hunter 4.2km

## Retaining Wall Inventory Data

Structure Number RWC-1011

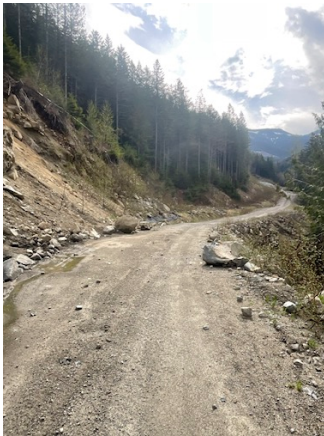
From town approach

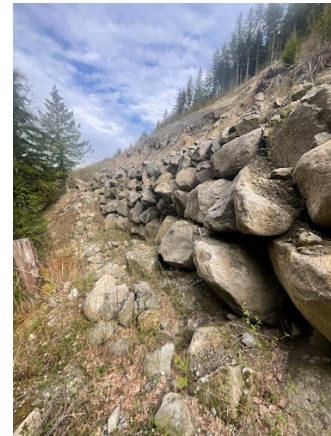
| | Rating | Comments |
|---|---|---|
| Retaining Wall Structure | Good | Large rock wall facing intact, #14 rebar dowels look good, geo textile visible and appearing to function as designed. Foundation is a flat terrace and looks fair. |

Wall facing

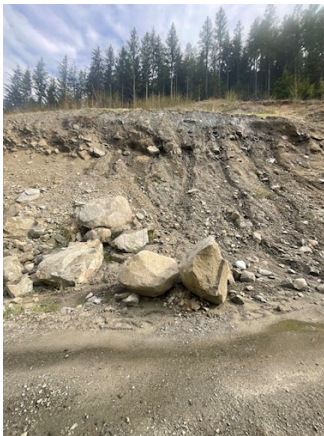
| | Rating | Comments |
|---|---|---|
| Road | Poor | Major rock fall from above. Will need to continually be cleaned up. |
| Upslope | Poor | Significant rockfall hazard. 2 m diameter boulders. |

The main concern for this wall is the observed instability of the upslope and rock falls.

Upslope rock debris

| Item | Status | Priority | Description | Ministry Engineer Comment |
|---|---|---|---|---|
| 1 | Suggested | High | Continue cleaning rockfall debris and cleaning ditch. | |

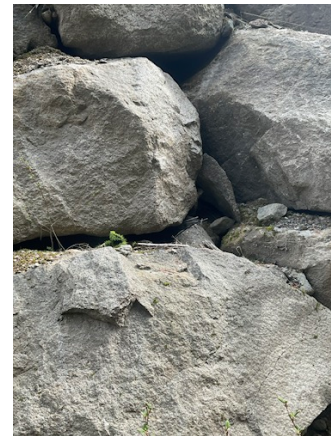
Geotextile

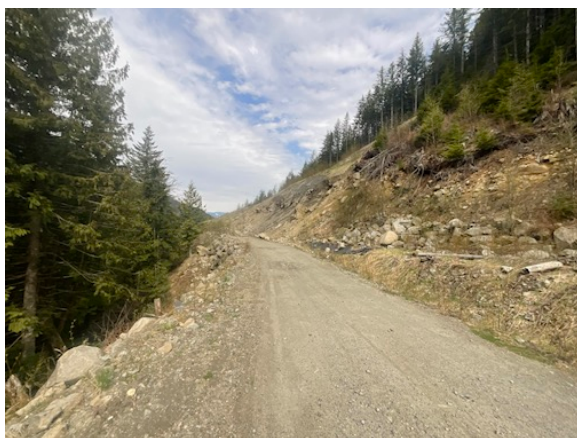
Approach from woods.

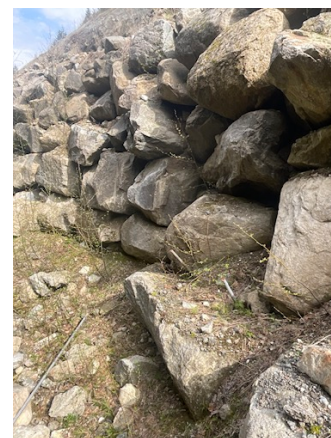
| | Rating | Comments |
|---|---|---|
| Foundation Material | Good | Flat soil with a terrace, rebar dowels reenforcing. Monitor this if it erodes back. |

Dowels foundation
