# RWC-1012 2023 Inspection

American 2.01km

## Retaining Wall Inventory Data

## Retaining Wall Inspection Report

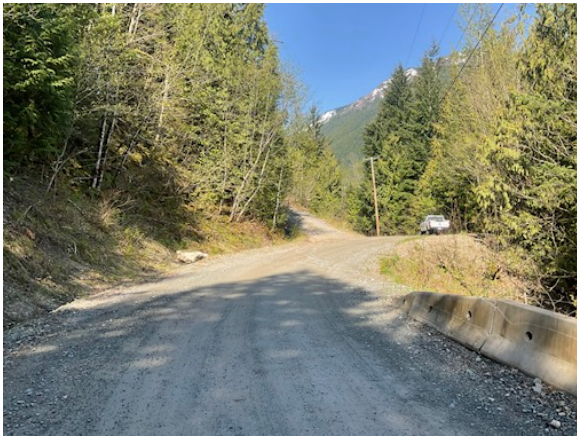
From Town approach

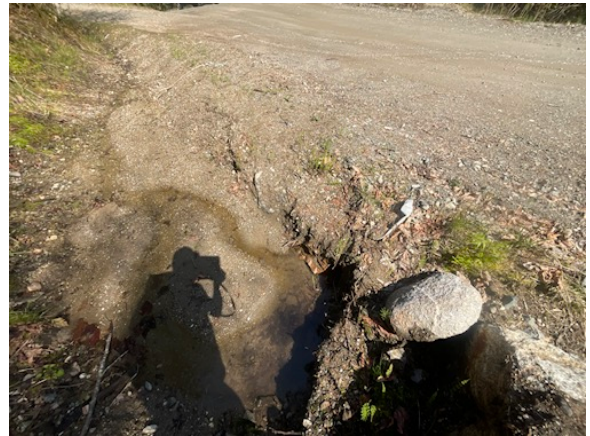
| | Rating | Comments |
|---|---|---|
| Drainage System | Poor | Although water is coming out of the CMP, inlet is plugged. Water could be flowing through failed road prism. Outlet water is diverted down slope to slow the inevitable erosion. |

| | Rating | Comments |
|---|---|---|
| Surface Drainage | Fair | There is a surface ditch but CMP inlet is plugged. |

CMP Inlet plugged

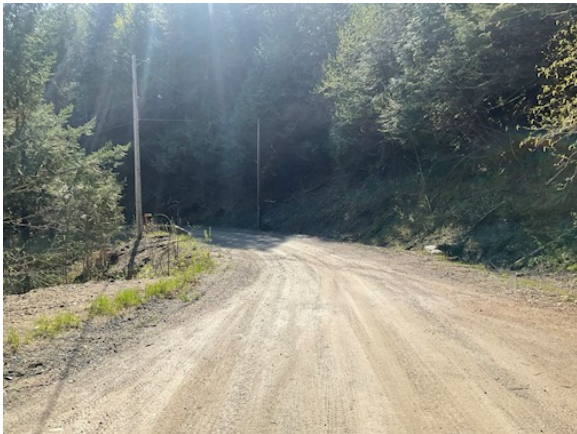
From Woods approach

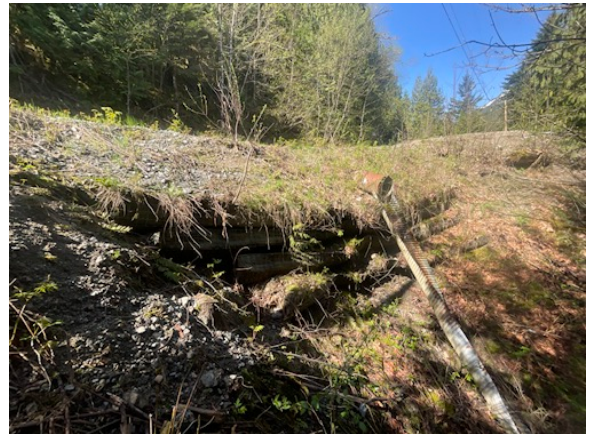
| | Rating | Comments |
|---|---|---|
| Retaining Wall Structure | Poor | Wall has essentially failed at the foundation. |
| Wall Movement Indicators | Poor | Wall is completely deformed with maximum sag in the Center. |

CMP outlet making water, but all elements of wall have failed. Each layer of mesh has failed as well as the whole foundation causing significant sagging in the middle

| Item | Status | Priority | Description | Ministry Engineer Comment |
|---|---|---|---|---|
| 1 | Required | High | Replace wall | |

Facing and foundation have failed. Recommend a new wall be designed and installed.

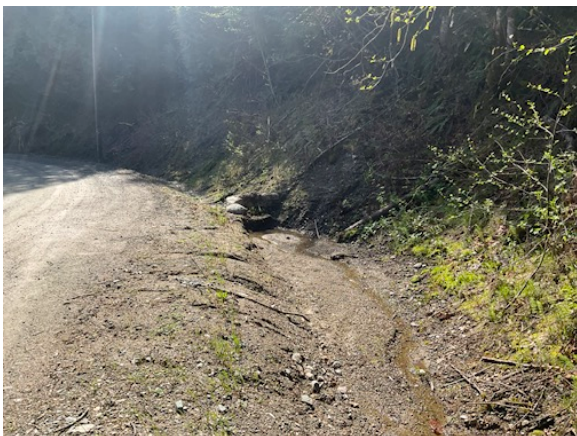
Functioning ditch

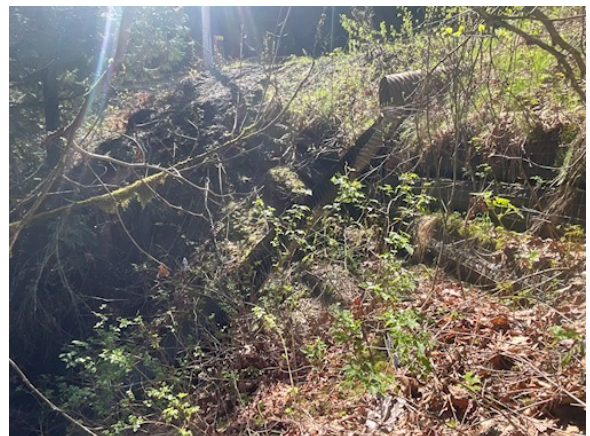
| | Rating | Comments |
|---|---|---|
| Foundation Material | Poor | Wall appears to be placed on cast over fill and is eroding and failing. |

Foundation appears to be cast over fill which is eroding.
