# RWC-1013 2023 Inspection

## Sumas Mountain 4.2km

### Retaining Wall Inventory Data

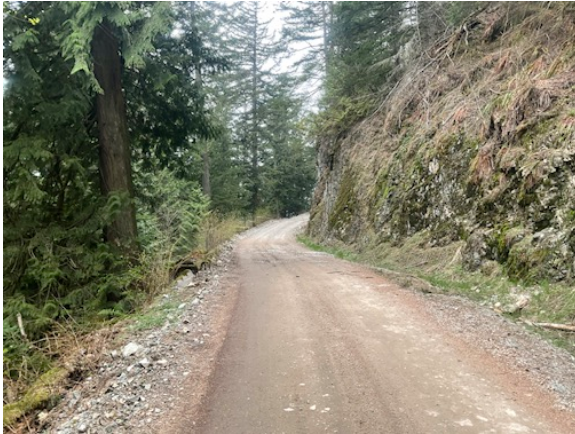
| | Rating | Comments |
|---|---|---|
| Drainage System | Fair | Ditch needs re establishing. |

| | Rating | Comments |
|---|---|---|
| Surface Drainage | Fair | Ditch needs cleaning from rockfall and general debris. |

Town approach, ditch needs work.

| Item | Status | Priority | Description | Ministry Engineer Comment |
|---|---|---|---|---|
| 1 | Suggested | High | Clean ditch | |

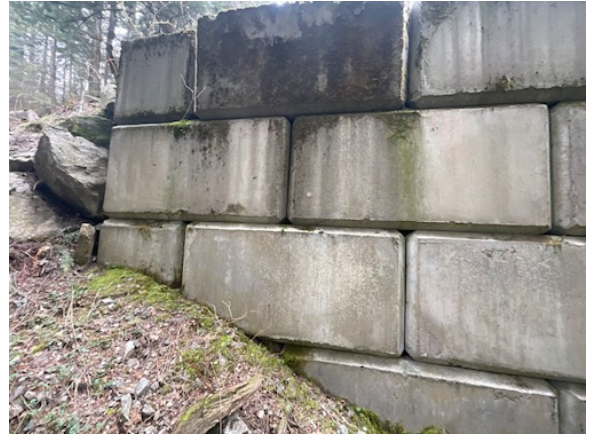
| | Rating | Comments |
|---|---|---|
| Lateral Slope | Good | Rip rap |

Woods lateral slope. Rip rap with Geo fabric

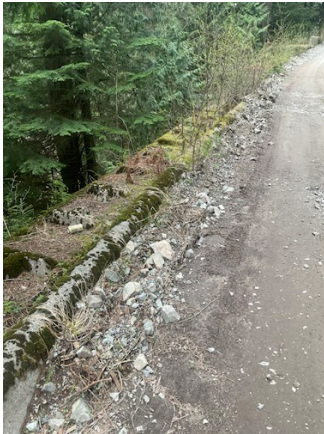
| | Rating | Comments |
|---|---|---|
| Traffic Barrier | Poor | Ends and only for portion of wall. Buried by road fill. |

Barrier needs to be re established

Wall is all in all in good shape. Some rockfall debris should be cleaned up and the barriers should be repaired such that they function as barriers instead of road fill retaining walls.

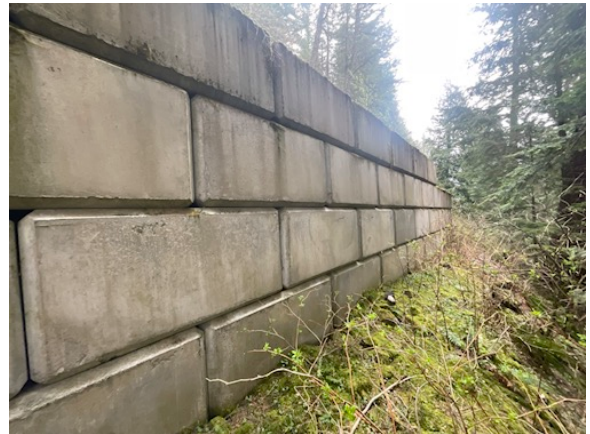
| | Rating | Comments |
|---|---|---|
| Foundation Material | Good | No settlement observed. |

Well founded wall

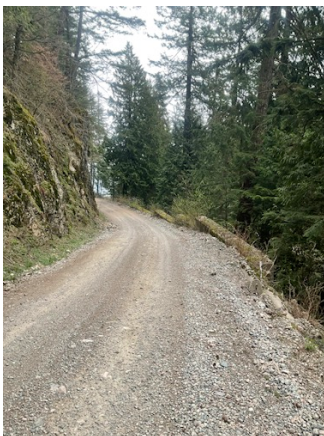
| | Rating | Comments |
|---|---|---|
| Upslope | Fair | Rock slope. Evidence of small failure visible. |

Woods approach, clean rock fall

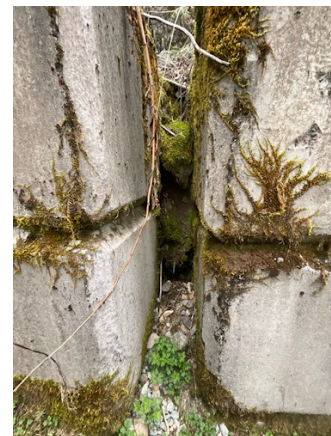
4 independent segments of lock blocks with some lateral stabilization elements observed in the gaps (bagged gravel).  
No settlement observed. The ditch needs to be cleaned up from a small rock fall.

Geotextile visible in gap
