# RWC-1014 2023 Inspection

Tamihi 3.1km

## Retaining Wall Inventory Data

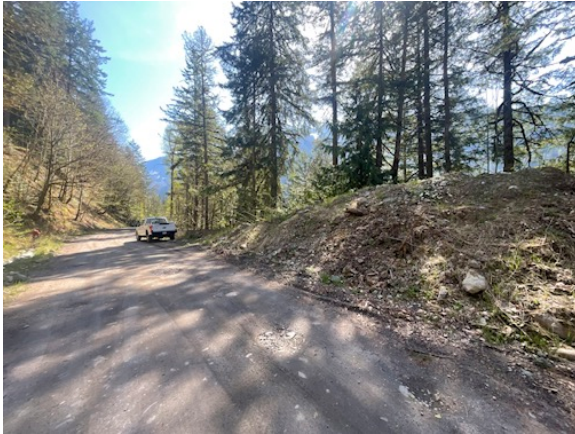
Town approach, remove spoil pile

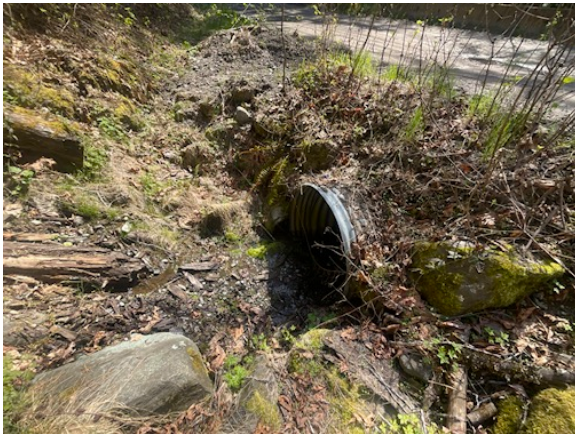
Inlet maintenance required

| Item | Status | Priority | Description | Ministry Engineer Comment |
|---|---|---|---|---|
| 2 | Suggested | Medium | Clean up culvert inlet. | |

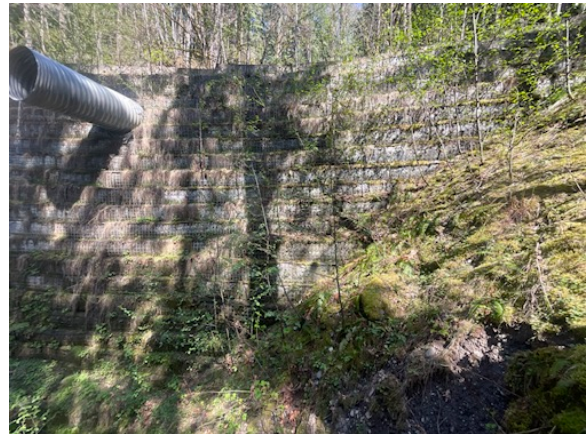
High wall with no signs of deformation.

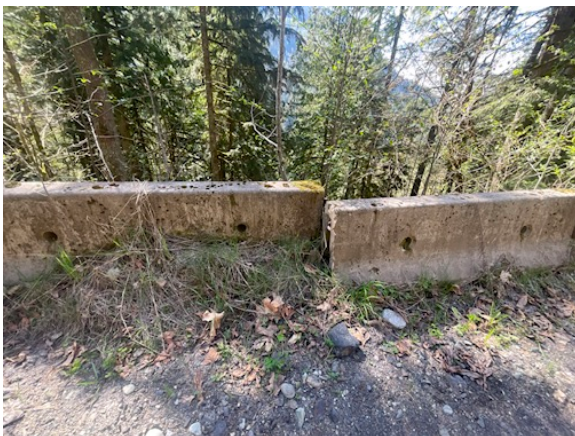
| | Rating | Comments |
|---|---|---|
| Traffic Barrier | Fair | One barrier unconnected. |

Connect the barriers

Barrier should be fixed as this wall is 11.5 meters high. Continue to monitor for signs of deformation and foundation erosion.

| Item | Status | Priority | Description | Ministry Engineer Comment |
|---|---|---|---|---|
| 1 | Required | High | Fix barriers at edge of wall | |
