# RWC-1015 2023 Inspection

Tamihi 3.4km

## Retaining Wall Inventory Data

## Retaining Wall Inspection Report

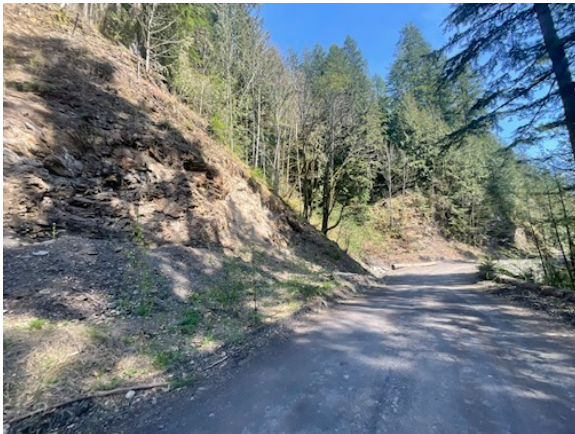
| | Rating | Comments |
|---|---|---|
| Upslope | Fair | Unstable rock slope however catch ditch and catch berm are present to mitigate the hazard. |

Approach from town, unstable slope above

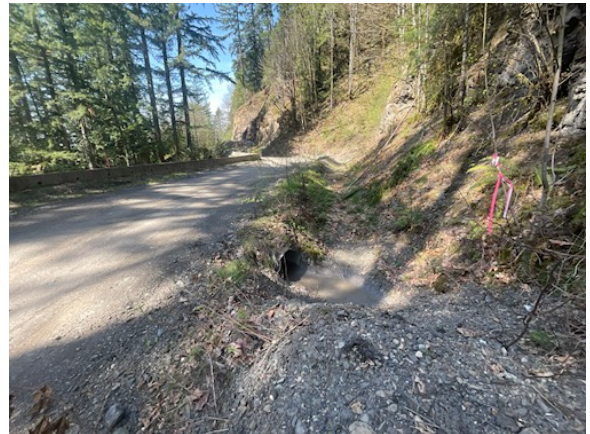
| | Rating | Comments |
|---|---|---|
| Drainage System | Fair | Two culverts but water pooling at inlet without being drained indicating culvert inlets are too high. |

| | Rating | Comments |
|---|---|---|
| Surface Drainage | Fair | Ditch doesn't properly drain water into culverts and results in residual ponds which keep the wall saturated for longer than optimal. This water could be causing the pre mature foundation erosion. |

Woods culvert has limited flow. Pool from town culvert should get here.

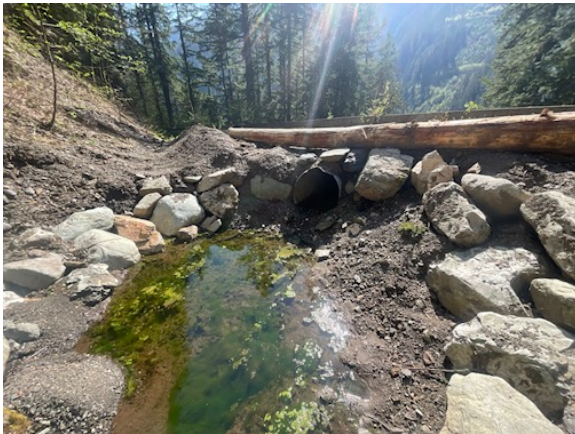
Town culvert inlet high.

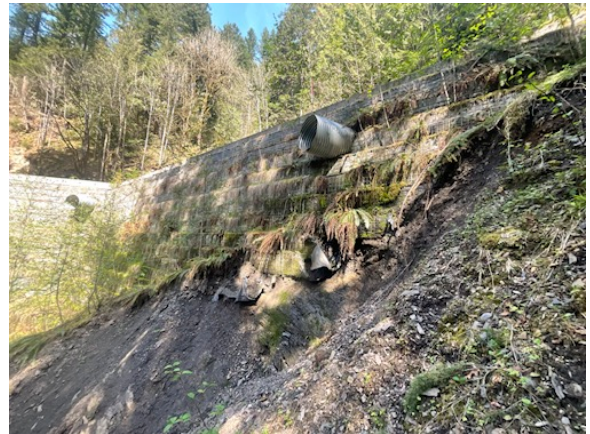
| | Rating | Comments |
|---|---|---|
| Foundation Material | Poor | Woods side eroding and causing wall failure with fill spilling out to downslope. |

| | Rating | Comments |
|---|---|---|
| Downslope | Poor | Foundation eroding on woods side. |

Woods culvert outlet. Failed wall below culvert. Seepage below culvert evident.

| Item | Frequency | Description | Ministry Engineer Comment |
|---|---|---|---|
| 1 | 1 year | Annual inspection due to foundation erodibility. | |

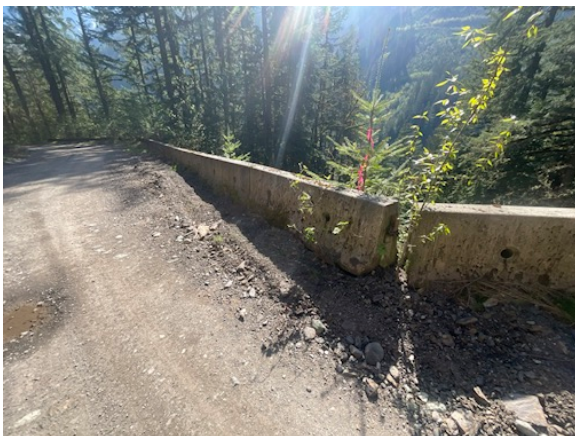
| | Rating | Comments |
|---|---|---|
| Traffic Barrier | Poor | Road fill material up to bottom 1/3 of traffic barrier. |

Road material scours down

| Item | Status | Priority | Description | Ministry Engineer Comment |
|---|---|---|---|---|
| 1 | Suggested | Medium | Repair barriers so they are full height on the road prism. | |

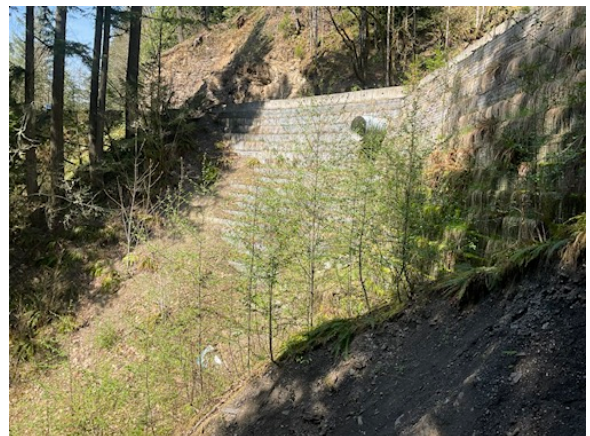
Town side of wall performing well
