# RWC-1016 2023 Inspection

Tamihi 3.7km

## Retaining Wall Inventory Data

**Retaining Wall Inspection Report**

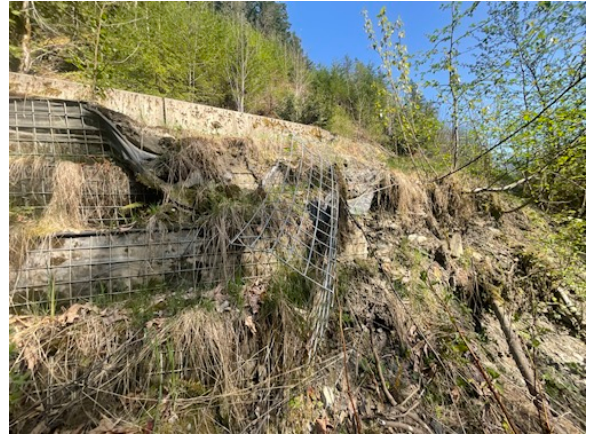
| | Rating | Comments |
|---|---|---|
| Retaining Wall Structure | Good | Welded wire mesh and geotextile are in good shape with some bulging noted in the bottom third of the wall where it appears saturated. Top of wall woods side shows some damage but since it's at top this can be repaired. |

Failed grs wall

| Item | Status | Priority | Description | Ministry Engineer Comment |
|---|---|---|---|---|
| 3 | Suggested | High | Repair top of wall woods side where fill has spilled out of failed wire mesh. | |

Repair failed elements of upper wall at woods side, clean culvert inlet, and reestablish traffic barrier.

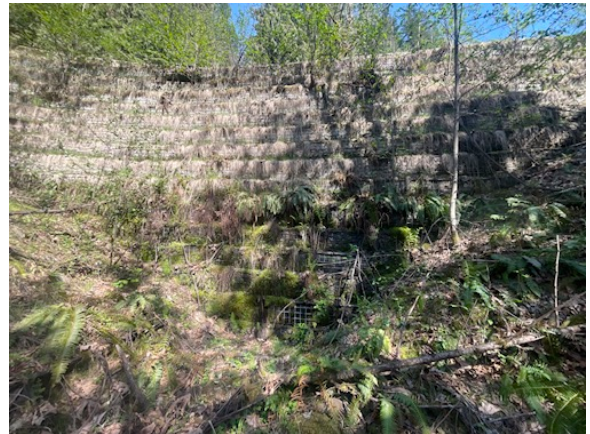
Seepage

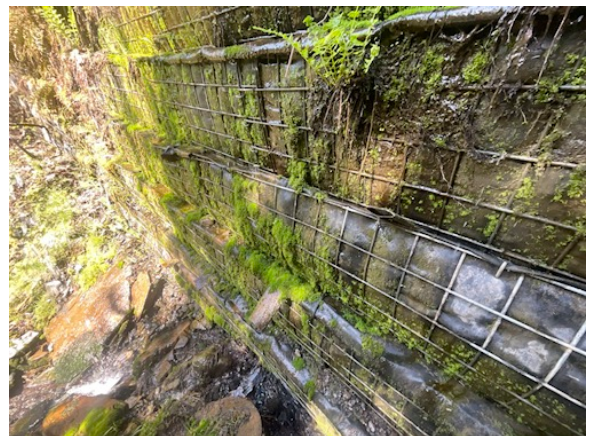
| | Rating | Comments |
|---|---|---|
| Wall Movement Indicators | Fair | Some bulging observed but no curves indicating foundation settlement observed. |

Bulging deformed wall town side
