# RWC-1017 2023 Inspection

Tamihi 4.1km

Structure Number RWC-1017

## Retaining Wall Inspection Report

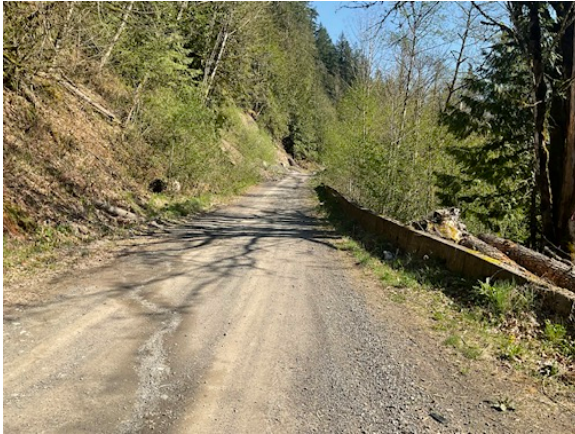
Town approach , upslope is good.

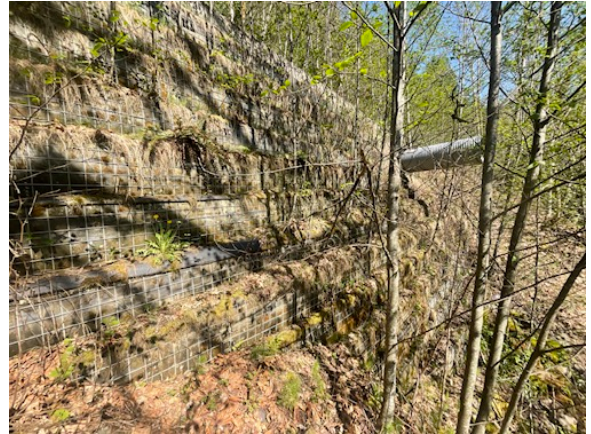
Wall facing. wwm tensioned up but not yielded.

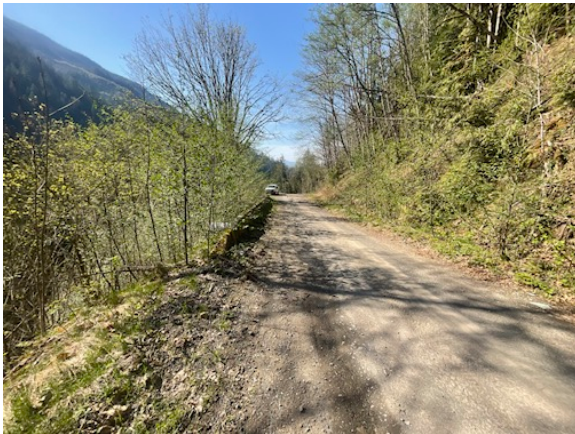
Woods approach, ditch is good.

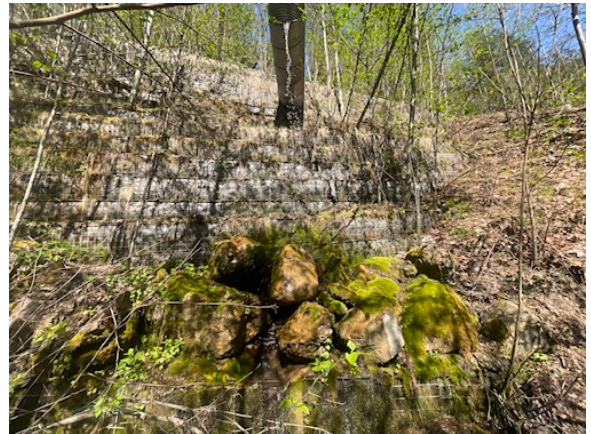
Splash pad and tensioned bulging wwm. Wicking socks visible.

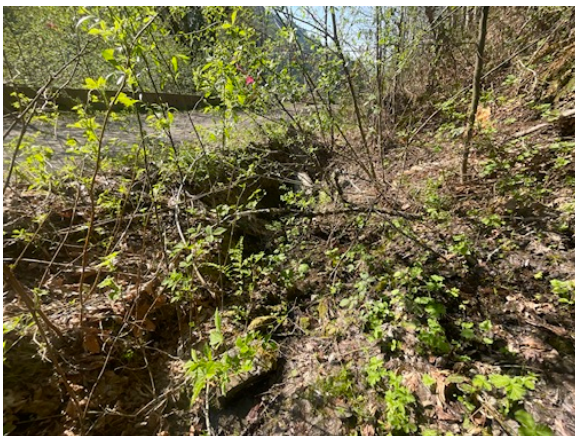
Culvert inlet brushy but functional
