# RWC-1018 2023 Inspection

Tamihi 4.15km

## Retaining Wall Inventory Data

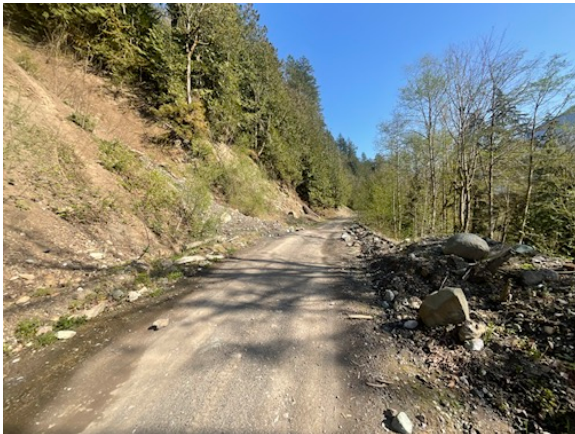
Town approach, unstable upslope and organic wood barrier

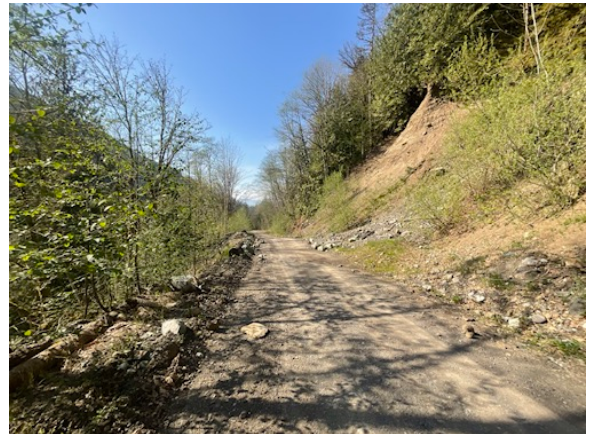
From woods approach. Unstable upslope and no ditch.

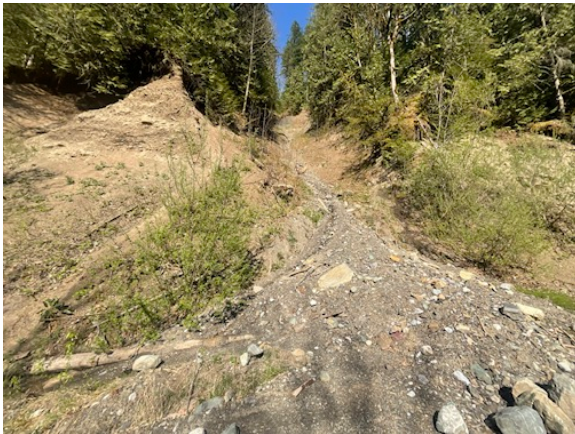
| | Rating | Comments |
|---|---|---|
| Surface Drainage | Poor | Upslope landslide filled up ditch. |
| Upslope | Poor | Landslide draw looks like it will continue to produce debris in rain events. |

Active landslide upslope. Filled in culvert and ditch.

Landslide debris should be cleaned so culvert inlet is exposed. Monitor annually.

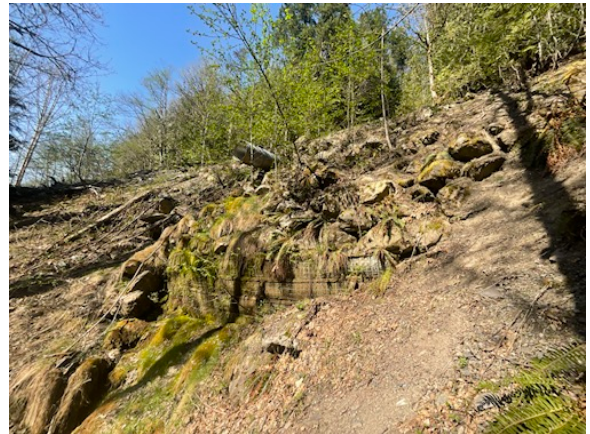
| | Rating | Comments |
|---|---|---|
| Retaining Wall Structure | Fair | Wall showing bulging of the mesh as well as sagging in middle of wall. |

Bulging GRS wall combined with a very unstable upslope result in this wall getting a fair to poor rating. Continue monitoring annually.

Bulging grs wall under stacked rocks. Seepage and water is somehow getting to culvert.

| Item | Frequency | Description | Ministry Engineer Comment |
|---|---|---|---|
| 1 | 1 year | Annual inspections for this wall showing signs of deformation. | |

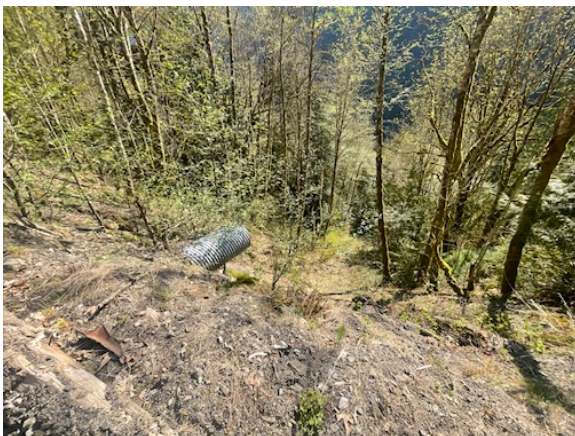
Downslope and culvert.
