# RWC-1019 2023 Inspection

Tamihi 4.2km

Structure Number RWC-1019

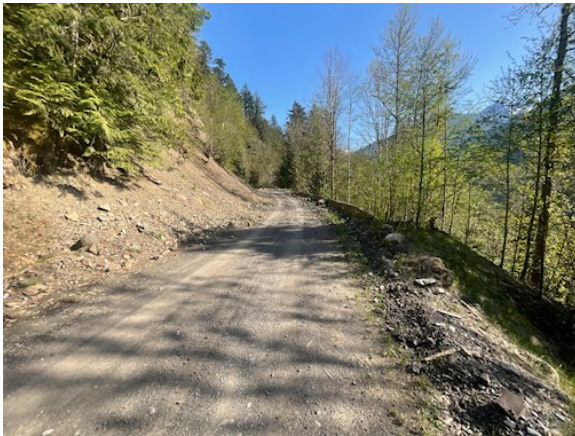
Town approach, unstable upslope.

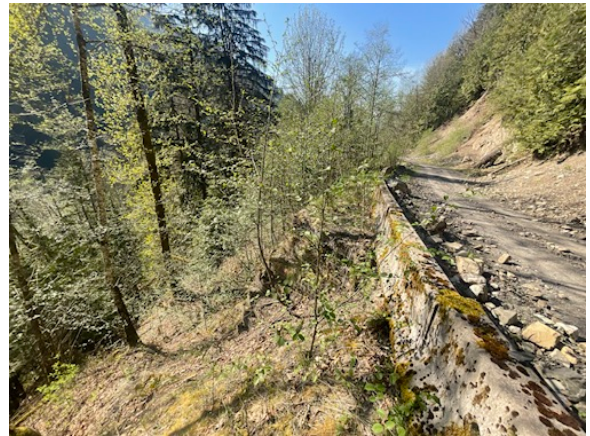
| | Rating | Comments |
|---|---|---|
| Foundation Material | Good | Stacked rocks appear to be holding up well. Failing wall appears to be located in wall rather than foundation. |

Grs wall on mse stacked rocks.

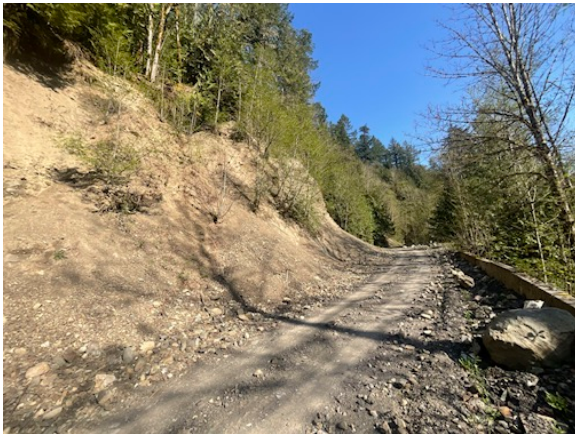
Big rock rolled into barrier.

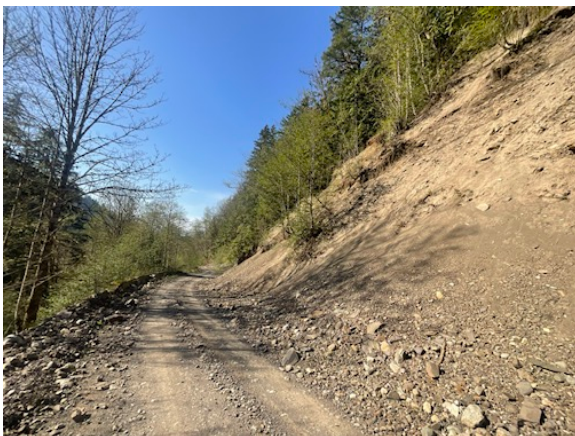
Woods approach no ditch.

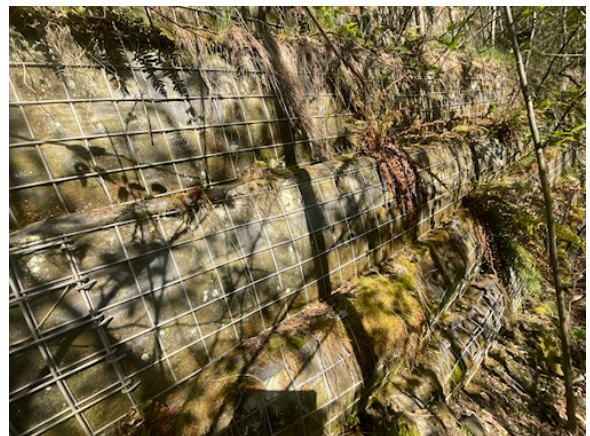
| | Rating | Comments |
|---|---|---|
| Retaining Wall Structure | Poor | Still functioning but very apparent bulging and signs of stress indicating the wall is yielding. |

GRS elements indicating signs of high stress. Monitor annually to assess progress of bulging.

Failing layer in bottom grs system.

| Item | Frequency | Description | Ministry Engineer Comment |
|---|---|---|---|
| 1 | 1 year | Monitor annually | |
