# RWC-1020

## 2023 Inspection

### Retaining Wall Inventory Data

### Retaining Wall Inspection Report

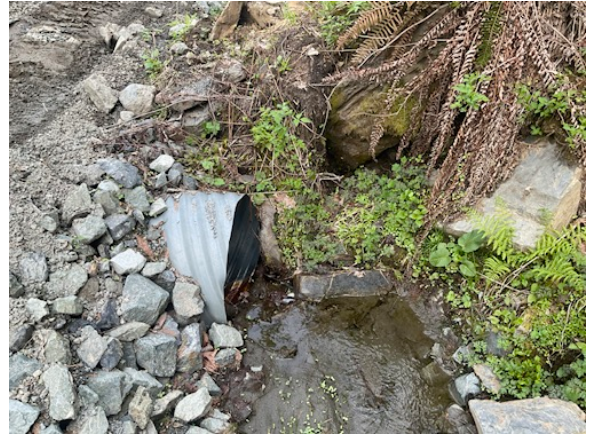
| | Rating | Comments |
|---|---|---|
| Drainage System | Good | Upper culvert inlet starting to be plugged |

Upper culvert inlet partial plug

| | Rating | Comments |
|---|---|---|
| Surface Drainage | Good | Culvert inlet should be unplugged. |

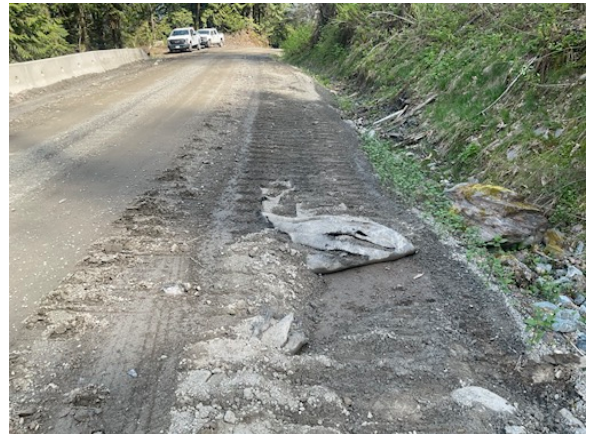
| | Rating | Comments |
|---|---|---|
| Road | Good | Some geotextile observed on road surface. |

Geotextile on road

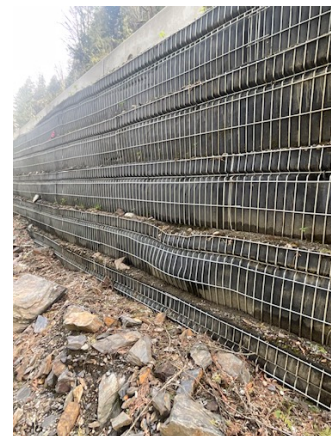
| | Rating | Comments |
|---|---|---|
| Wall Movement Indicators | Fair | Some suspicious bulging observed above loose foundation. |

Wall built in late 2021 as a GRS wall with galvanized welded wire mesh and woven geotextile facing. Drainage is done by a combination of 6" performances pvc at the toe and 600mm culverts draining from the road ditch. Only note of concern is some bulging in the mesh at the bottom indicating potentially some early settling or failure.

Bulging

Wall is performing very well, however next inspection should focus on foundation and how the observed bulging is performing over time.
