# RWC-1021

## 2023 Inspection

### Retaining Wall Inventory Data

### Retaining Wall Inspection Report

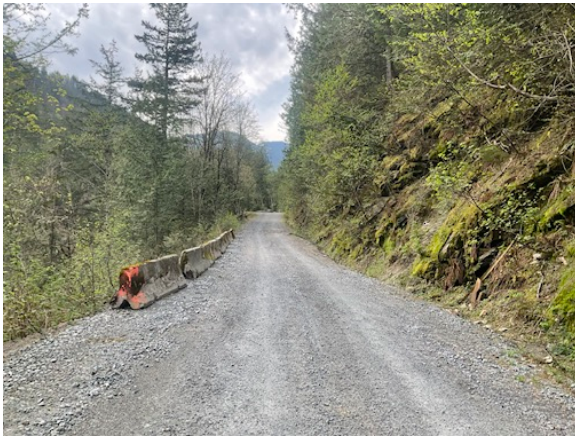
From town approach

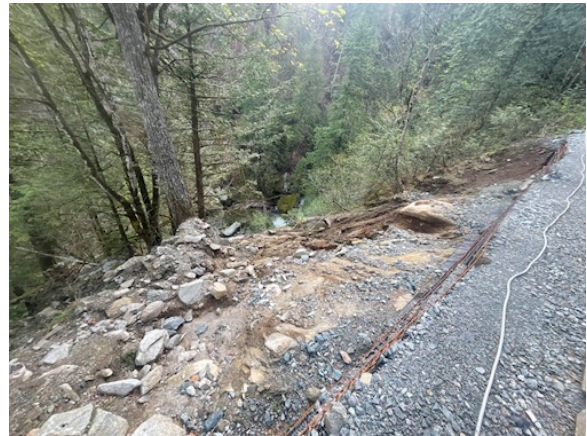
| | Rating | Comments |
|---|---|---|
| Lateral Slope | Fair | Steep vegetated slope with river below. |

Slope below wall down to creek

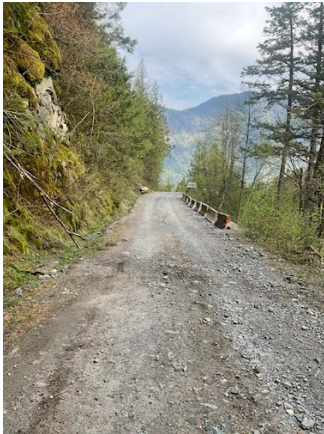
| | Rating | Comments |
|---|---|---|
| Surface Drainage | Excellent | French drain diverts water to cross ditch |

From woods approach. Note cross ditch diverting water to ditch.

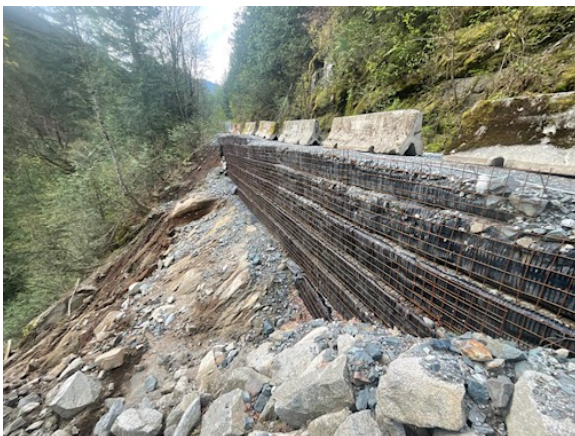
| | Rating | Comments |
|---|---|---|
| Retaining Wall Structure | Excellent | New structure appears well built and well founded. Facing mesh isn't galvanized and is rusting. |

Well constructed GRS wall showing no signs of failure. Foundation is visible bedrock. At least one square over lap for all the welded wire mesh. Some bunched up geosynthetic observed on facing and this will continue to be monitored.

GRS wall face
